# 2022 Systemwide Safety and Capacity Study

June 30, 2023

Maine Turnpike Authority  
2360 Congress Street  
Portland, ME 04102

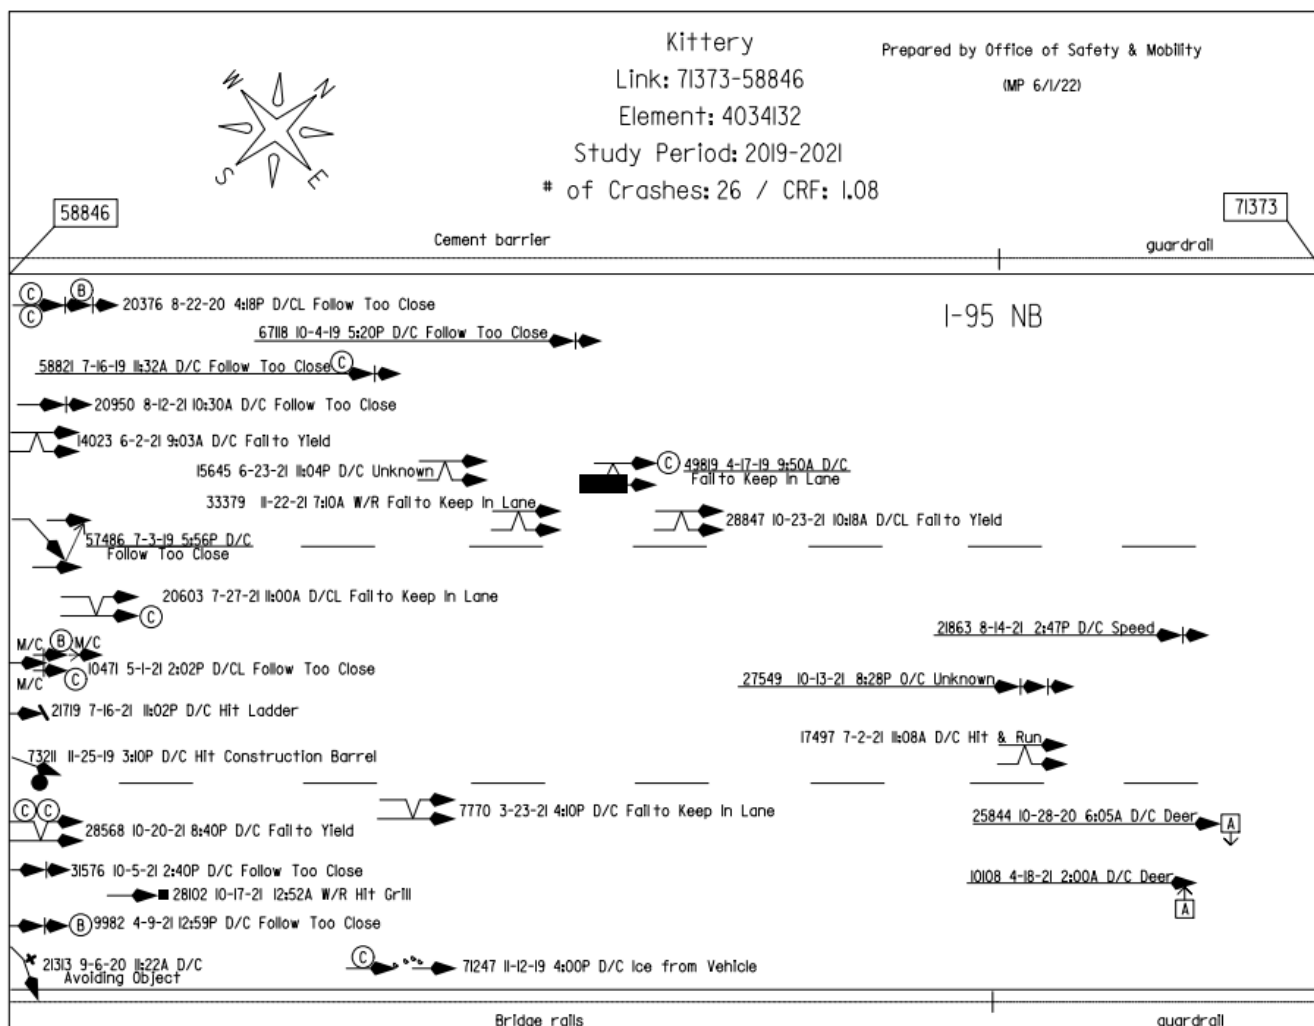
**Figure 2: 2019 – 2021 NB Crash Diagram**

As shown in **Figure 2**, there were 26 crashes resulting in a 30.8% injury rate during this analysis period.

- Nearly 70% of the crashes occurred in 2021, during the peak summer and fall months when volumes were highest
- 73% of crashes were rear-end – sideswipe type crashes
- Of the recorded causes, crashes were most often a result of vehicles following too closely (7), not staying in their lane (4), and failing to yield (3)
- Injury crashes in this location follow the same patterns as overall crashes, with the most severe crashes caused by vehicles following too closely

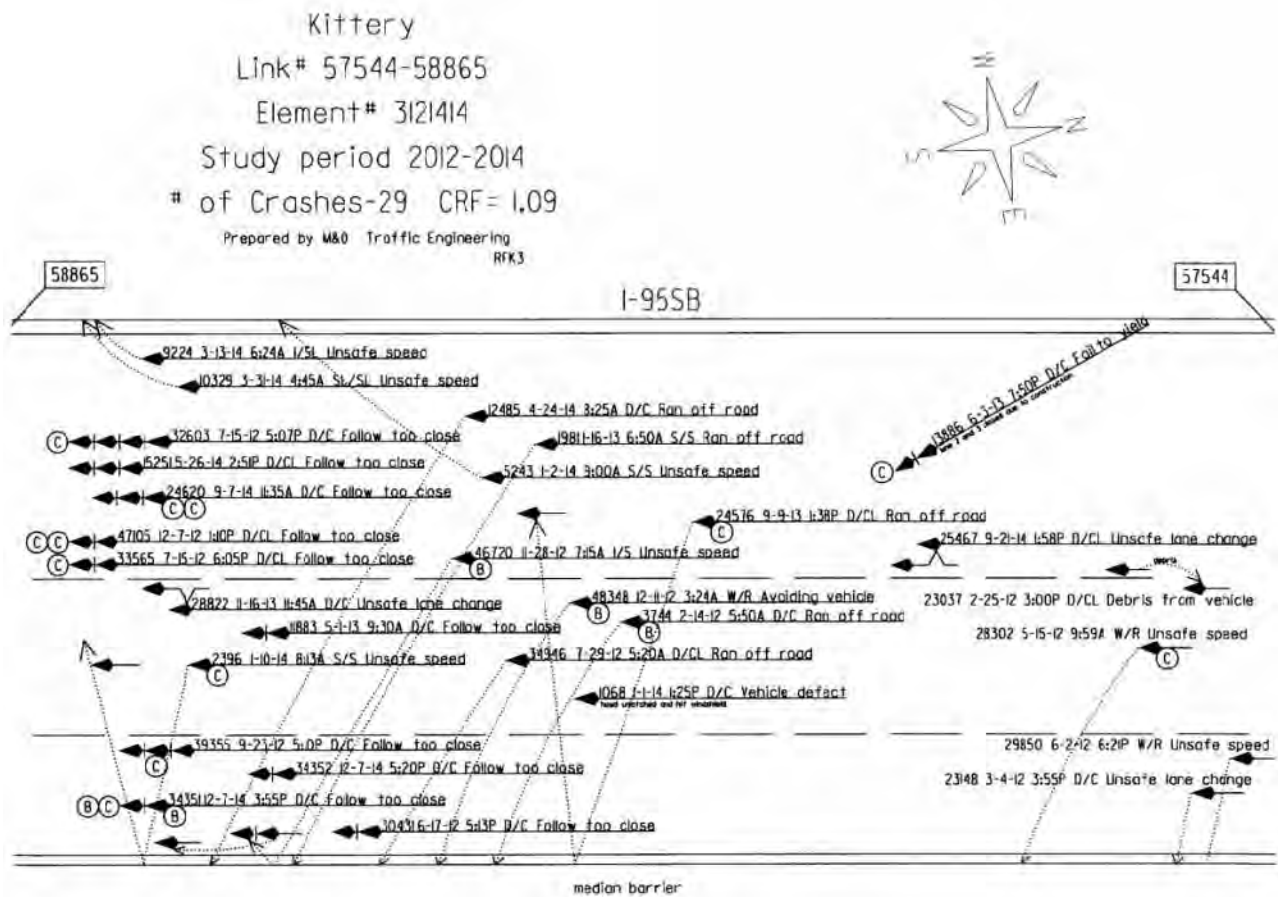
**Figure 3: 2012 – 2014 SB Crash Diagram**

As shown in the diagram, there were 29 crashes resulting in a 44.8% injury rate during this analysis period.

- 34% of crashes occurred on a Sunday
- 52% of crashes were rear-end – sideswipe type crashes
- Of the recorded causes, crashes were most often a result of vehicles following too closely (10), unsafe speed (6), and running off the road (4)
- Injuries were most frequent in crashes caused by vehicles following too closely

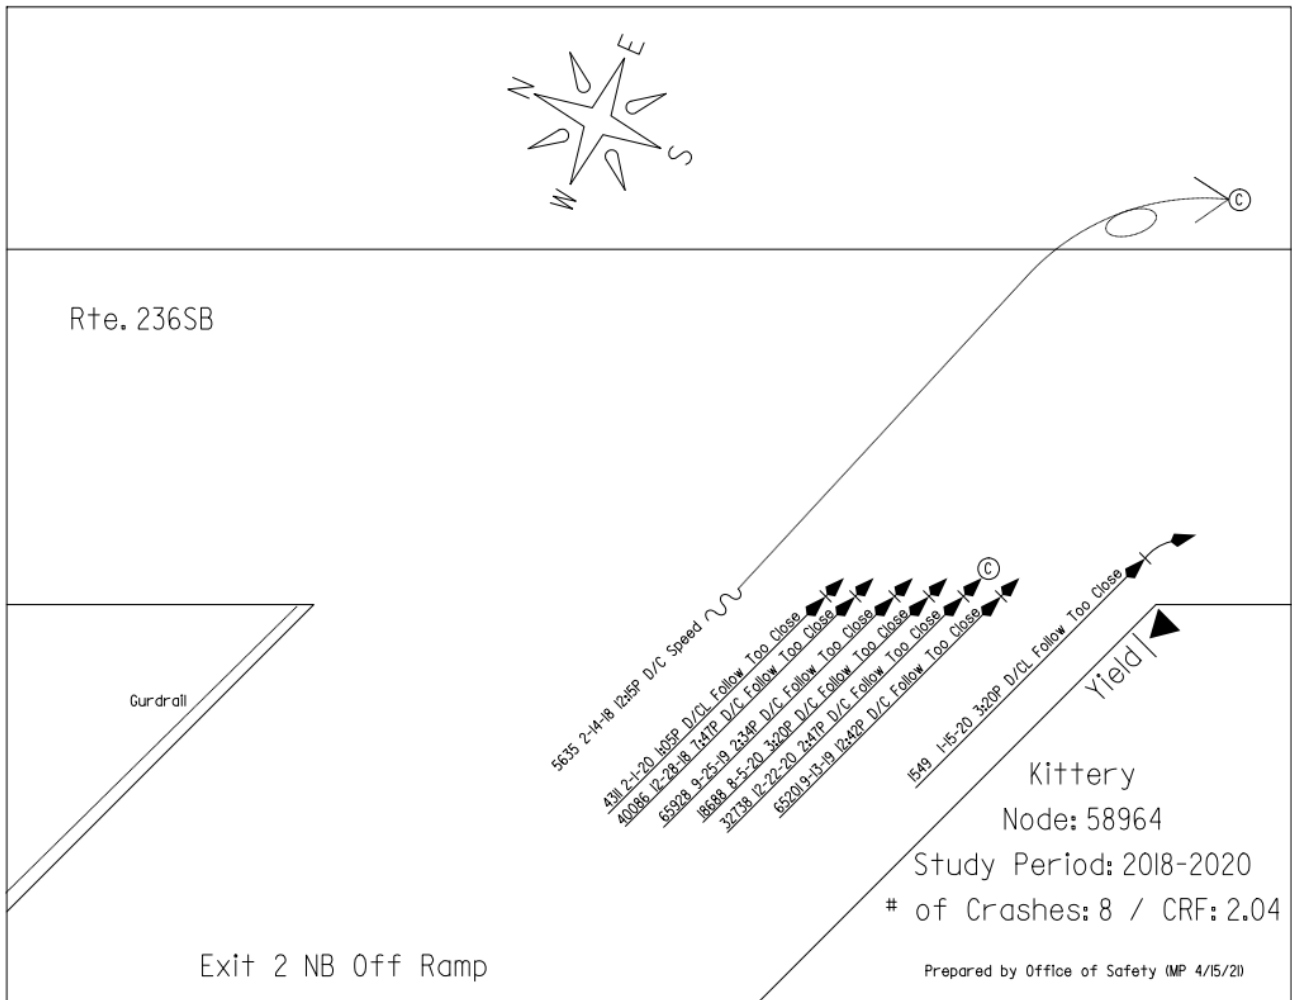
**Figure 3: 2018 – 2020 NB Crash Diagram**

As shown in **Figure 3**, there were 8 crashes resulting in a 12.5% injury rate.

- All crashes but one were caused by vehicles following too close trying to enter Route 236.
- All crashes but one were rear-end – sideswipe type crashes

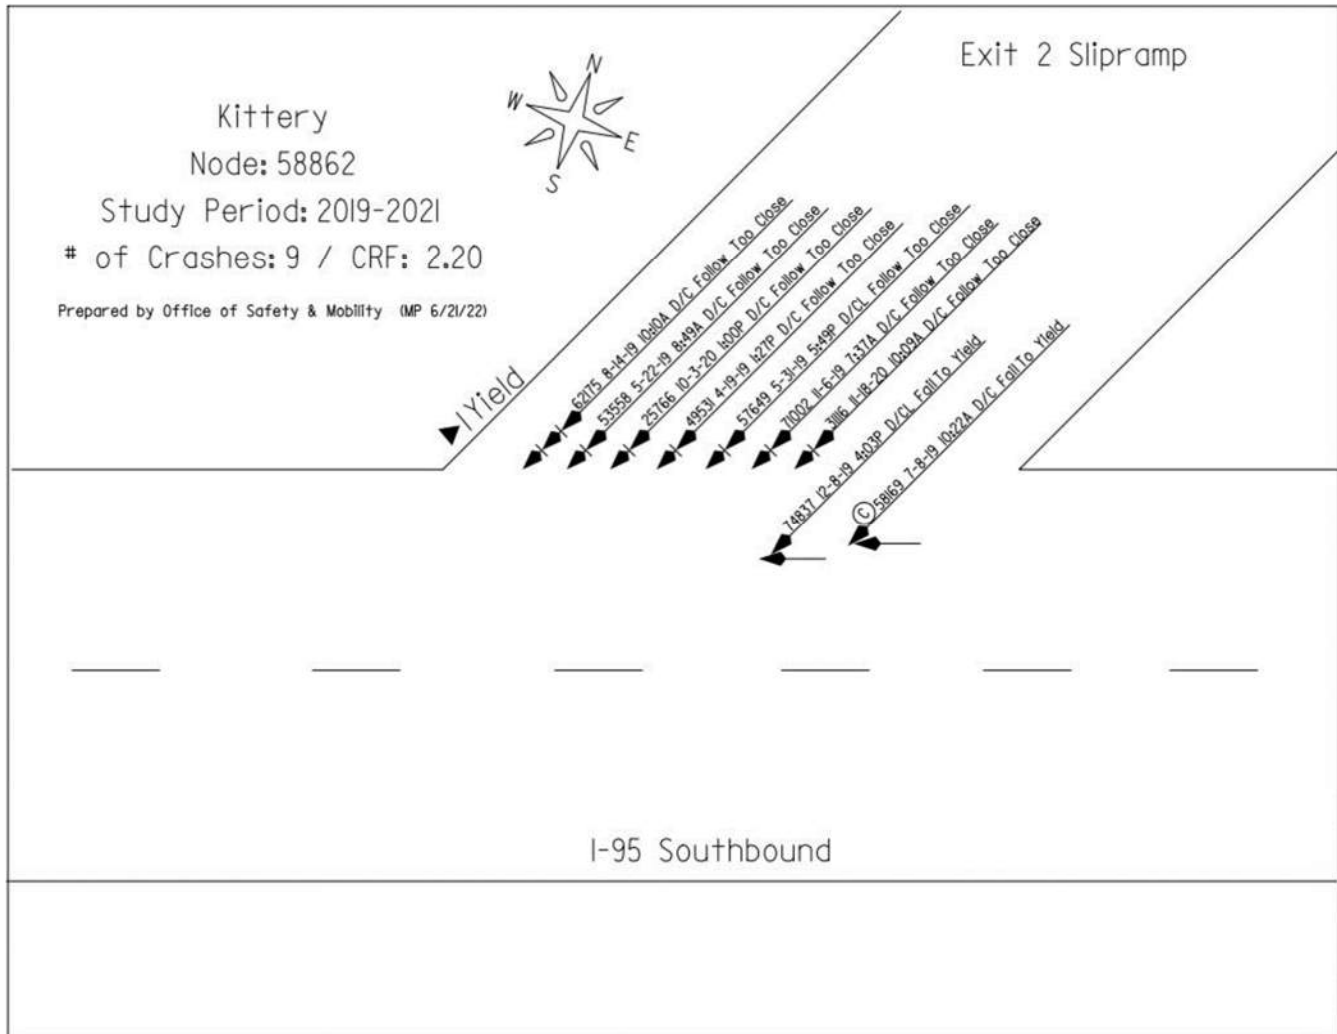
**Figure 2: 2019-2021 Southbound Exit 2 On Ramp Merge Crash Diagram**

As shown in **Figure 2**, there were 9 crashes resulting in a 11.1% injury rate during this analysis period.

- The crashes during the most recent HCL period were almost exclusively as a result of following too close along the slip ramp (9 crashes)
- The other two crashes were a result of failure to yield
- These crash types are typical in areas of high congestion such as this, especially at yield-controlled movements where vehicles are trying to identify mainline gaps.
- One of these crashes resulted in injury
- While it was nearly an even split between crashes at this location occurring during the morning or afternoon, lighting does not appear to be an impacting factor as all crashes occurred during typical daylight hours

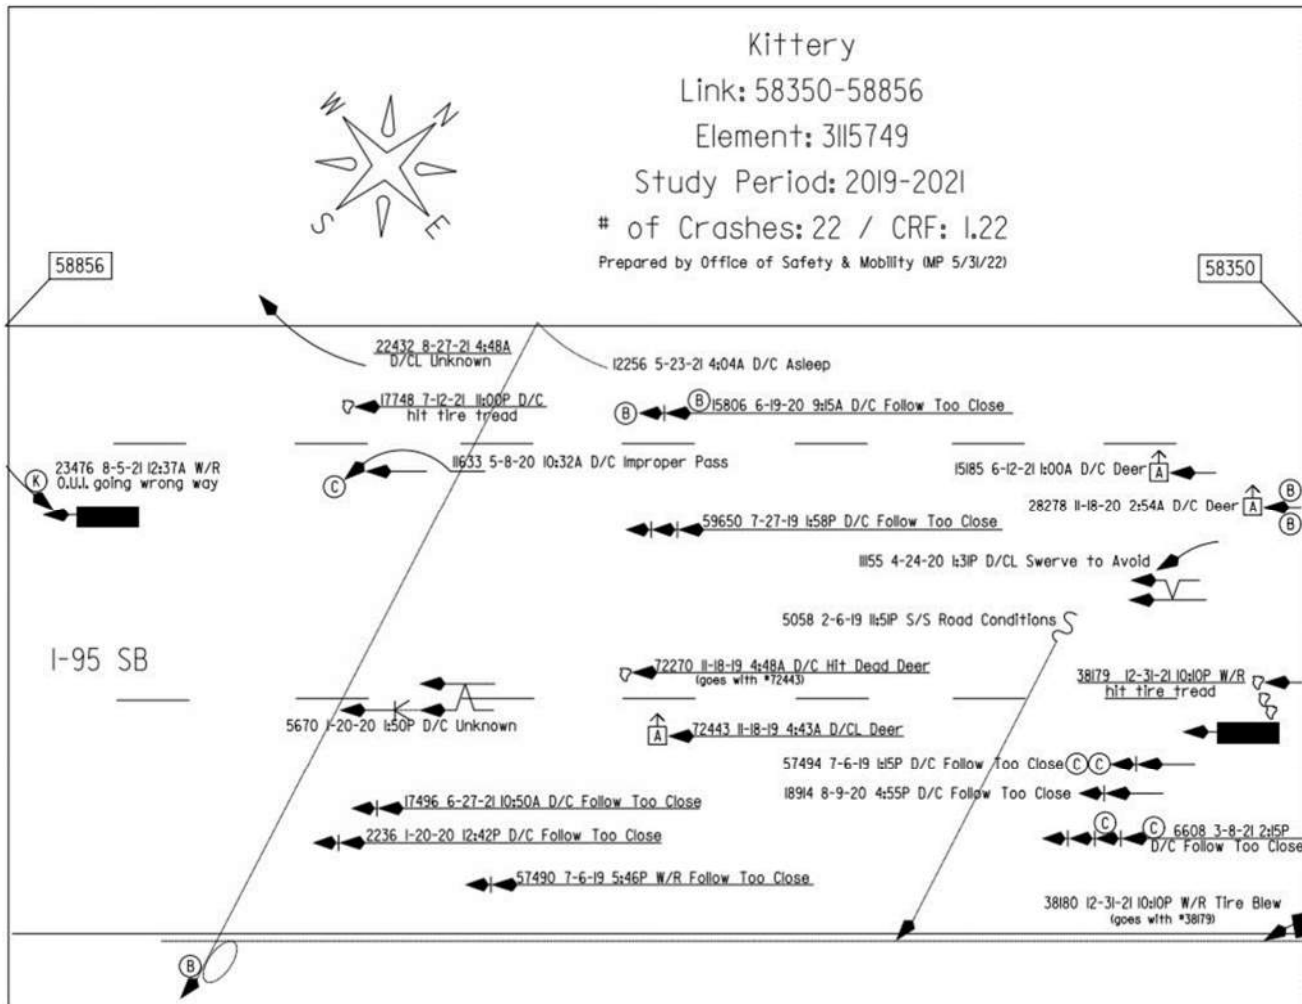
**Figure 3: 2019-2021 I-95 SB Just North of C-D Split Crash Diagram**

As shown in **Figure 3**, there were 22 crashes resulting in a 31.8% injury rate during this analysis period.

- 8 of the crashes included in the diagram (36%) were a result of vehicles following too close, which is a typical crash cause in locations of high congestion
- 6 crashes (27%) were a result of drivers hitting animals or debris in the roadway
- There was 1 fatality included in this HCL diagram, which was caused by a driver under the influence driving the wrong way on the Turnpike
- The majority of these crashes occurred during the summer months which is when there is the highest percentage of unfamiliar drivers traveling for recreational purposes

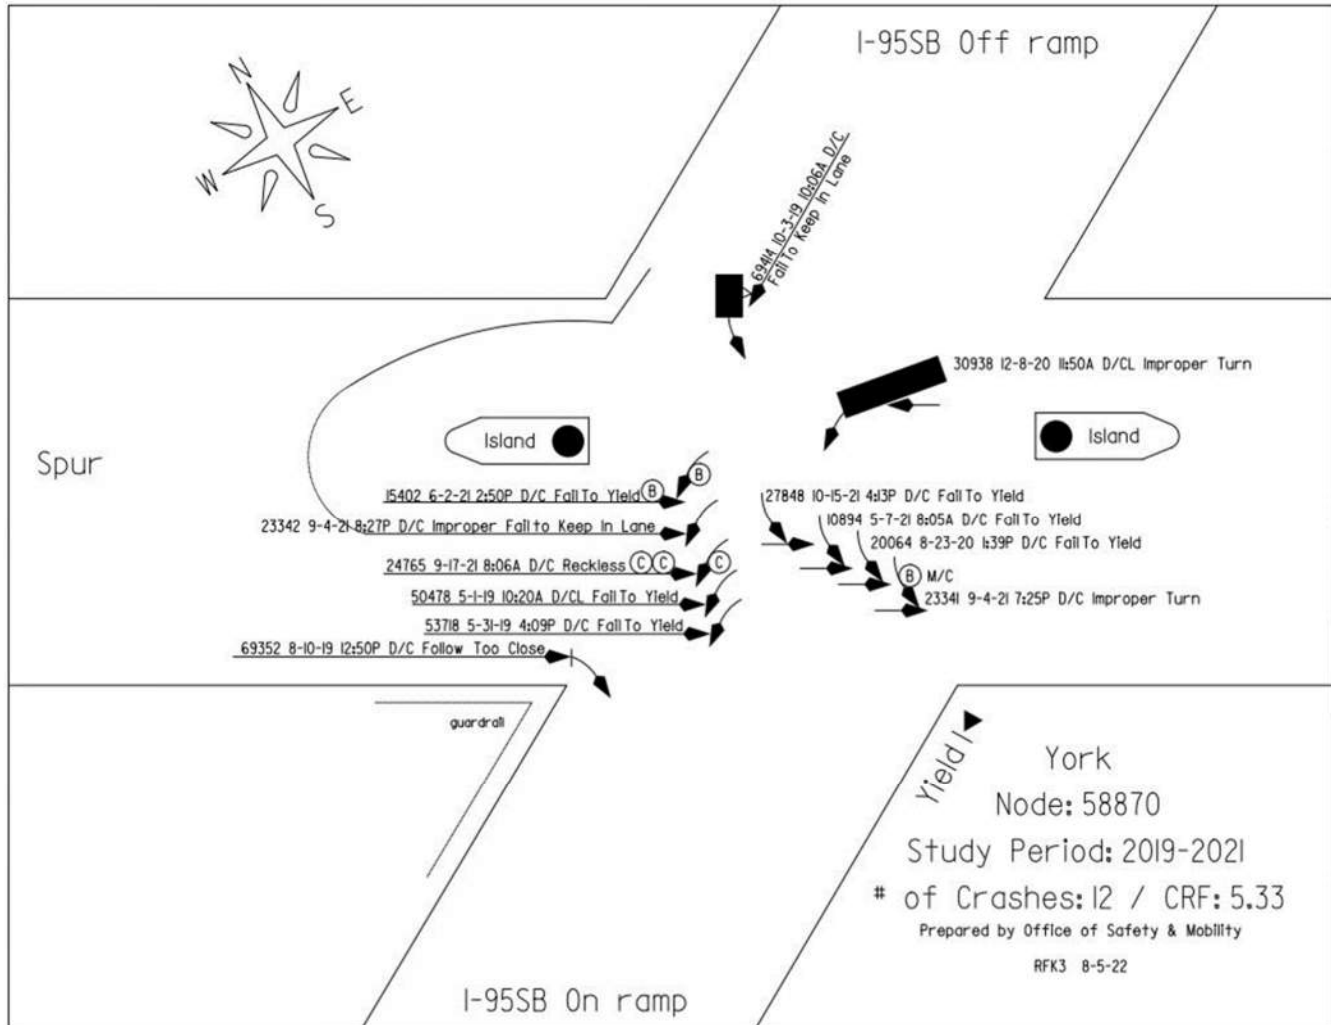
**Figure 2: 2019-2021 Exit 7 Southbound Ramps Intersection Crash Diagram**

As shown in **Figure 2**, there were 12 crashes resulting in a 25% injury rate during this analysis period.

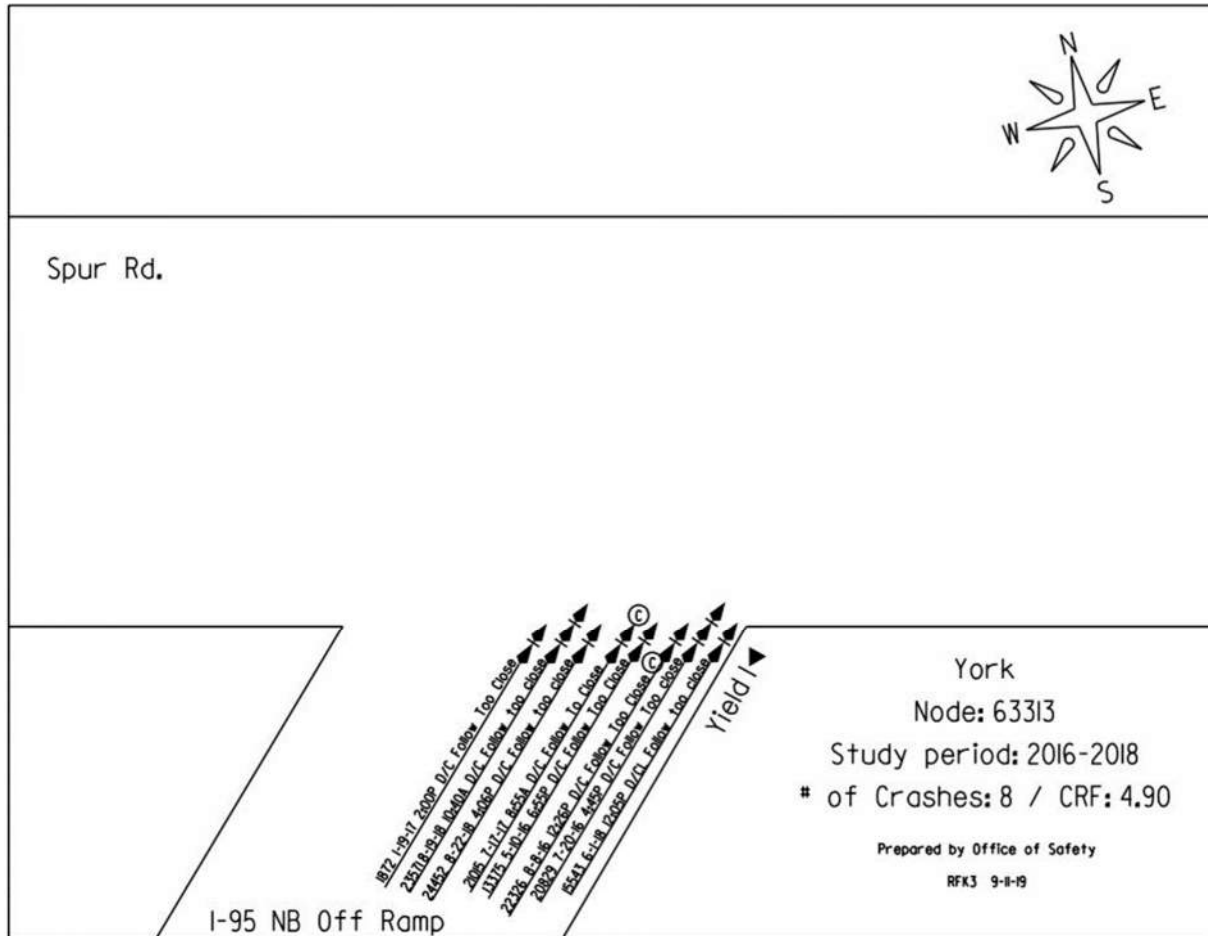
**Figure 3: 2016-2018 Exit 7 Northbound Off Slip Ramp Lane Merge Crash Diagram**

As shown in **Figure 3**, there were 8 crashes resulting in a 25% injury rate during this analysis period.

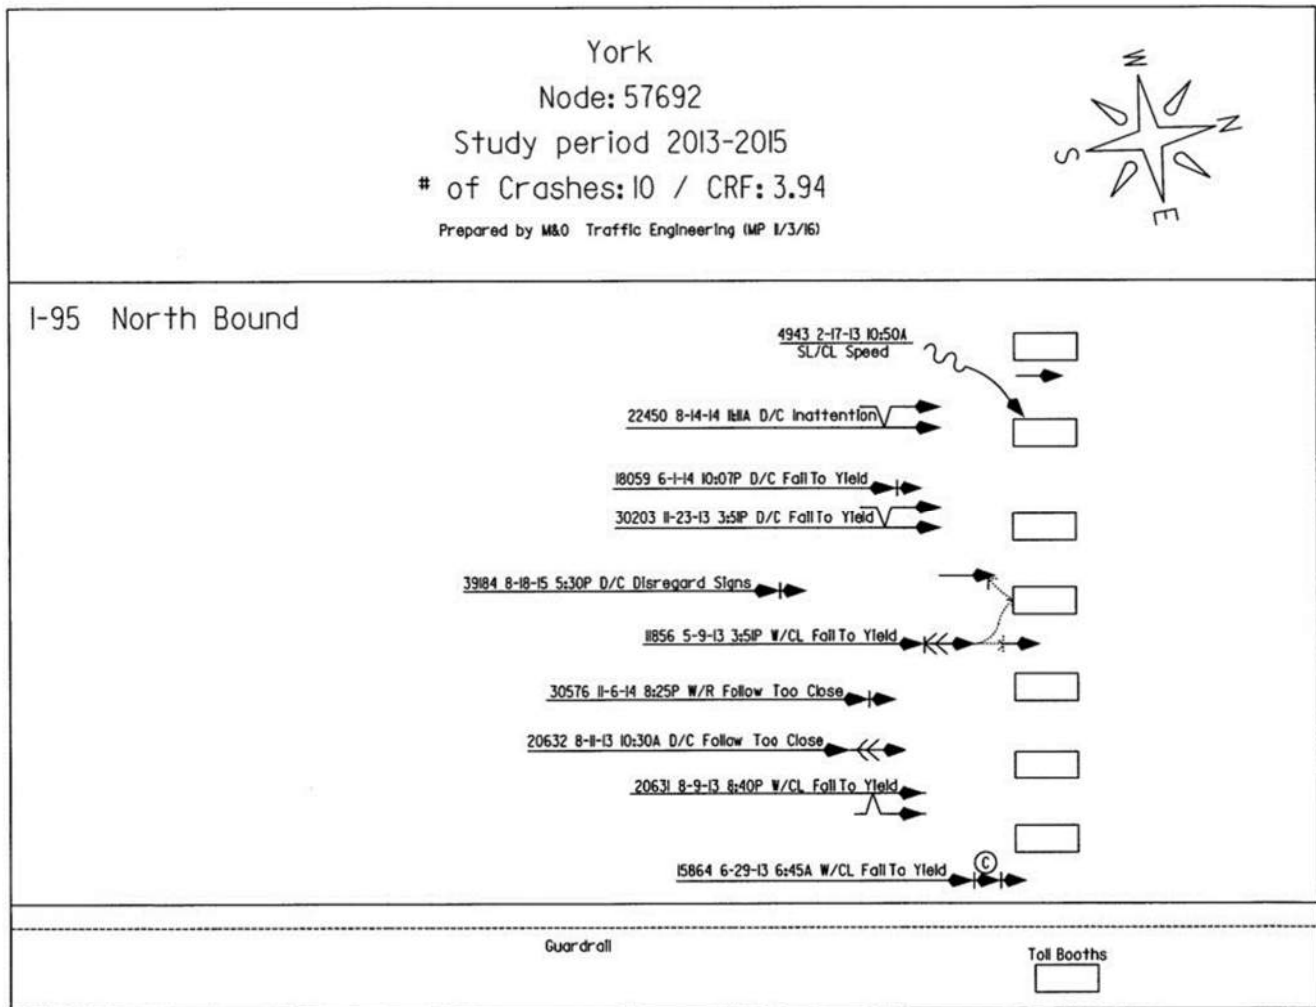
**Figure 2: 2013-2015 Old York Toll NB Crash Diagram**

As shown in **Figure 2**, there were 10 crashes resulting in a 10% injury rate during this analysis period.

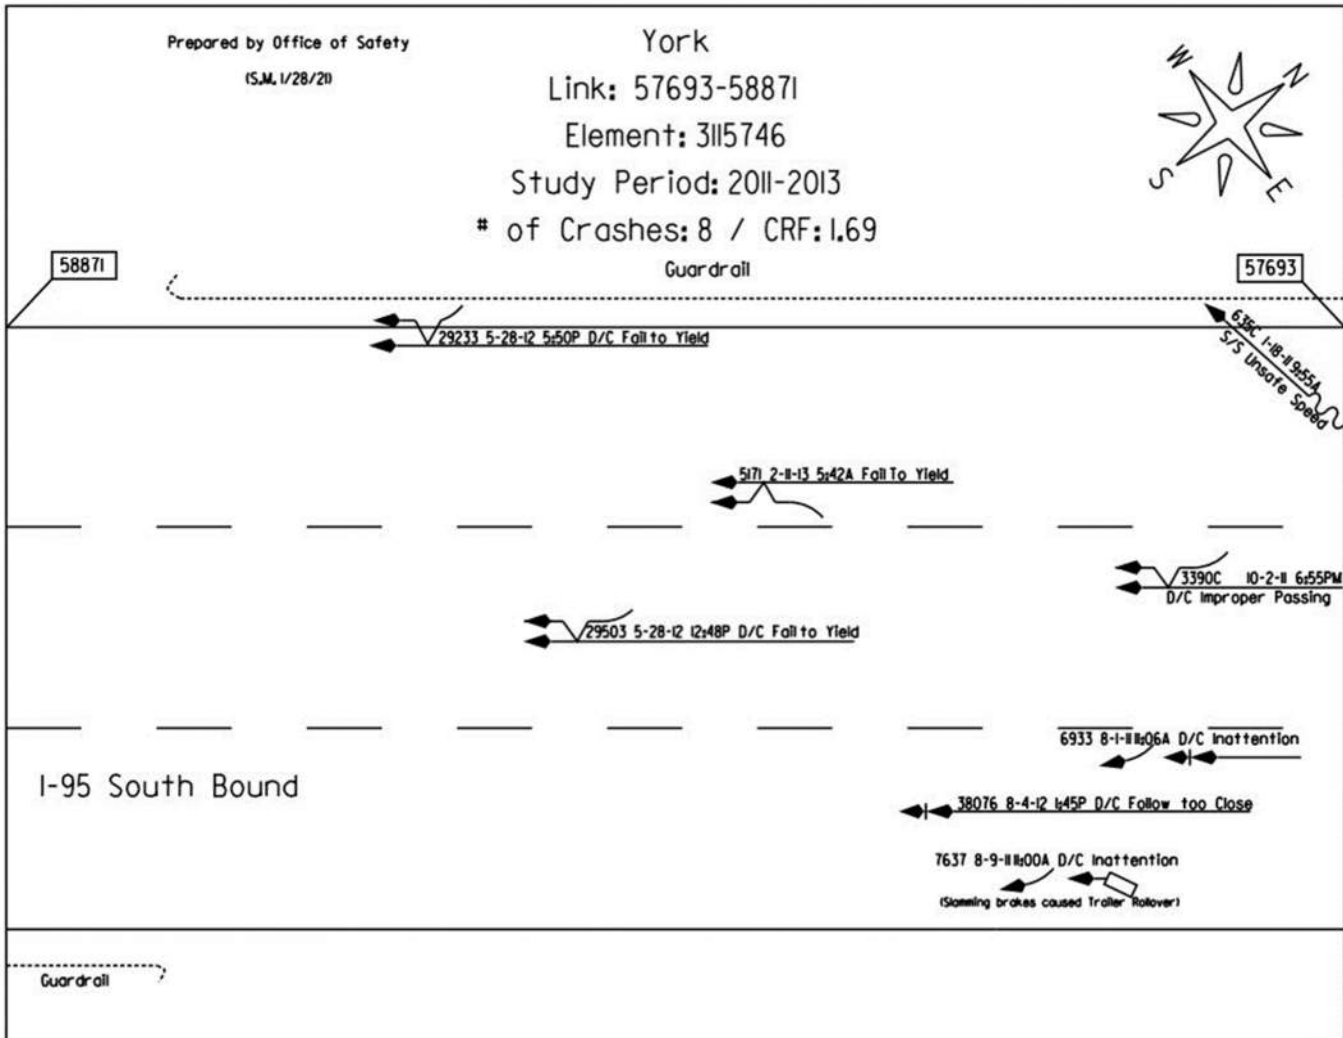
**Figure 3: 2011-2013 South of Old York Toll Plaza SB Crash Diagram**

As shown in **Figure 3**, there were 8 crashes resulting in a 0% injury rate during this analysis period.

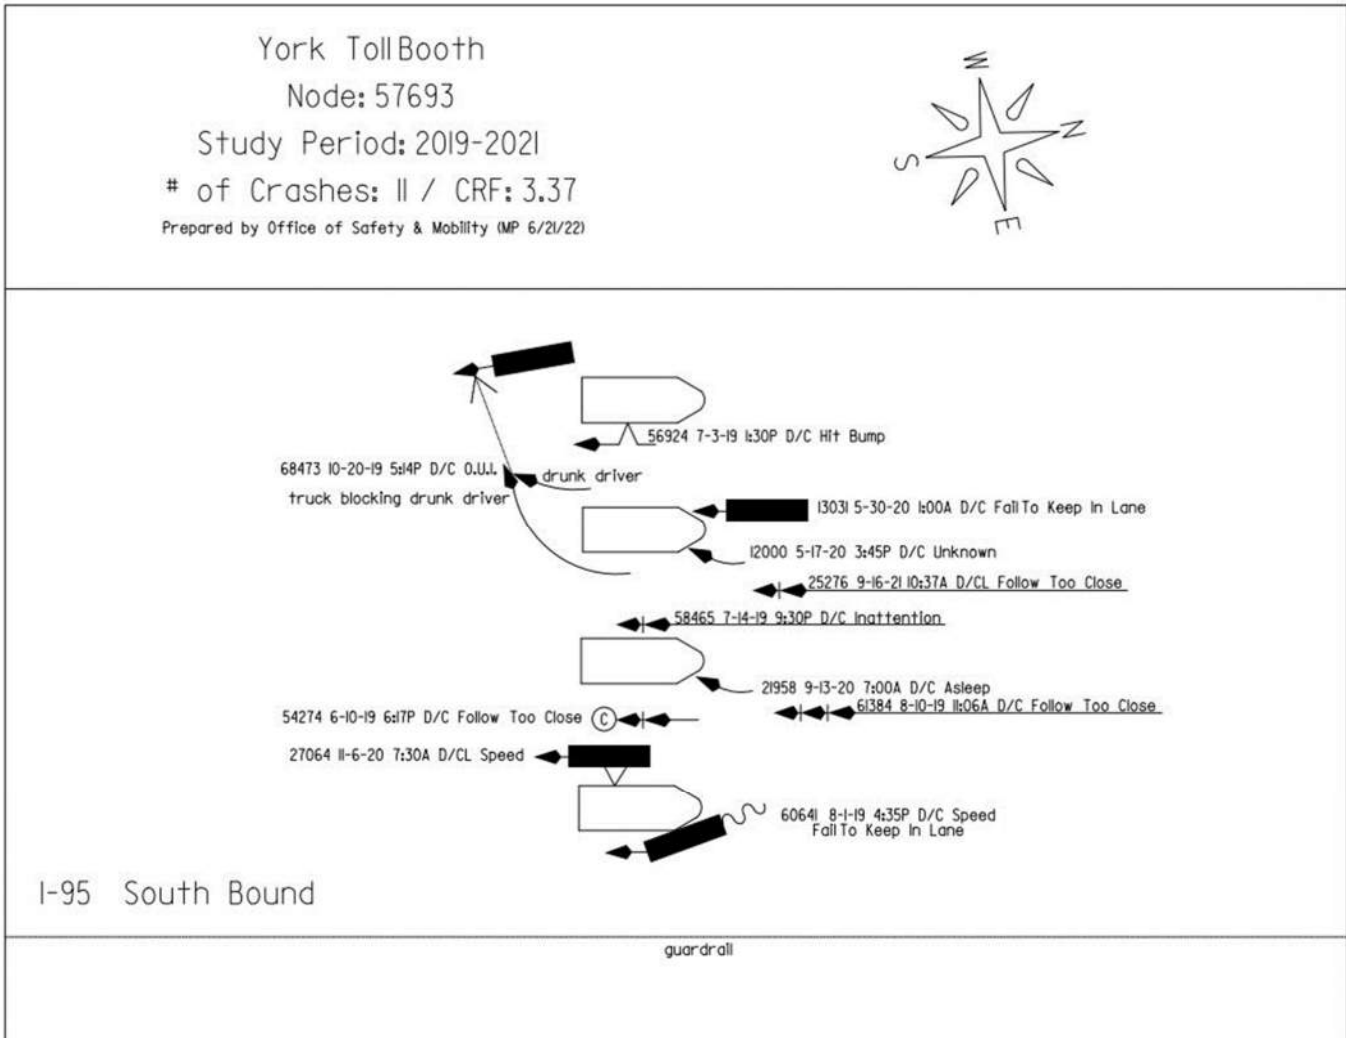
**Figure 4: 2019-2021 Old York Toll SB Crash Diagram**

As shown in **Figure 4**, there were 11 crashes resulting in a 9.1% injury rate during this analysis period.

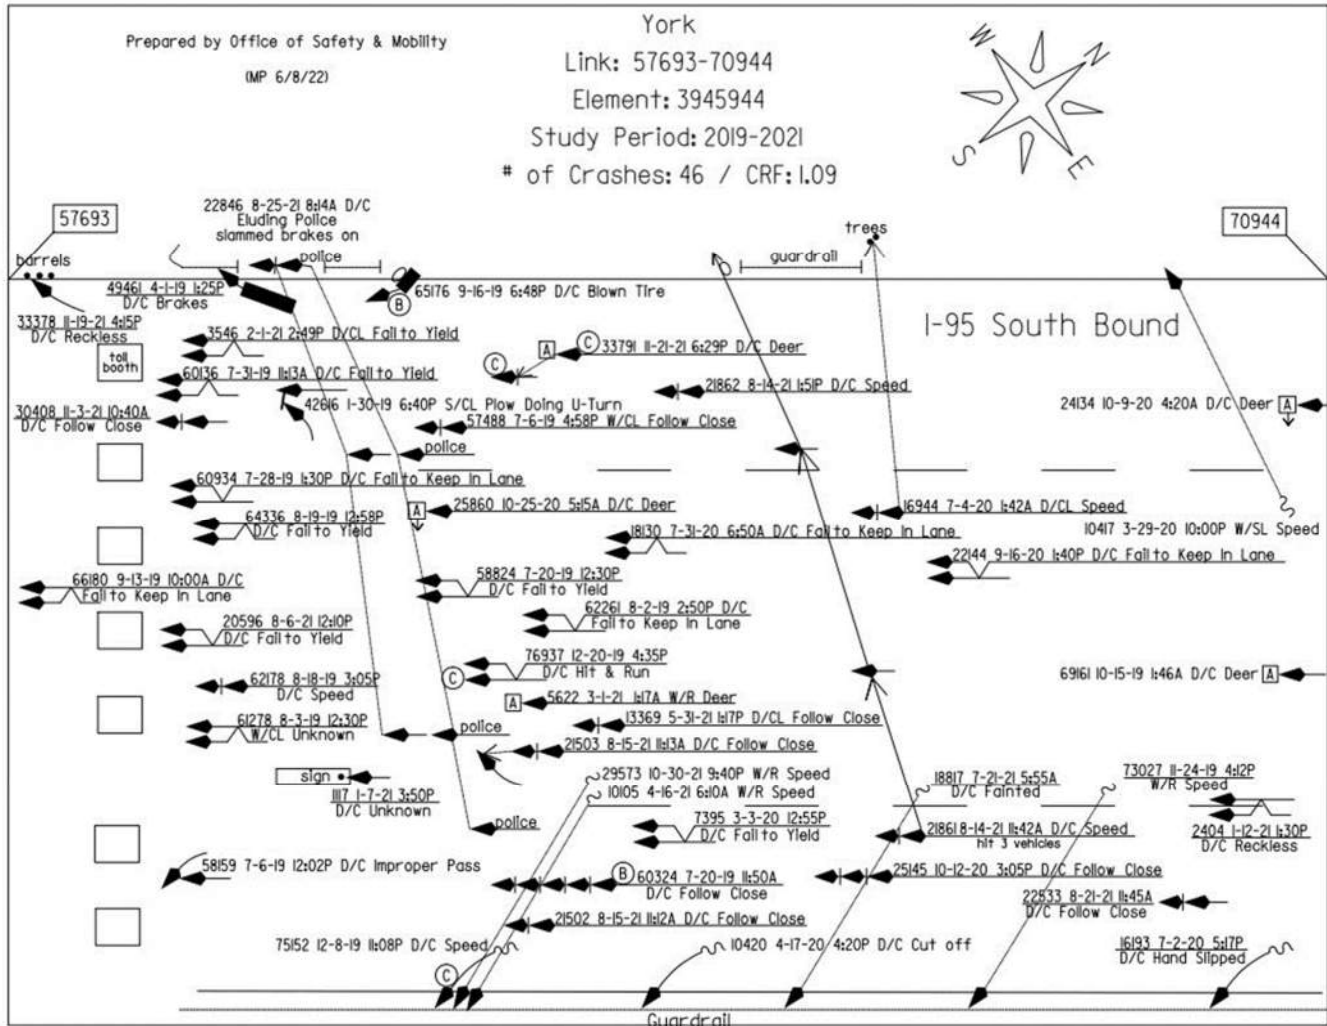
**Figure 5: 2019-2021 North of Old York Toll Plaza Crash Diagram**

As shown in **Figure 5**, there were 46 crashes resulting in a 13% injury rate during this analysis period.

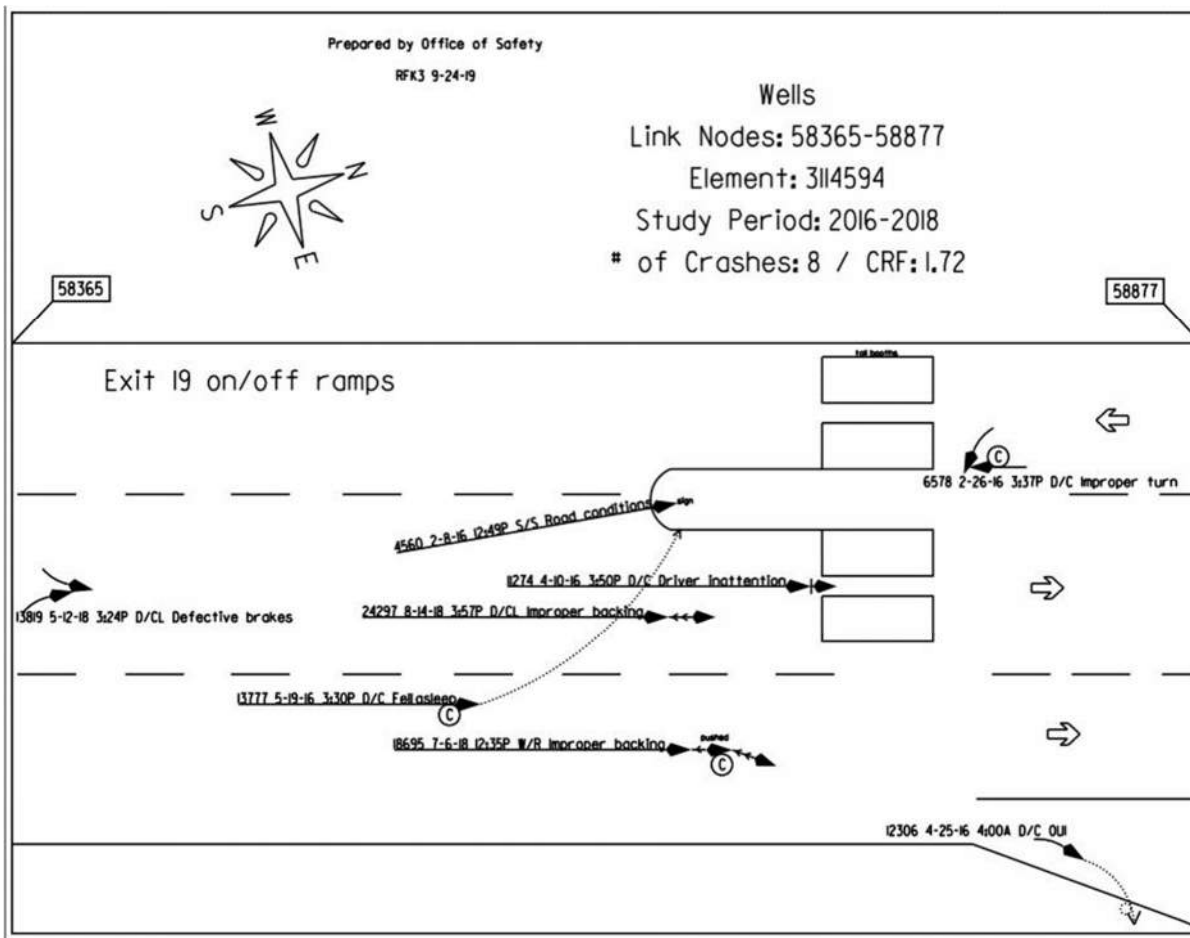
**Figure 2: 2016-2018 Exit 19 Toll Plaza Crash Diagram**

As shown in **Figure 2**, there were 8 crashes resulting in a 37.5% injury rate during this analysis period.

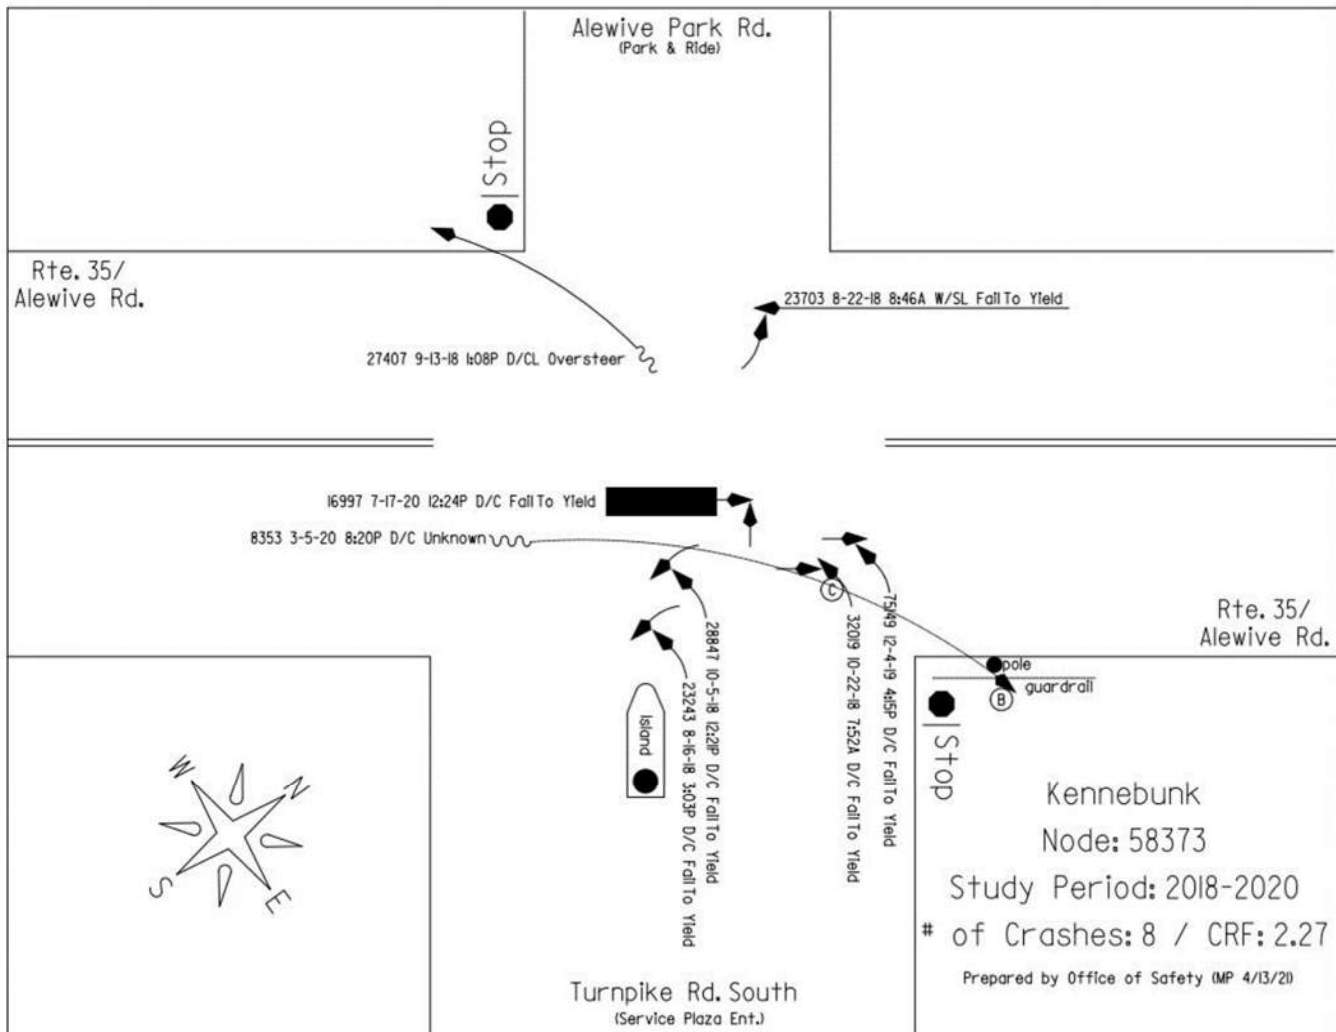
**Figure 2: 2018-2020 Exit 25 SB Ramps intersection Crash Diagram**

As shown in **Figure 2**, there were 8 crashes resulting in a 25% injury rate during this analysis period.

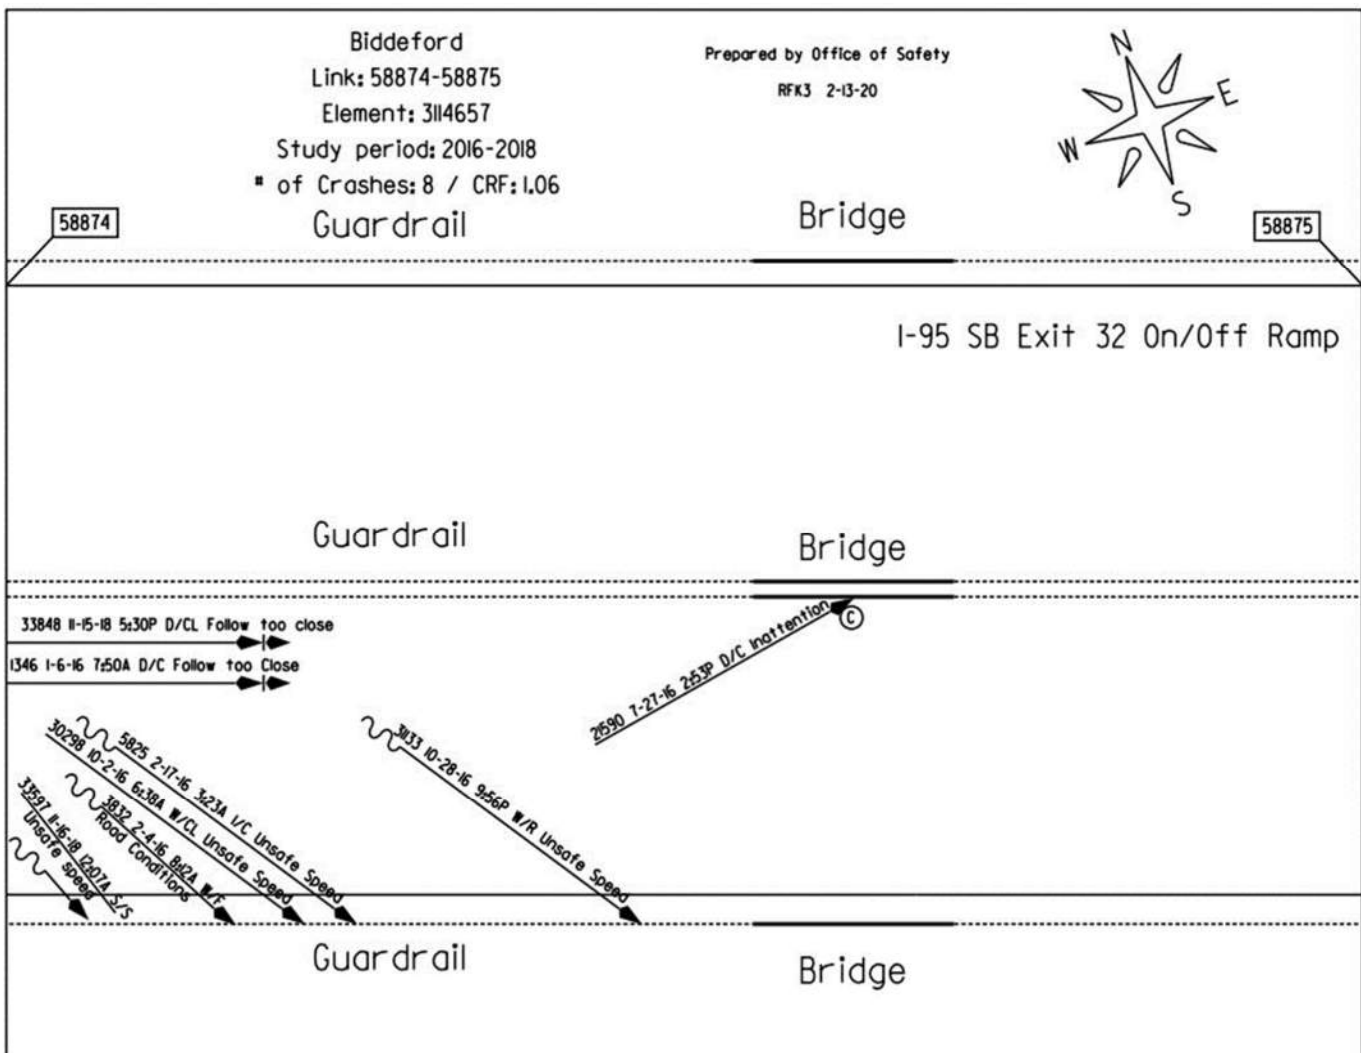
**Figure 4: 2016-2018 Exit 32 SB Off Ramp Crash Diagram**

As shown in **Figure 4**, there were 8 crashes resulting in a 12.5% injury rate during this analysis period.

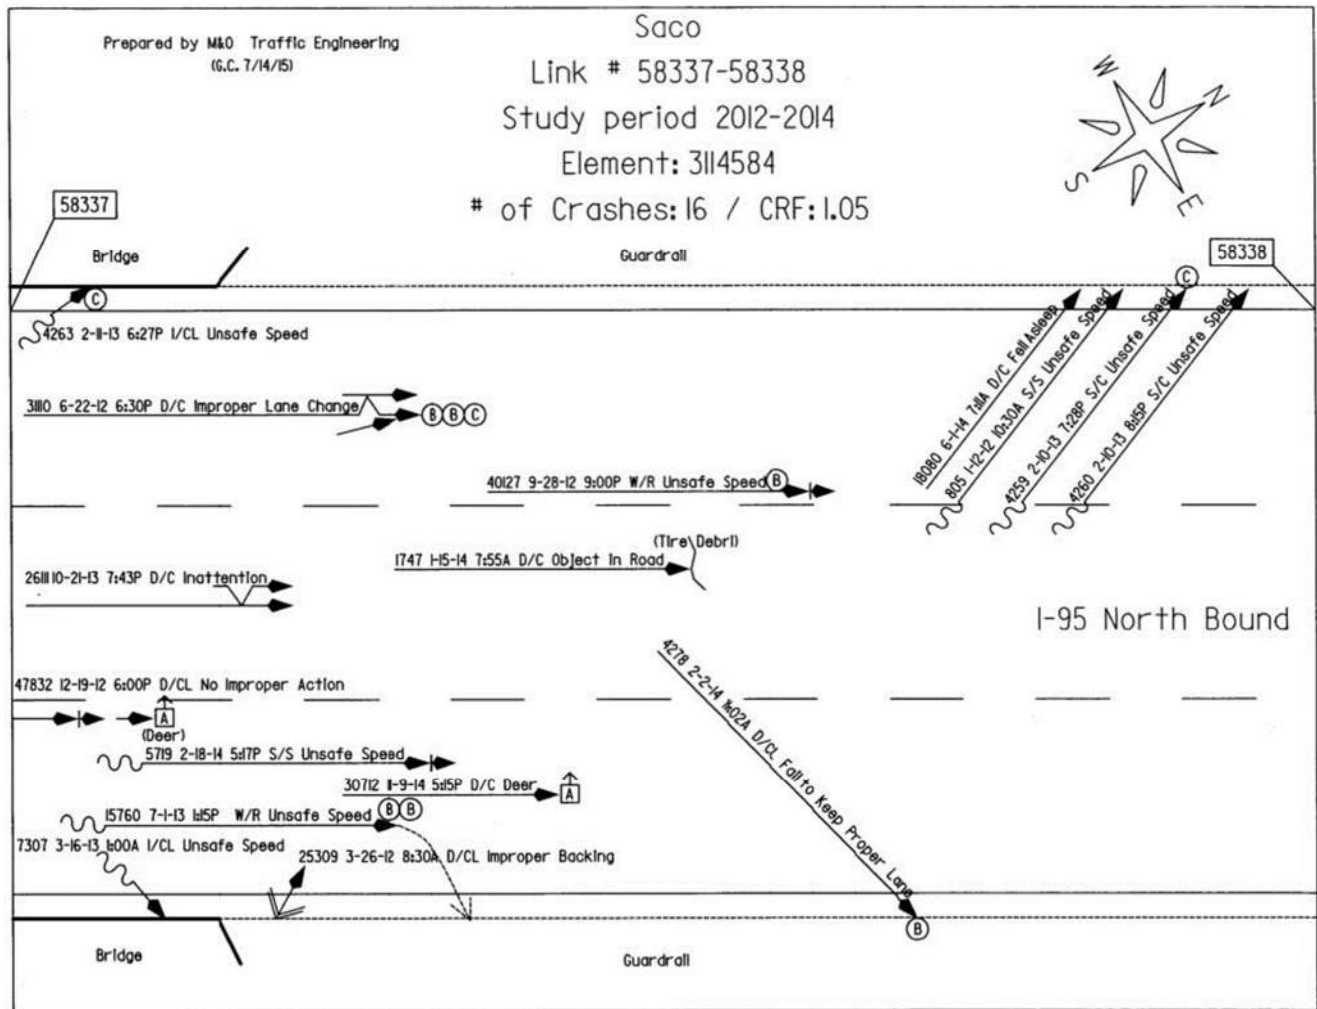
**Figure 2: 2012-2014 NB Segment Over Saco River Crash Diagram**

As shown in **Figure 2**, there were 16 crashes resulting in a 37.5% injury rate during this analysis period.

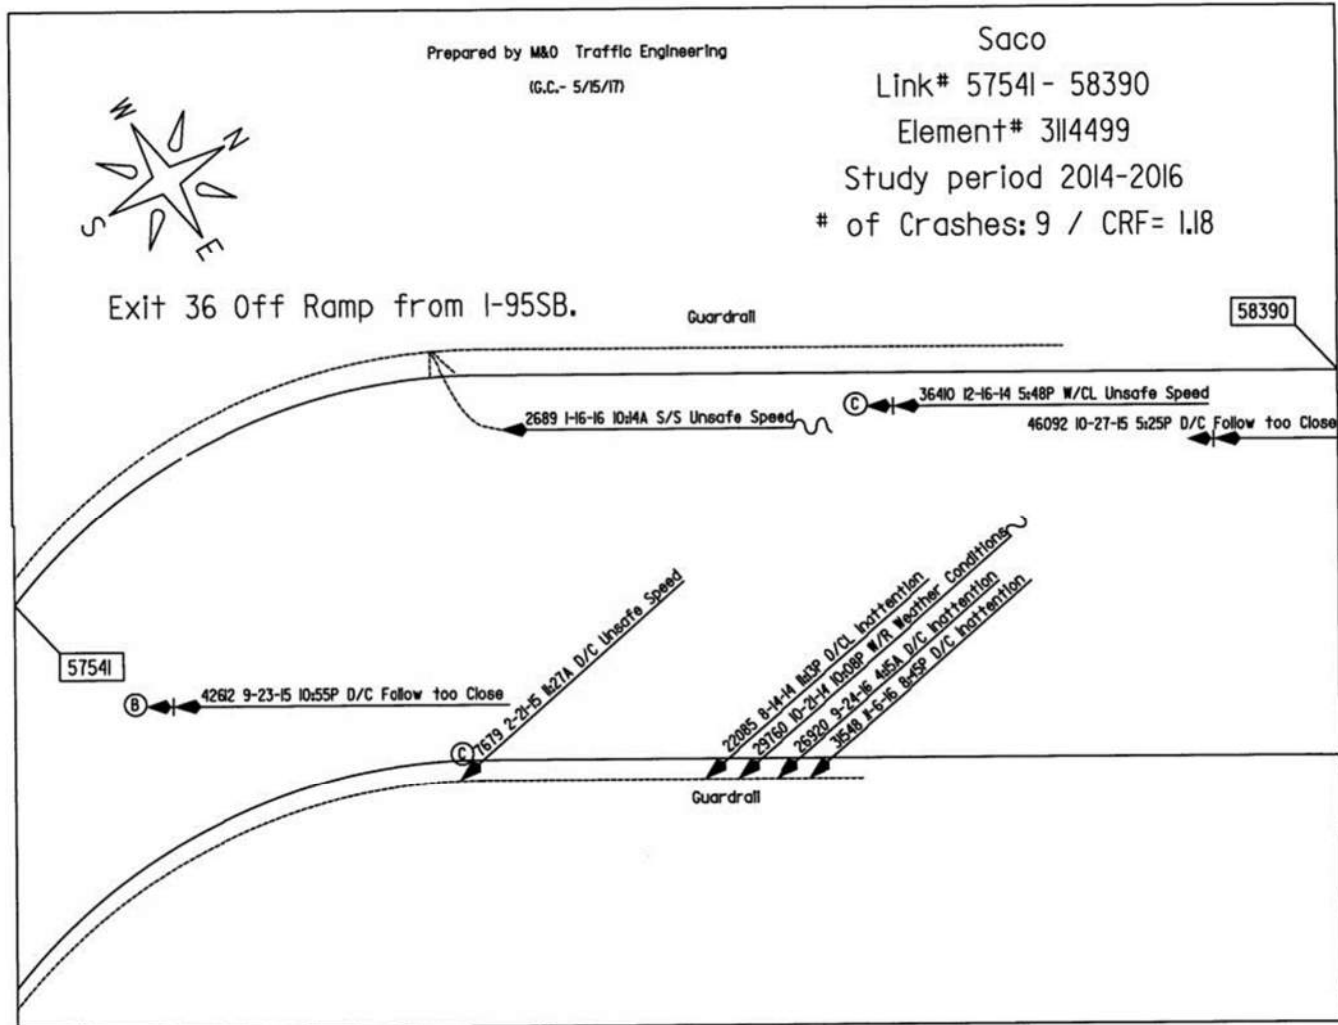
Figure 2: 2014-2016 Exit 36 SB Off Ramp Crash Diagram

As shown in Figure 2, there were 9 crashes resulting in a 33.3% injury rate during this analysis period.
