# 2022 Systemwide Safety and Capacity Study

June 30, 2023

Maine Turnpike Authority  
2360 Congress Street  
Portland, ME 04102

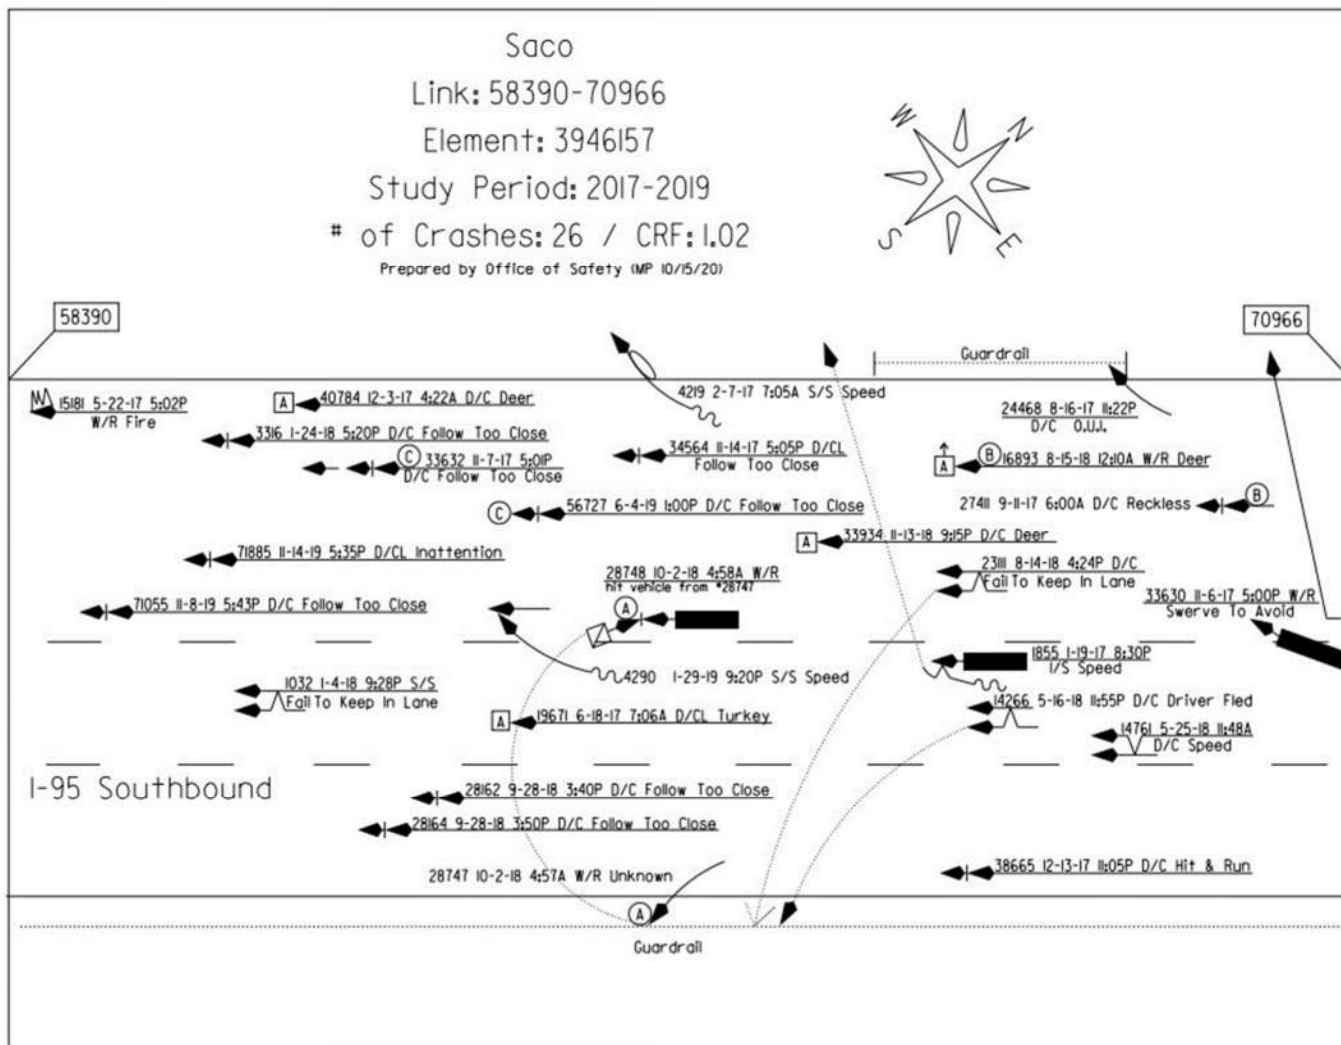
**Figure 2: 2017-2019 SB Mainline Between Exit 36 and 42 Crash Diagram**

As shown in **Figure 2**, there were 26 crashes resulting in a 23.1% injury rate during this analysis period.

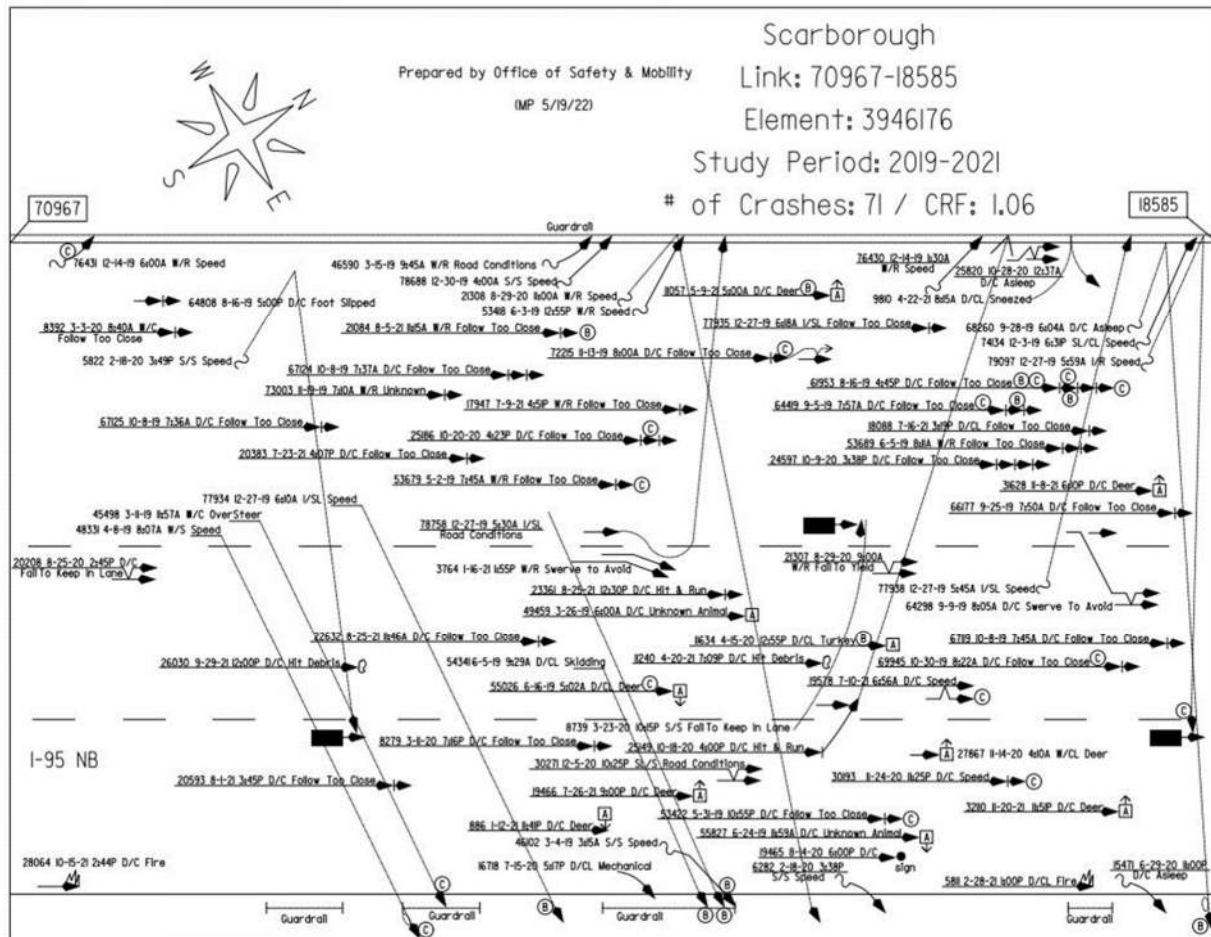
**Figure 3: 2019-2021 NB Mainline Between Exit 36 and 42 Crash Diagram**

As shown in **Figure 3**, there were 71 crashes resulting in a 31% injury rate during this analysis period.

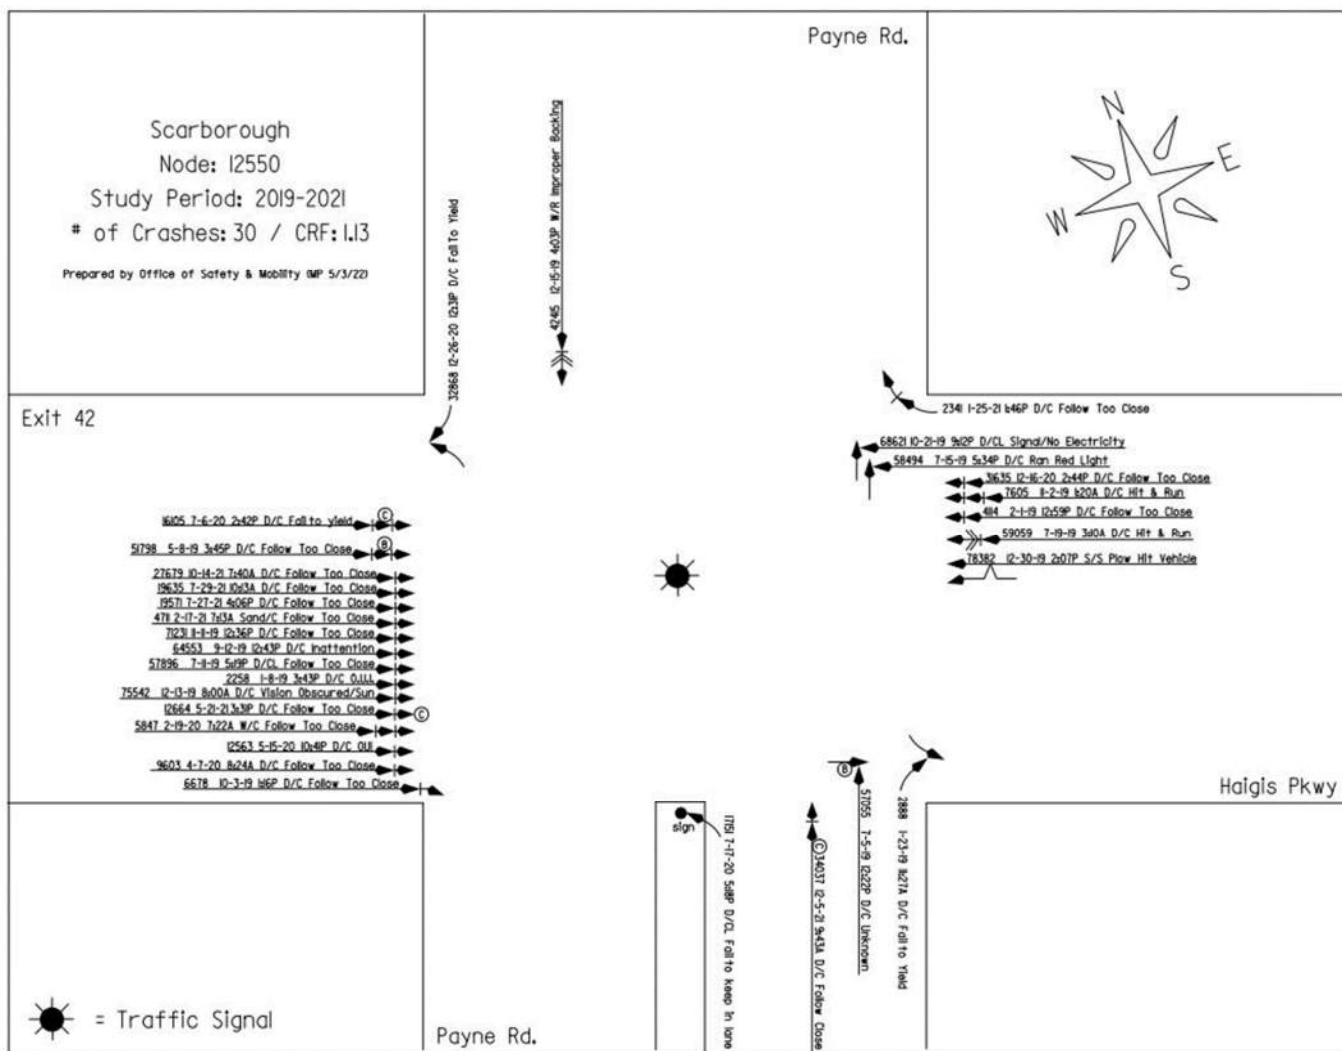
Figure 2: (2019-2021) Exit 42 Intersection Crash Diagram

As shown in Figure 2, there were 30 crashes resulting in a 16.7% injury rate during this analysis period.

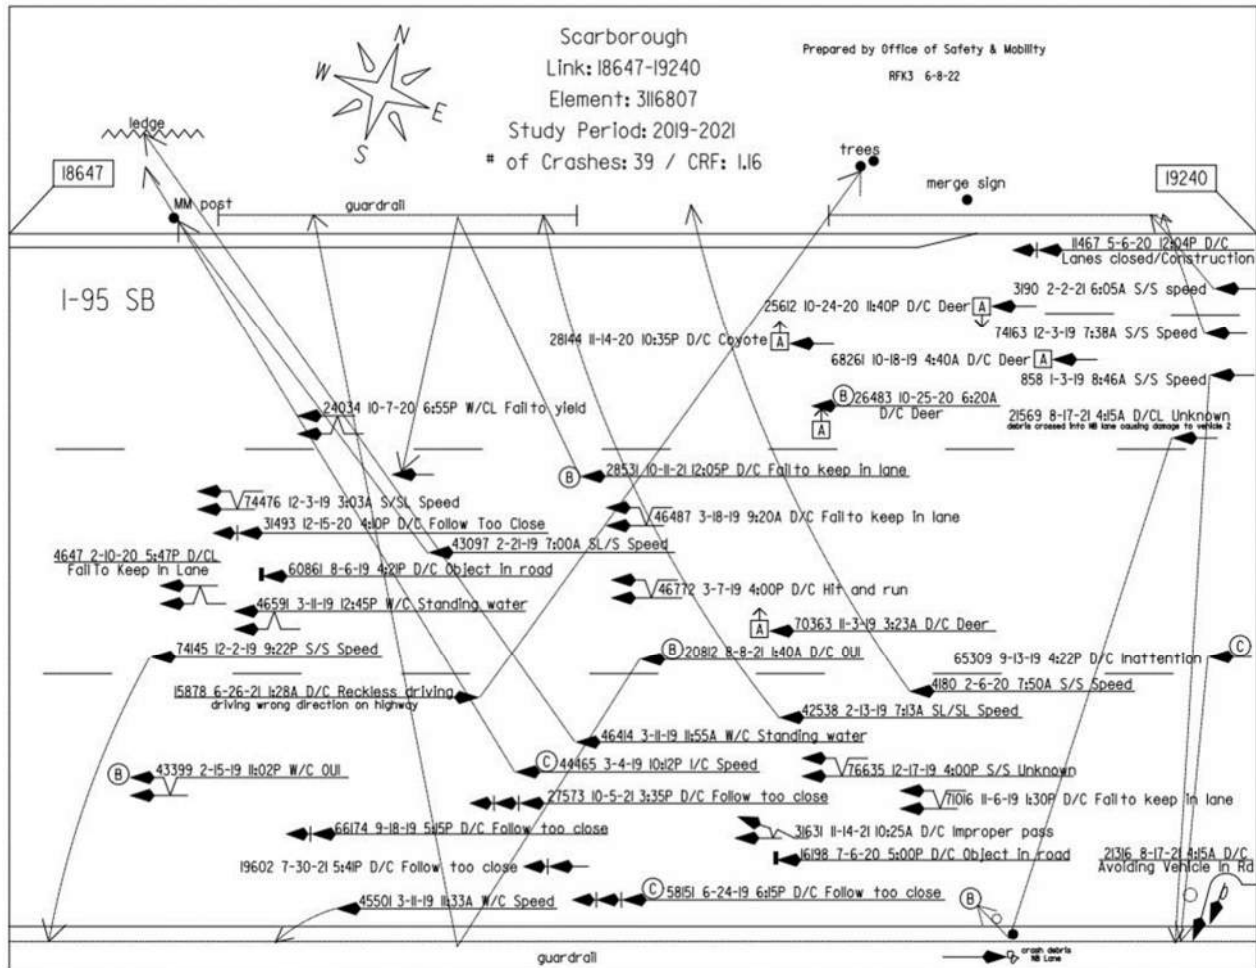
Figure 2: 2019-2021 Exit 42 SB Off Ramp Approach Crash Diagram

As shown in Figure 2, there were 39 crashes resulting in a 20.5% injury rate during this analysis period.

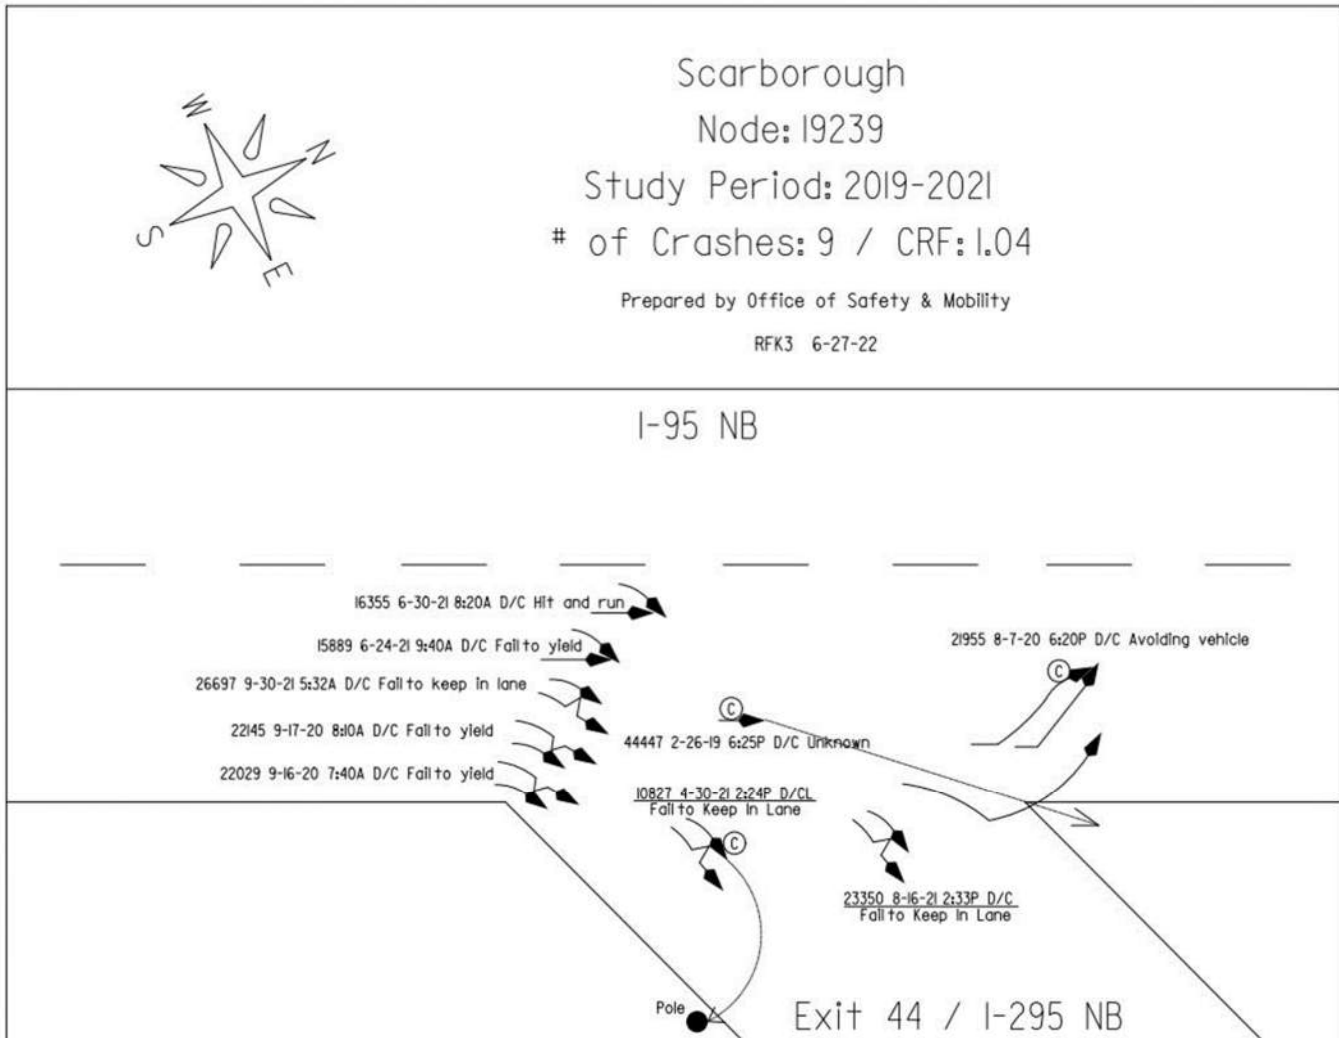
**Figure 4: 2019-2021 Exit 44 NB Diverge Crash Diagram**

As shown in **Figure 4**, there were 9 crashes resulting in a 33.3% injury rate during this analysis period.

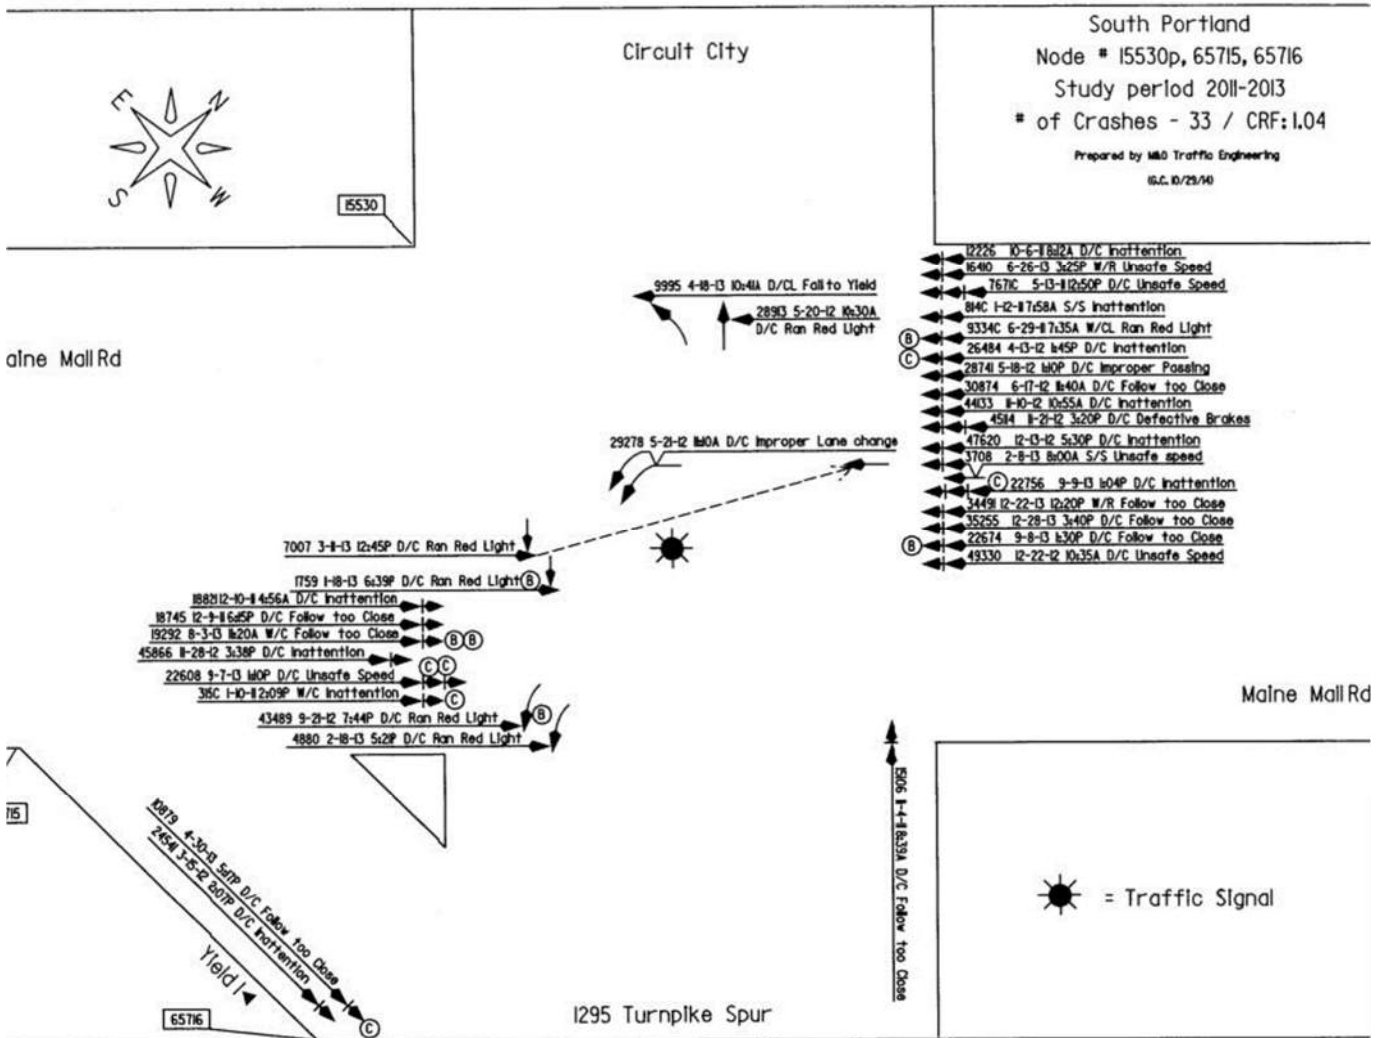
**Figure 2: 2011-2013 Exit 45 Off Ramp Intersection Crash Diagram**

As shown in **Figure 2**, there were 33 crashes resulting in a 30.3% injury rate during this analysis period.

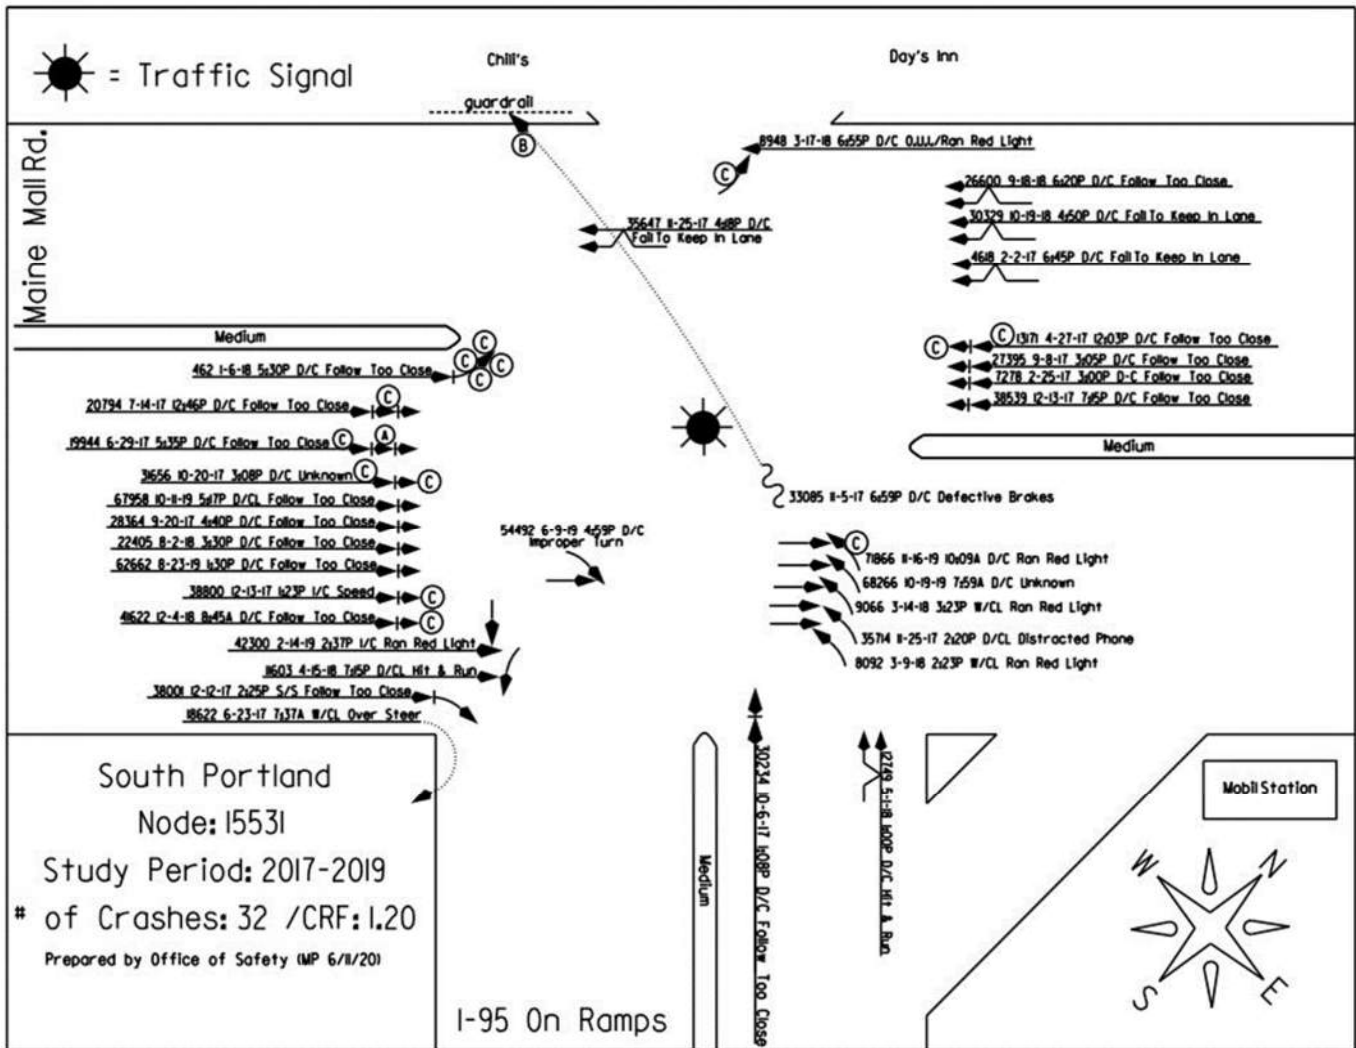
**Figure 3: 2017-2019 Exit 45 On Ramps Intersection Crash Diagram**

As shown in **Figure 3**, there were 32 crashes resulting in a 31.3% injury rate during this analysis period.

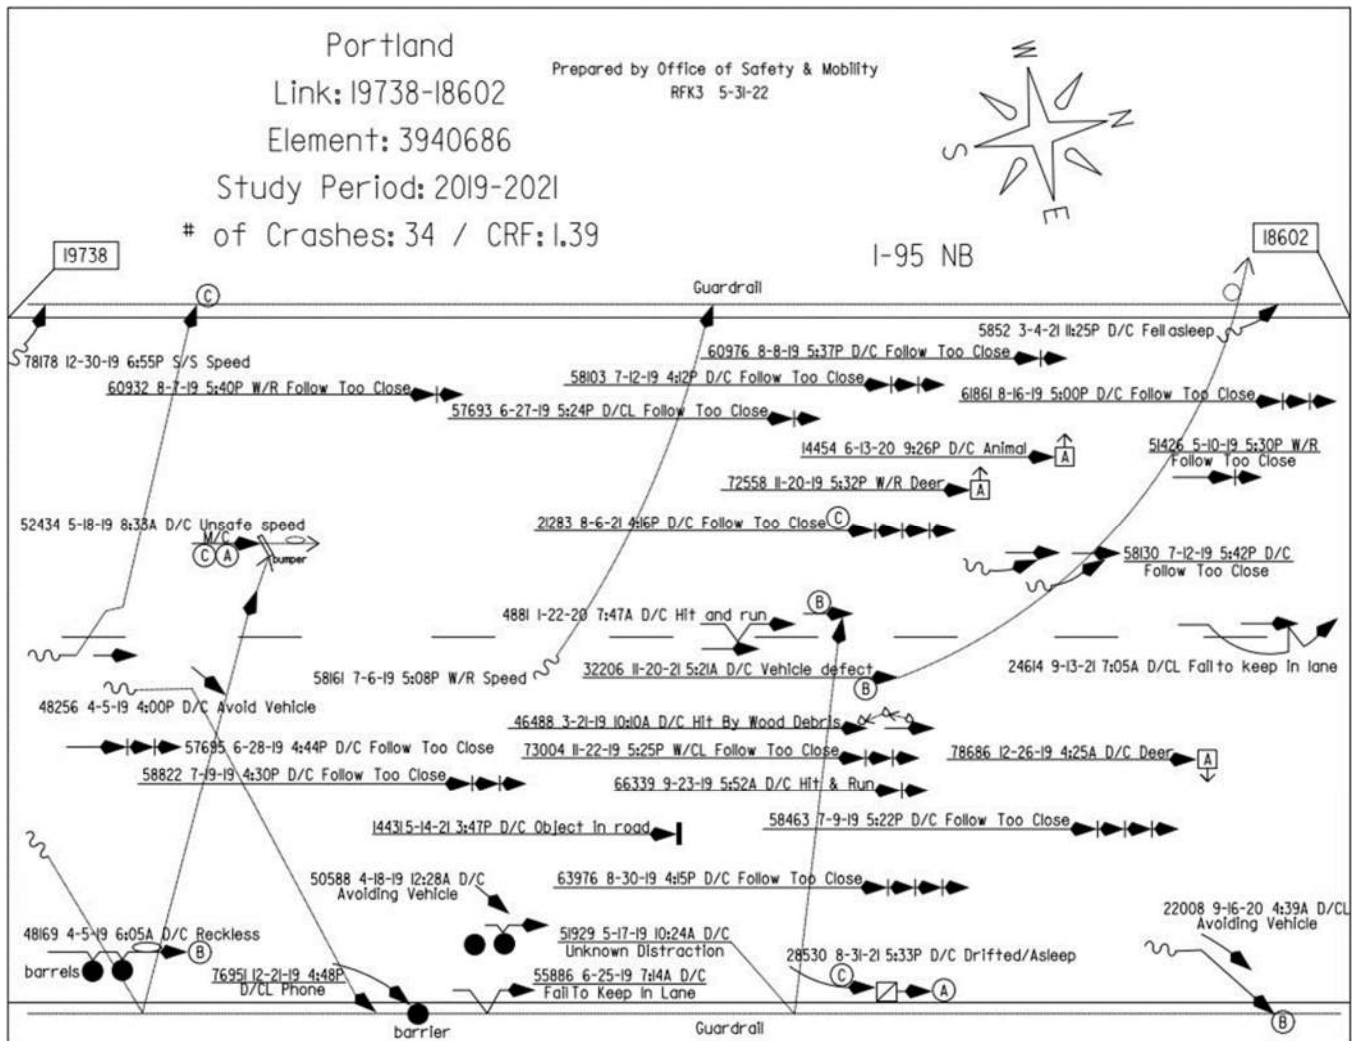
**Figure 2: 2019-2021 NB Mile Marker 46-47 Crash Diagram**

As shown in **Figure 2**, there were 34 crashes resulting in a 20.6% injury rate during this analysis period.

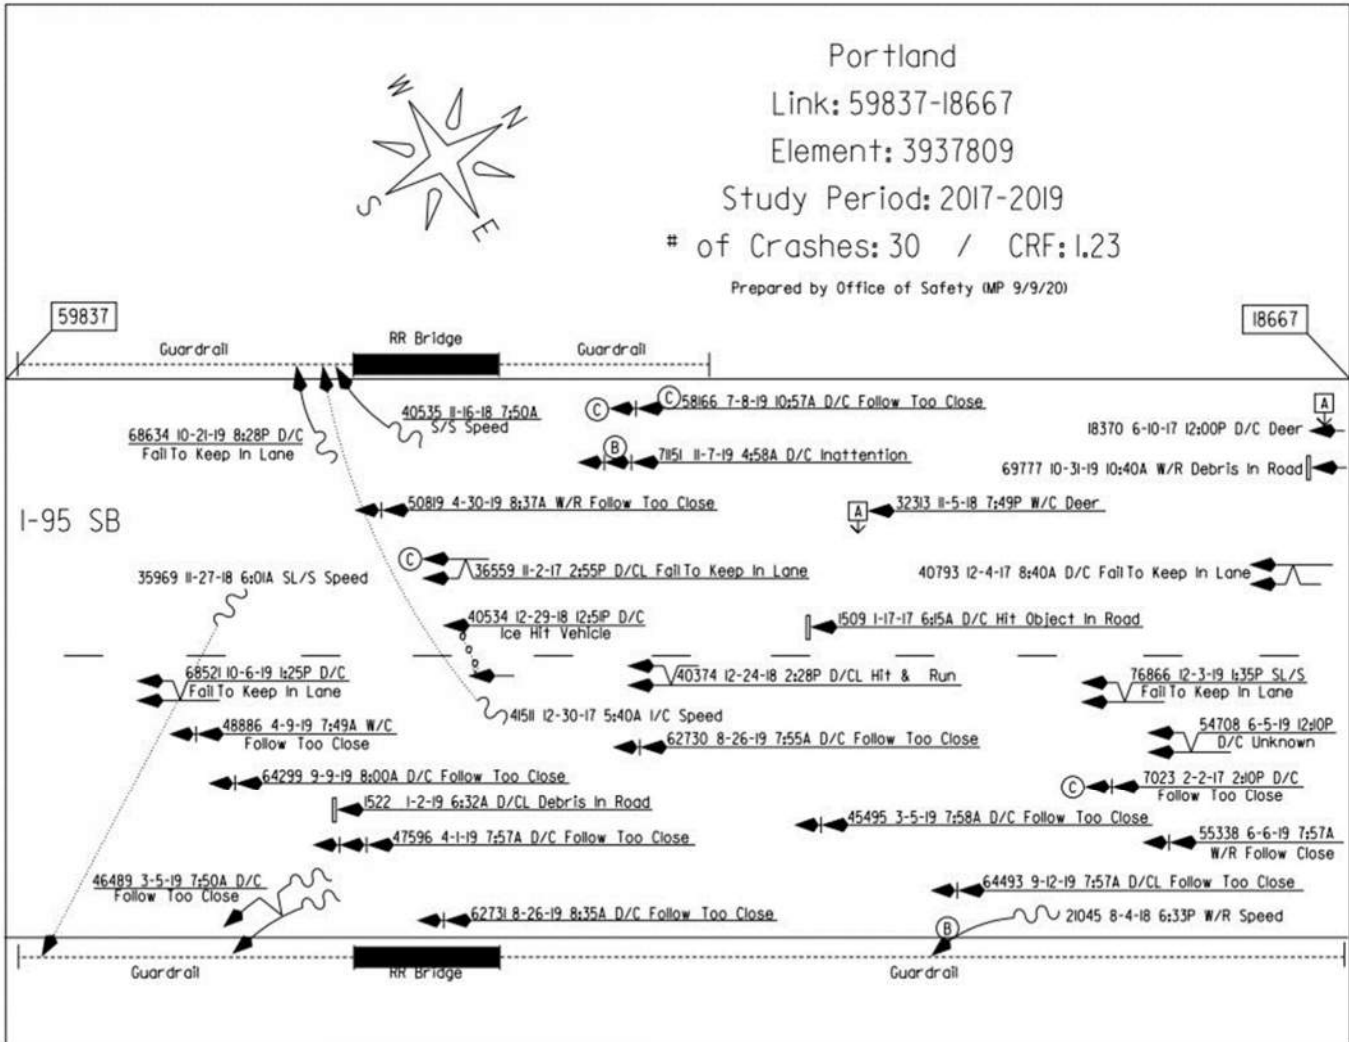
Figure 2: 2017-2019 I-95 SB Mile Marker 47-48 Crash Diagram

As shown in Figure 2, there were 30 crashes resulting in a 16.7% injury rate during this analysis period.

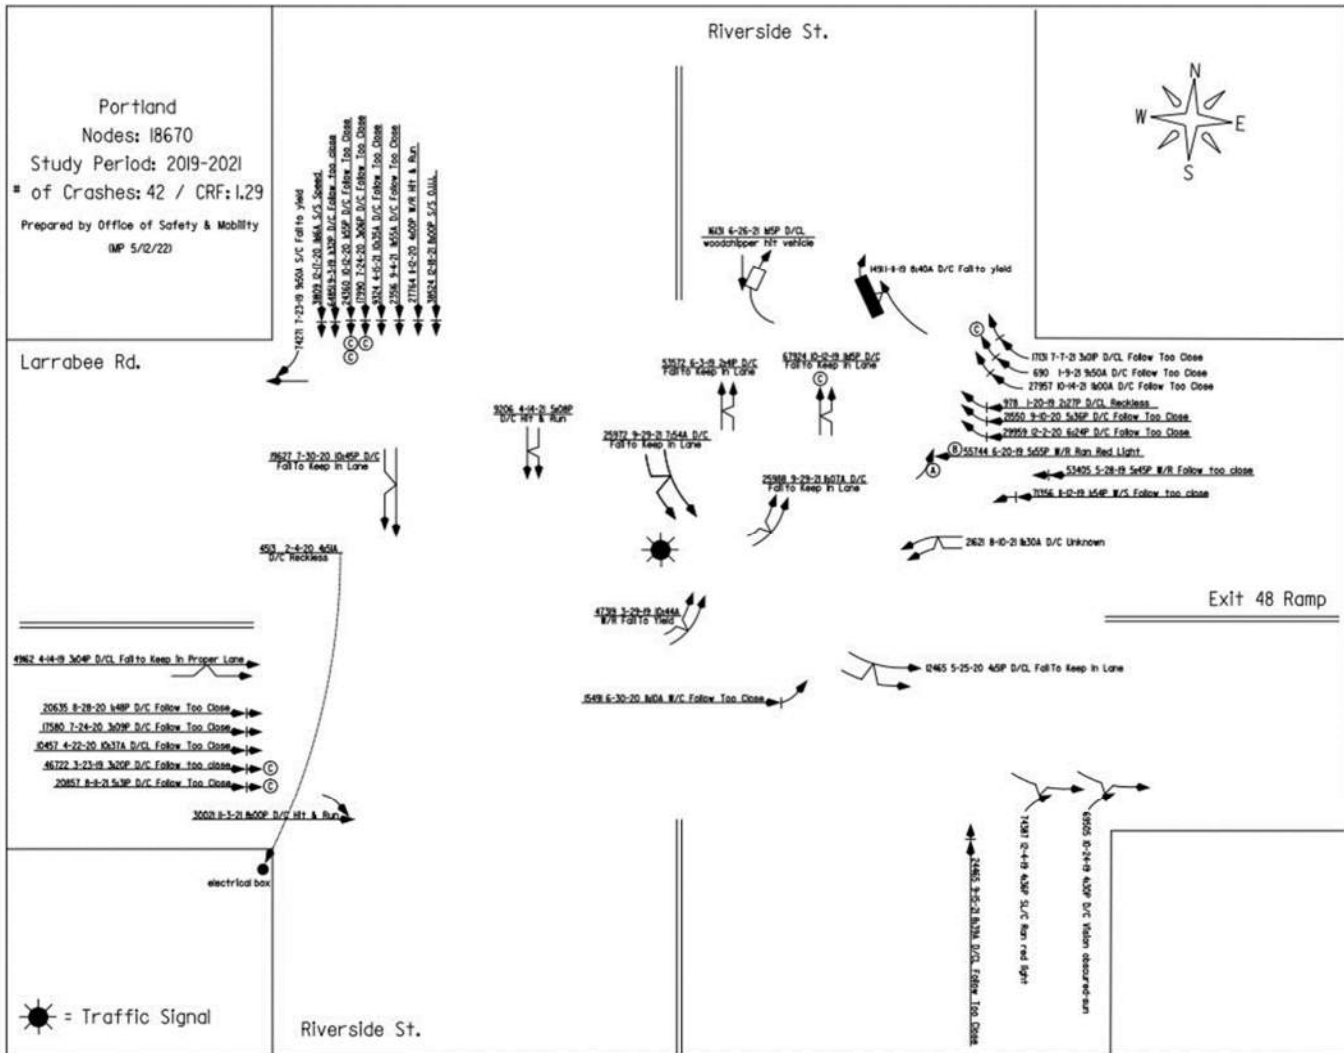
**Figure 2: 2019-2021 Exit 48 Intersection Crash Diagram**

As shown in **Figure 2**, there were 42 crashes resulting in a 16.7% injury rate during this analysis period.

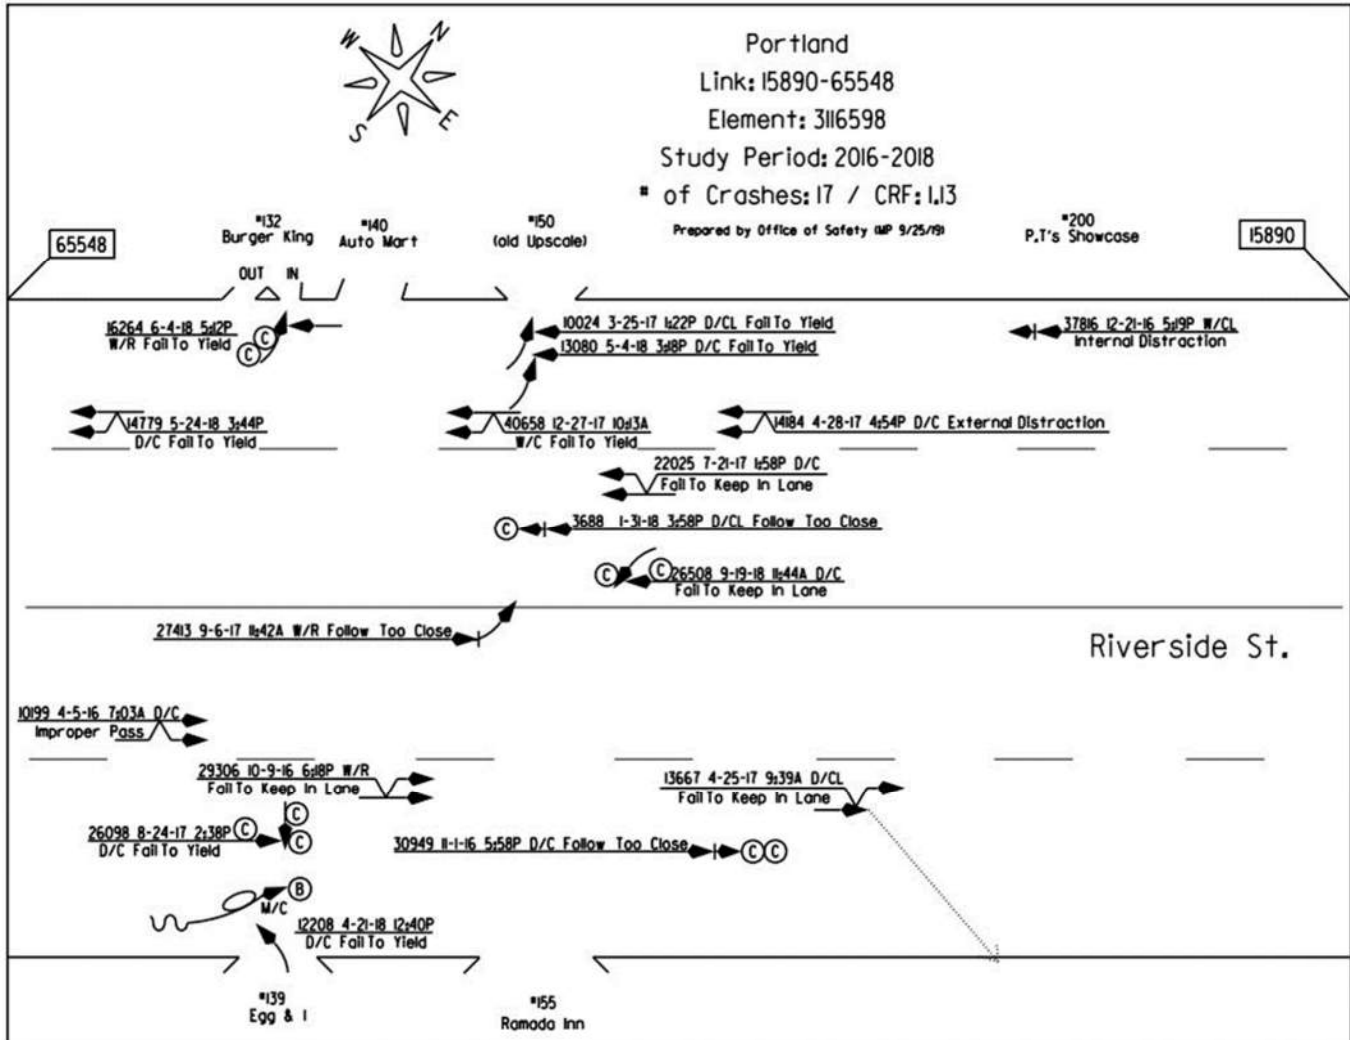
**Figure 3: 2016-2018 Riverside Street SB Approach Crash Diagram**

As shown in **Figure 3**, there were 17 crashes resulting in a 35.3% injury rate during this analysis period.

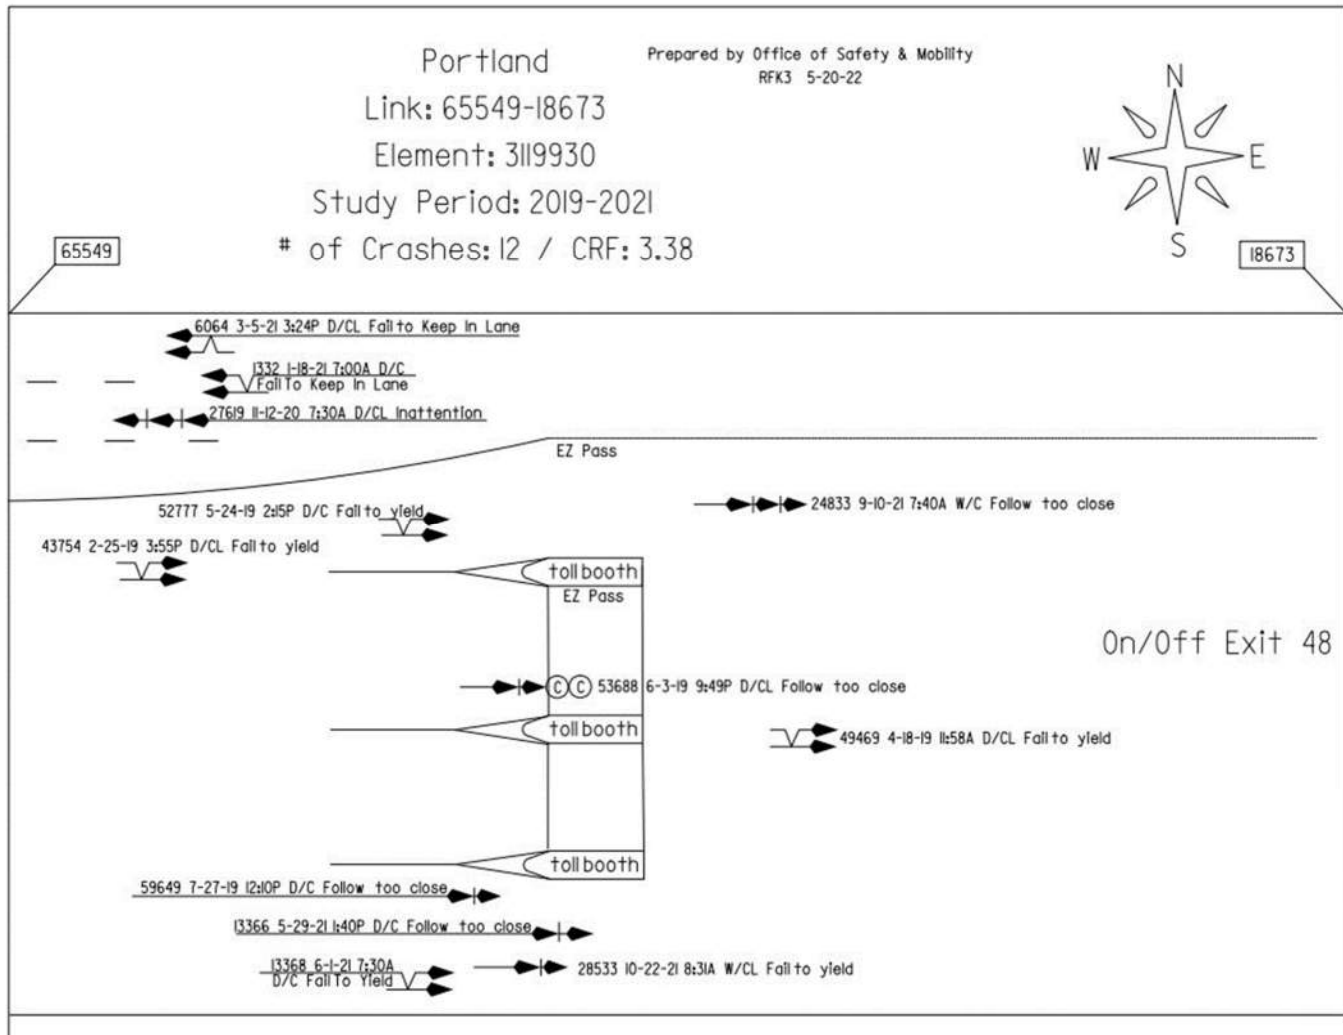
**Figure 4: 2019-2021 Exit 48 Toll Plaza Crash Diagram**

As shown in **Figure 4**, there were 12 crashes resulting in a 8.3% injury rate during this analysis period.

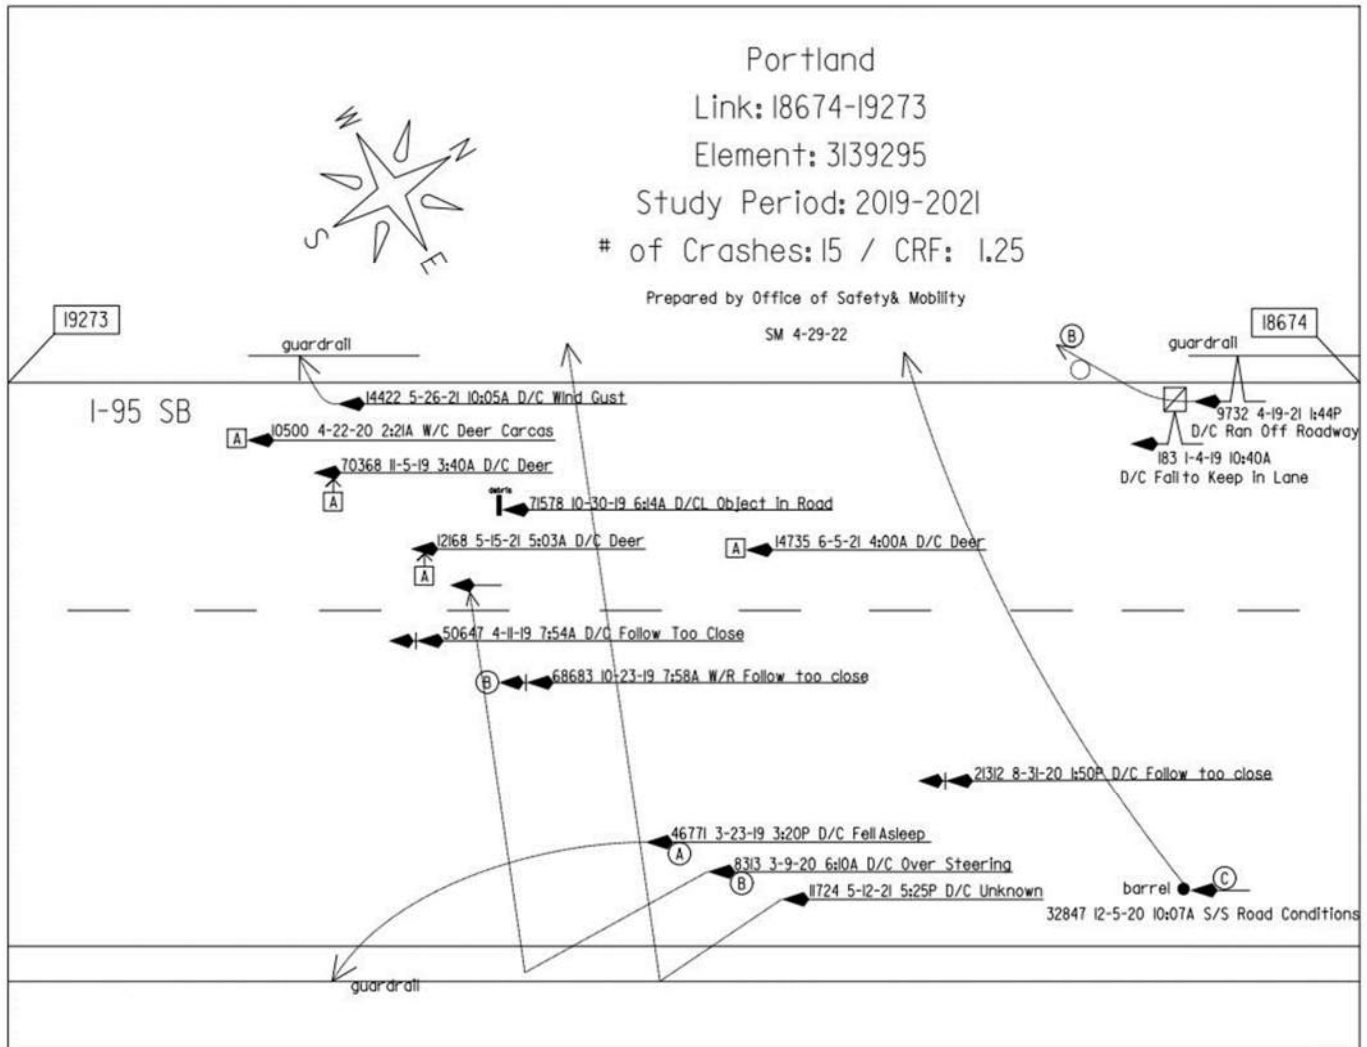
**Figure 2: 2019-2021 Exit 48 SB Ramp Approach Crash Diagram**

As shown in **Figure 2**, there were 15 crashes resulting in a 33.3% injury rate during this analysis period.

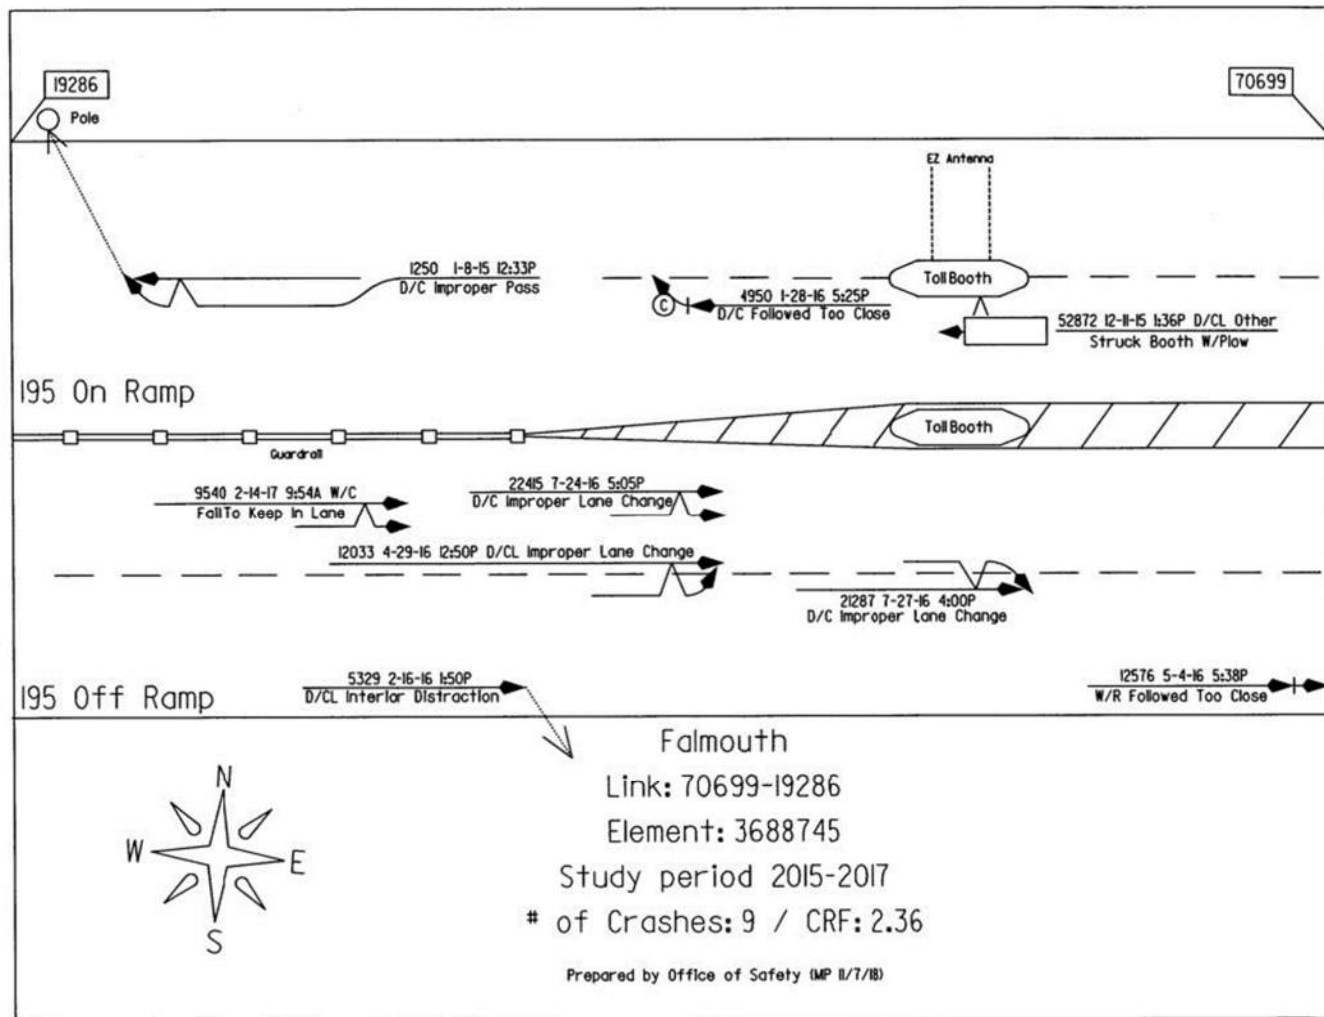
**Figure 2: 2015-2017 Exit 53 Toll Plaza Crash Diagram**

As shown in **Figure 2**, there were 9 crashes resulting in a 11.1% injury rate during this analysis period.

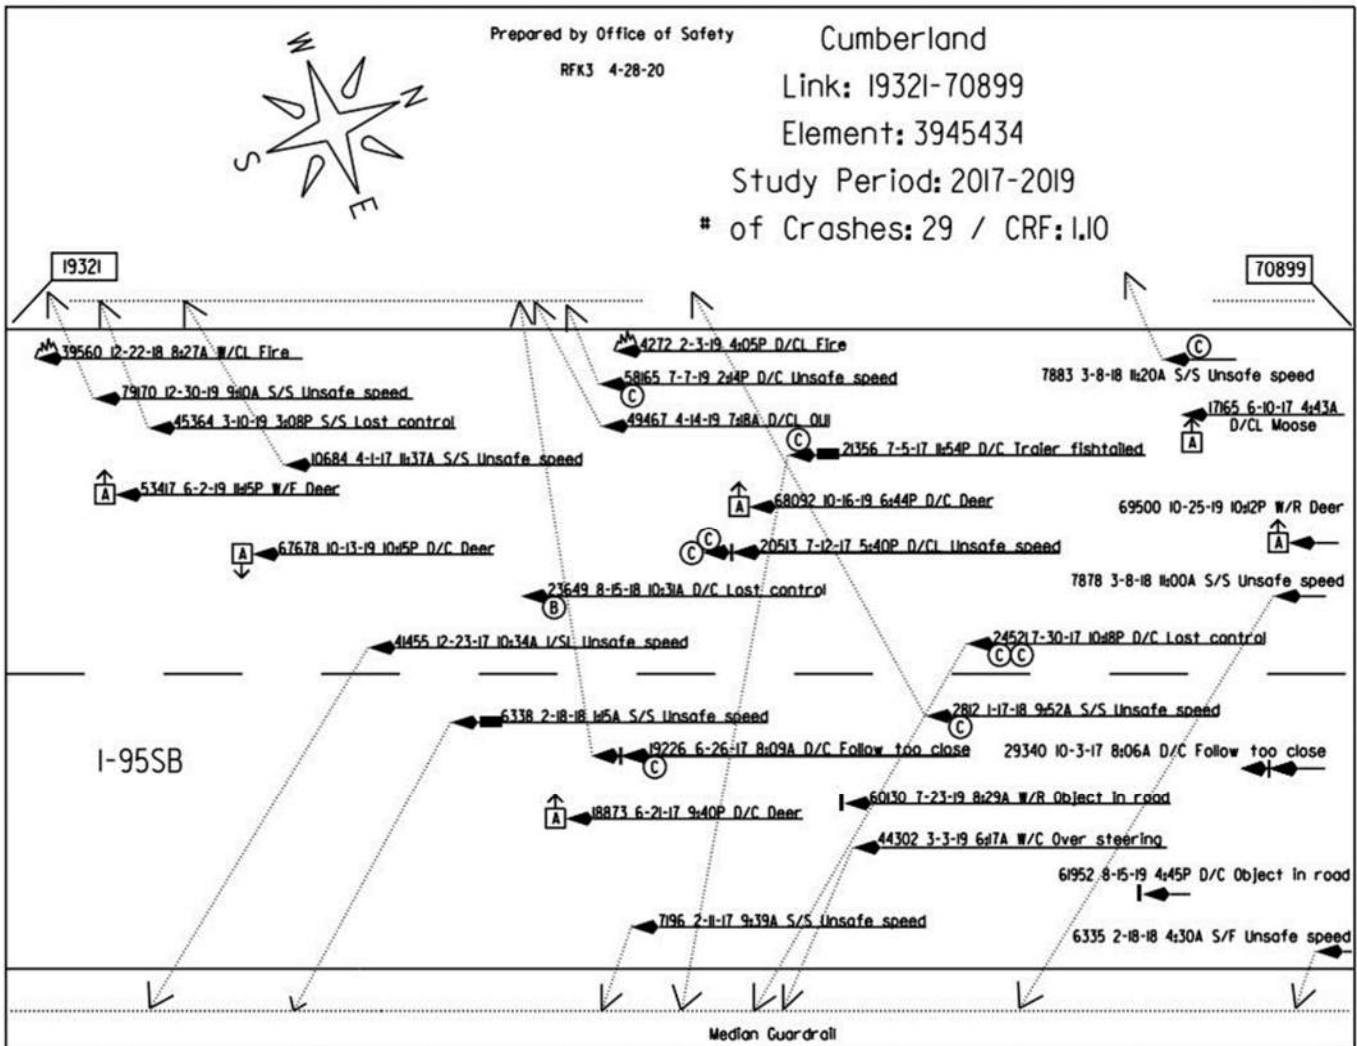
**Figure 2: 2017-2019 SB South of Upper Blackstrap Road Crash Diagram**

As shown in **Figure 2**, there were 29 crashes resulting in a 27.6% injury rate during this analysis period.

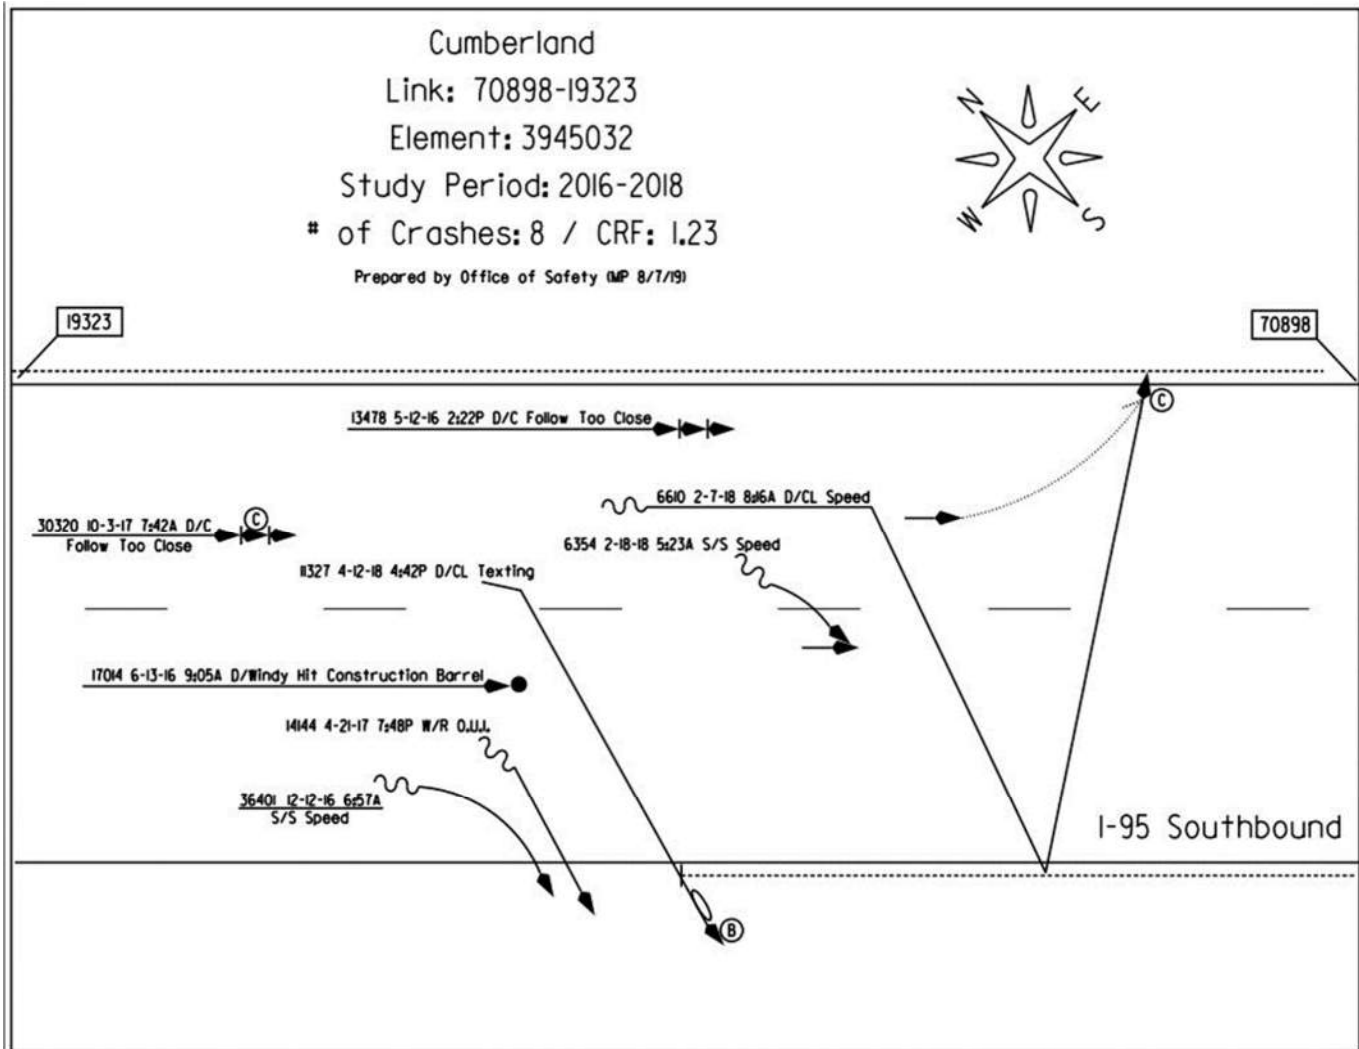
**Figure 2: 2016-2018 SB Plaza Approach Crash Diagram**

As shown in **Figure 2**, there were 8 crashes resulting in a 37.5% injury rate during this analysis period.
