# 2022 Systemwide Safety and Capacity Study

June 30, 2023

Maine Turnpike Authority  
2360 Congress Street  
Portland, ME 04102

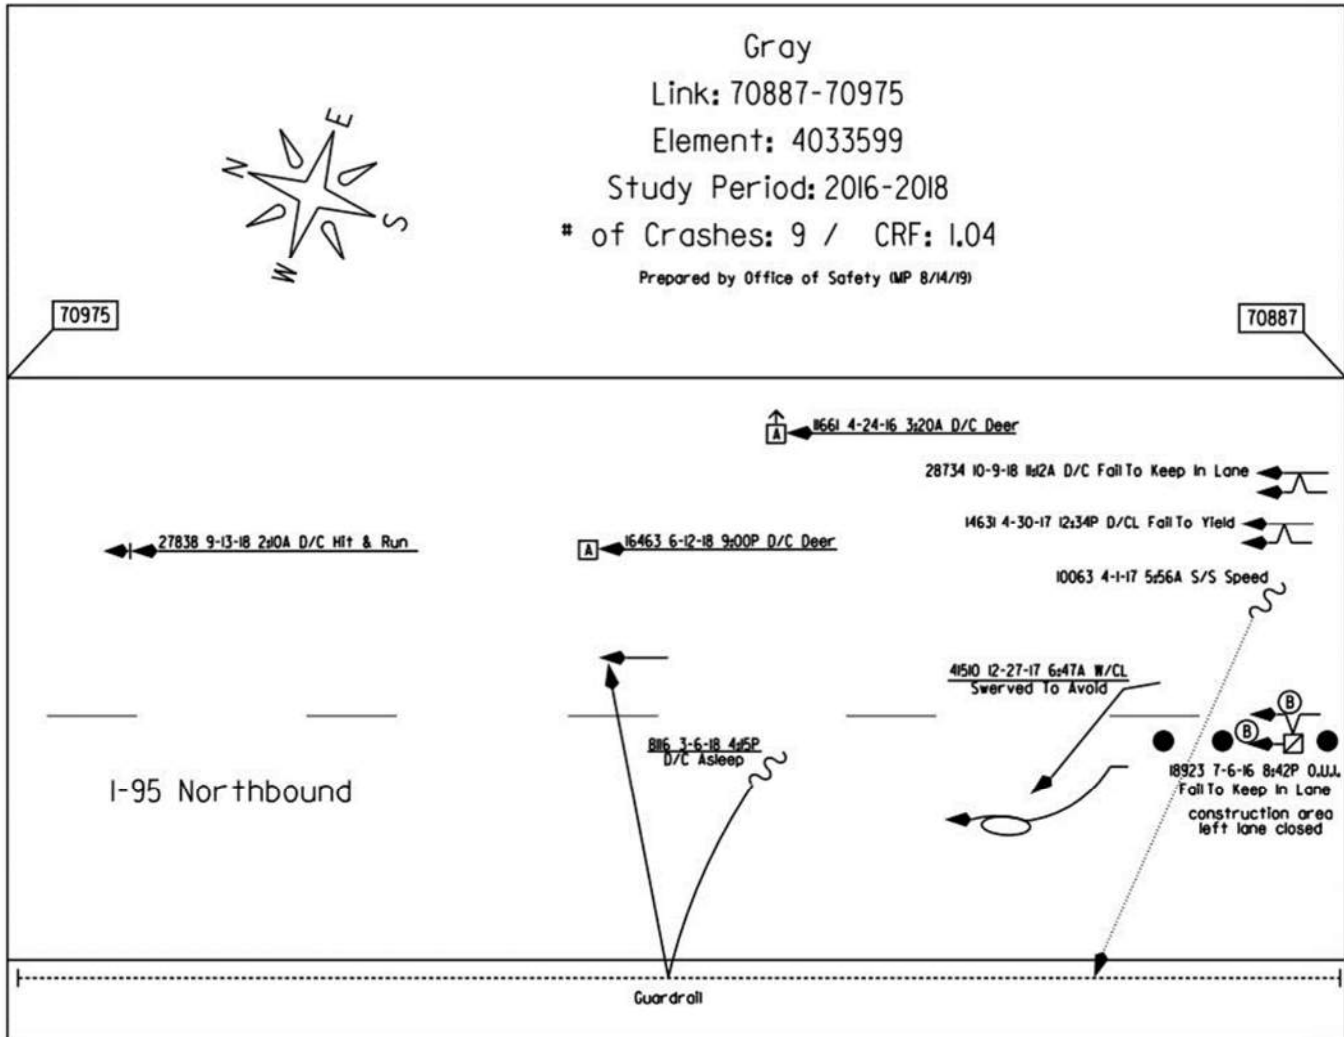
**Figure 3: 2016-2018 NB North of Gray Service Plaza Crash Diagram**

As shown in **Figure 3**, there were 9 crashes resulting in a 11.1% injury rate during this analysis period.

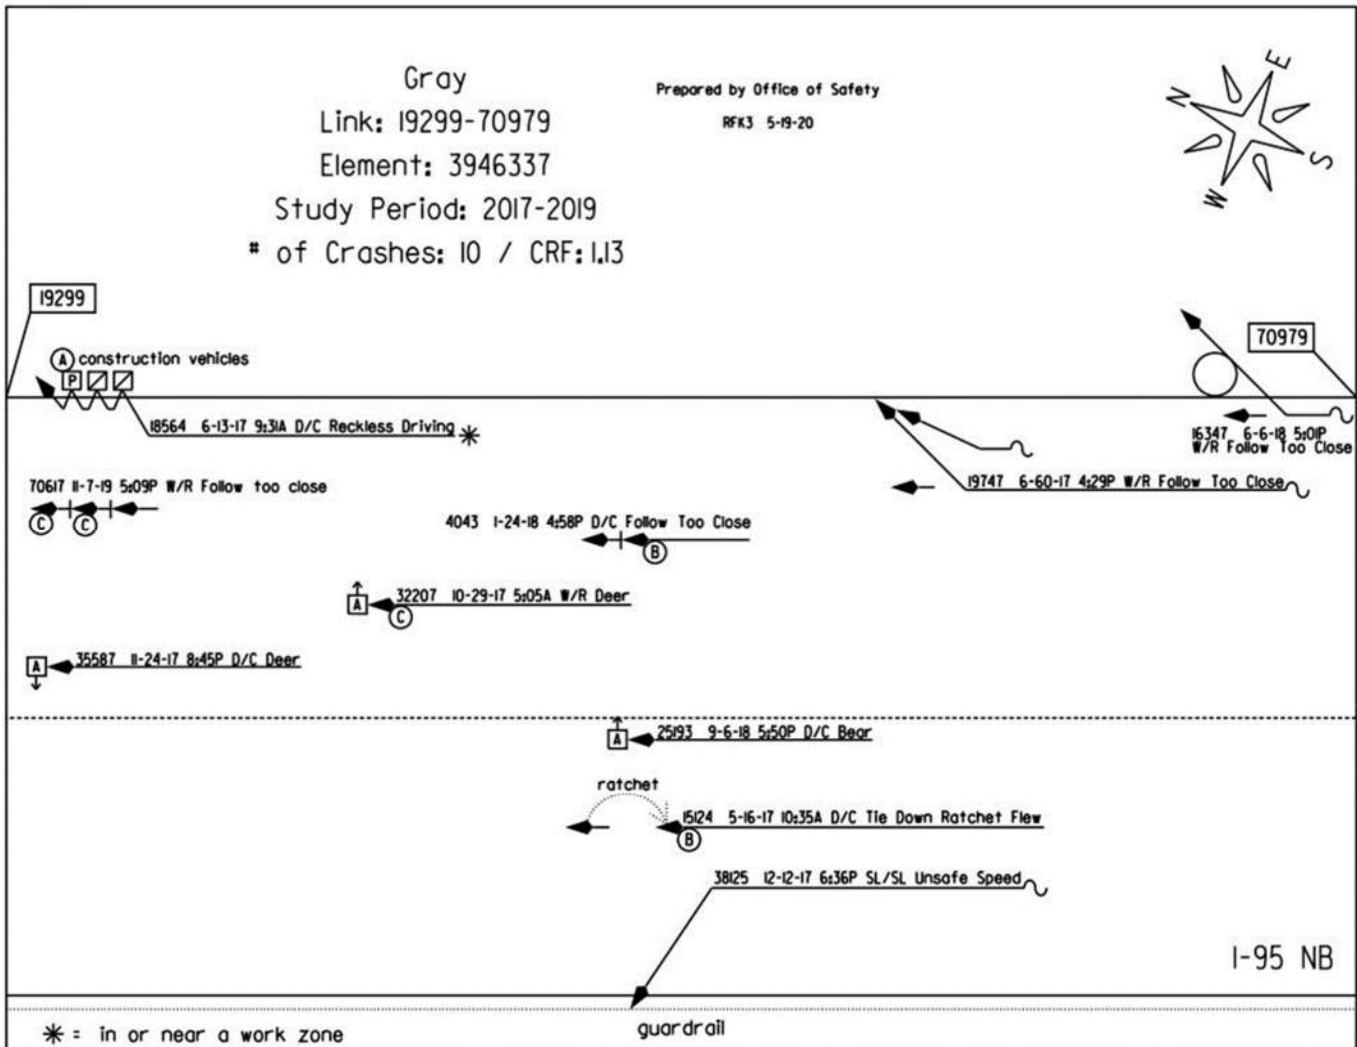
**Figure 2: 2017-2019 NB Exit 63 Off Ramp Approach Crash Diagram**

As shown in **Figure 2**, there were 10 crashes resulting in a 50% injury rate during this analysis period.

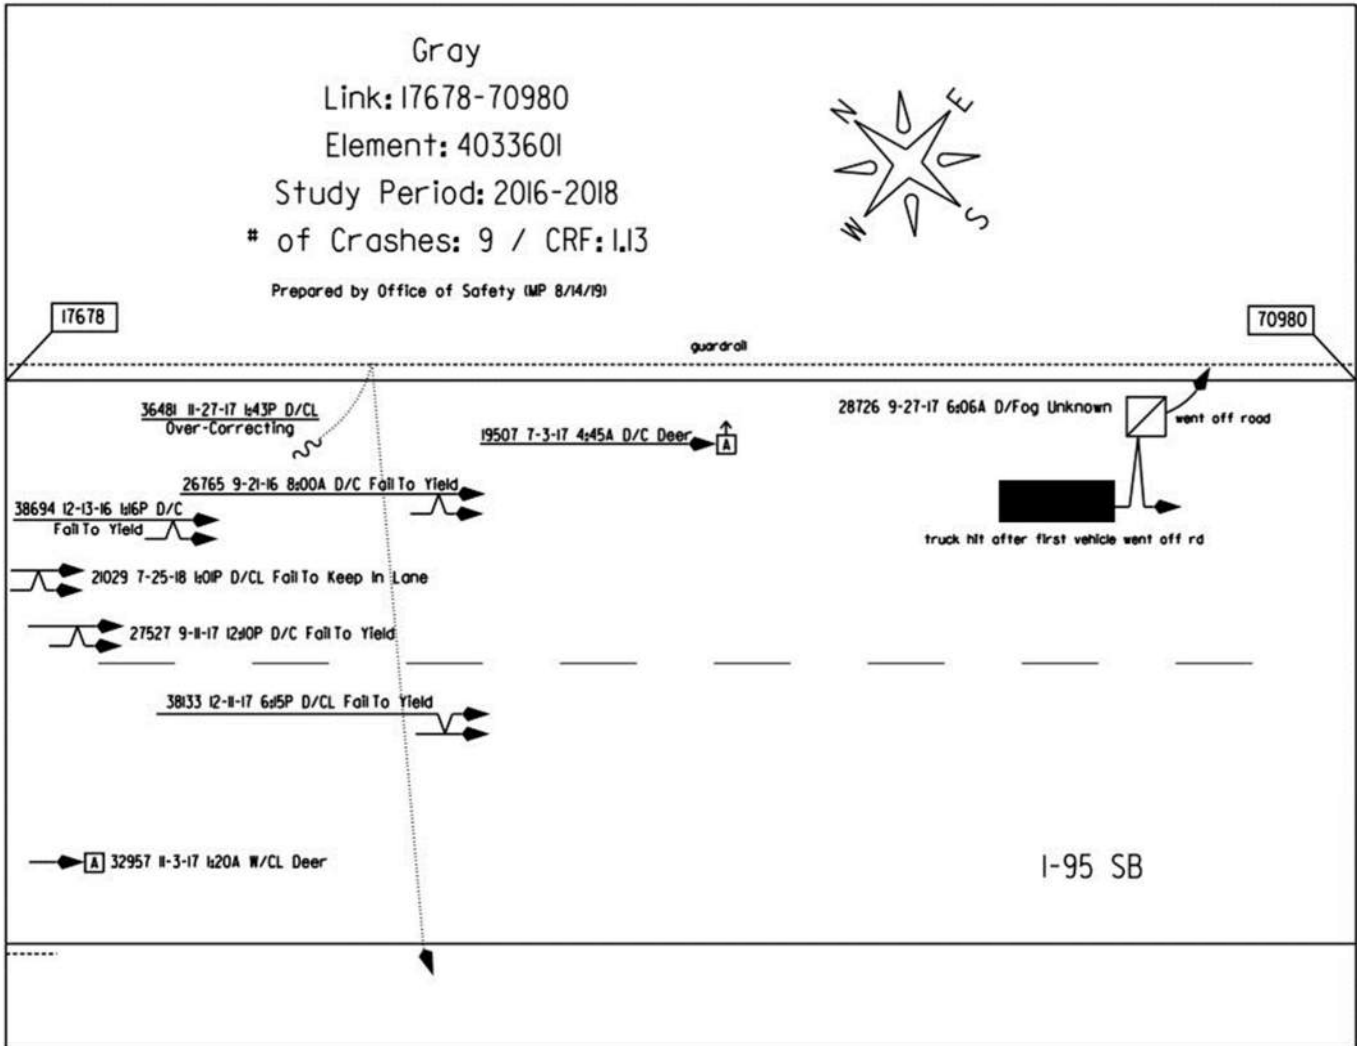
**Figure 3: 2016-2019 SB South of Exit 63 On Ramp Crash Diagram**

As shown in **Figure 3**, there were 9 crashes resulting in a 0% injury rate during this analysis period.

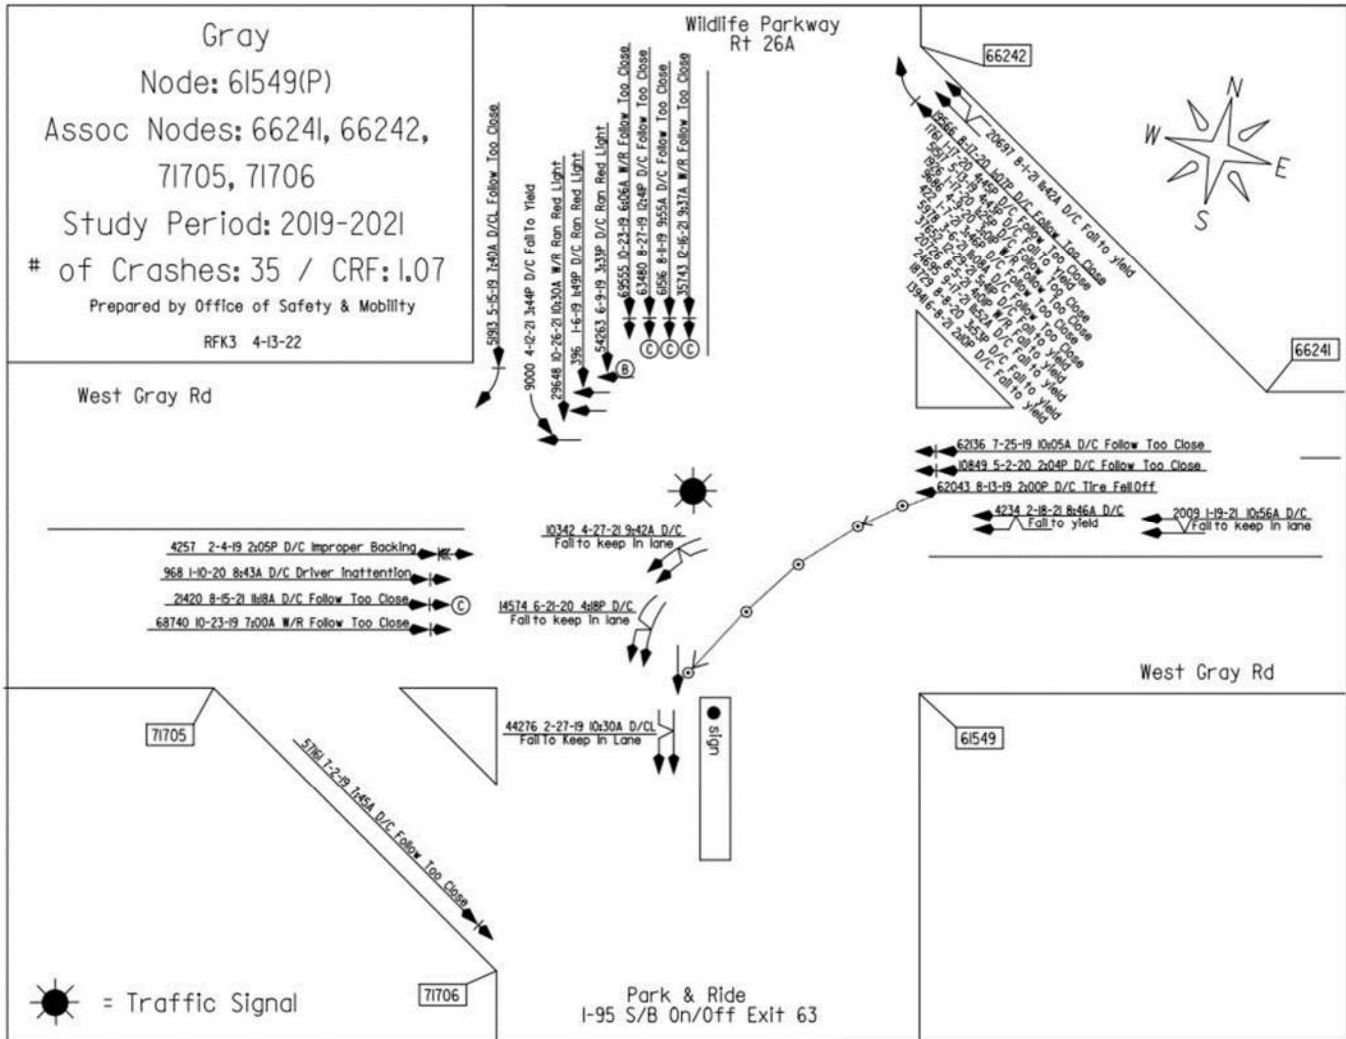
**Figure 3: 2019-2021 SB Ramps Intersection Crash Diagram**

As shown in **Figure 3**, there were 35 crashes resulting in a 14.3% injury rate during this analysis period.

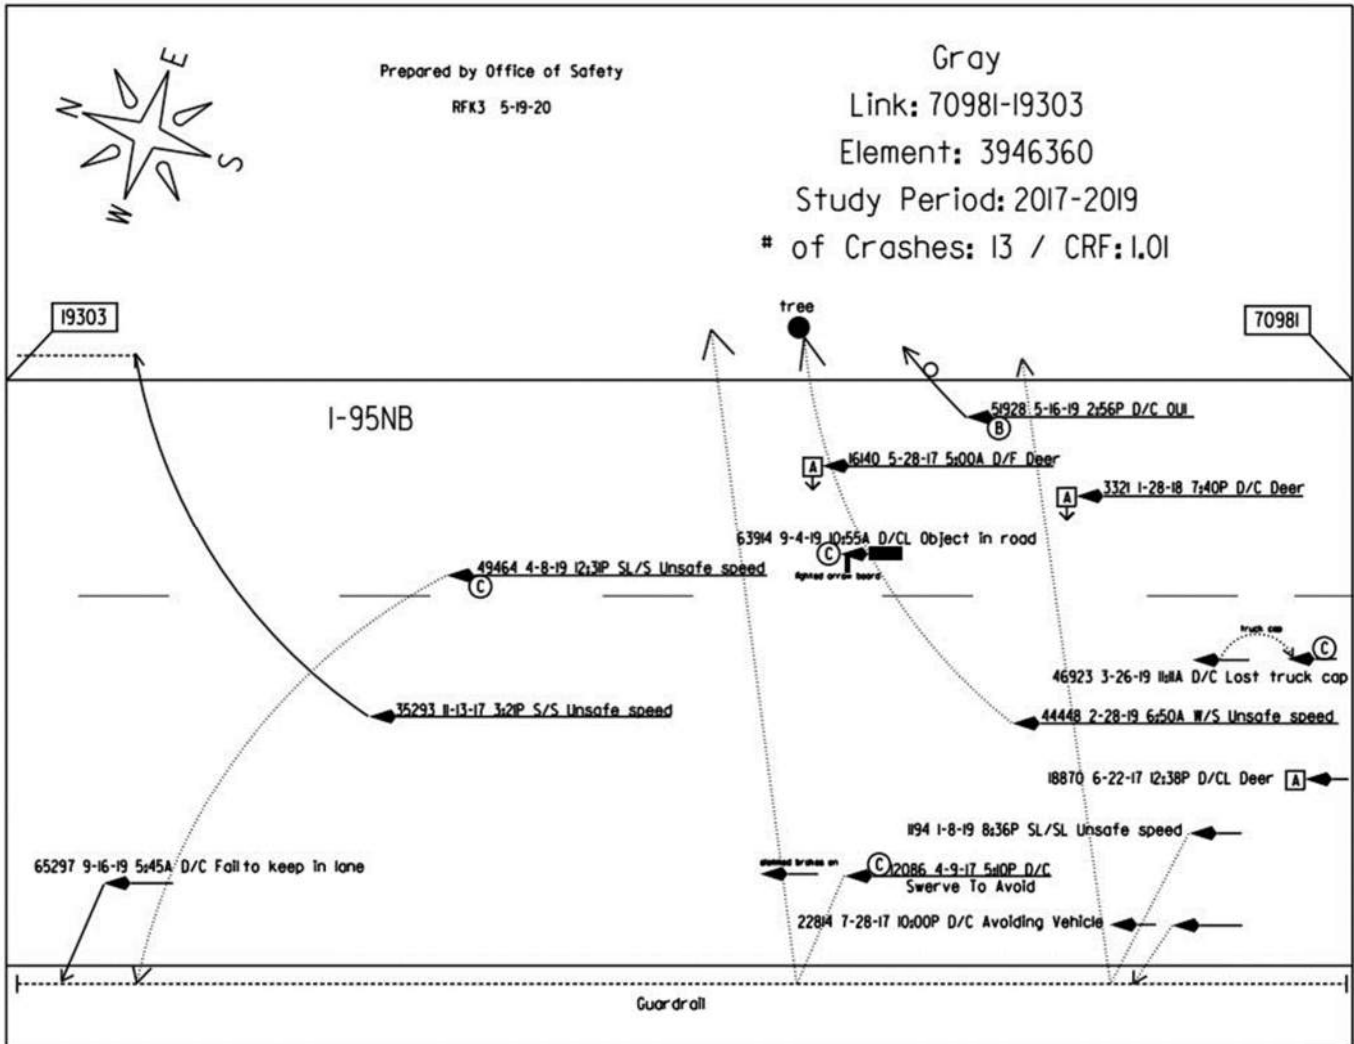
**Figure 3: 2017-2019 I-95 NB Near Shaker Road Crash Diagram**

As shown in **Figure 3**, there were 13 crashes resulting in a 38.5% injury rate during this analysis period.

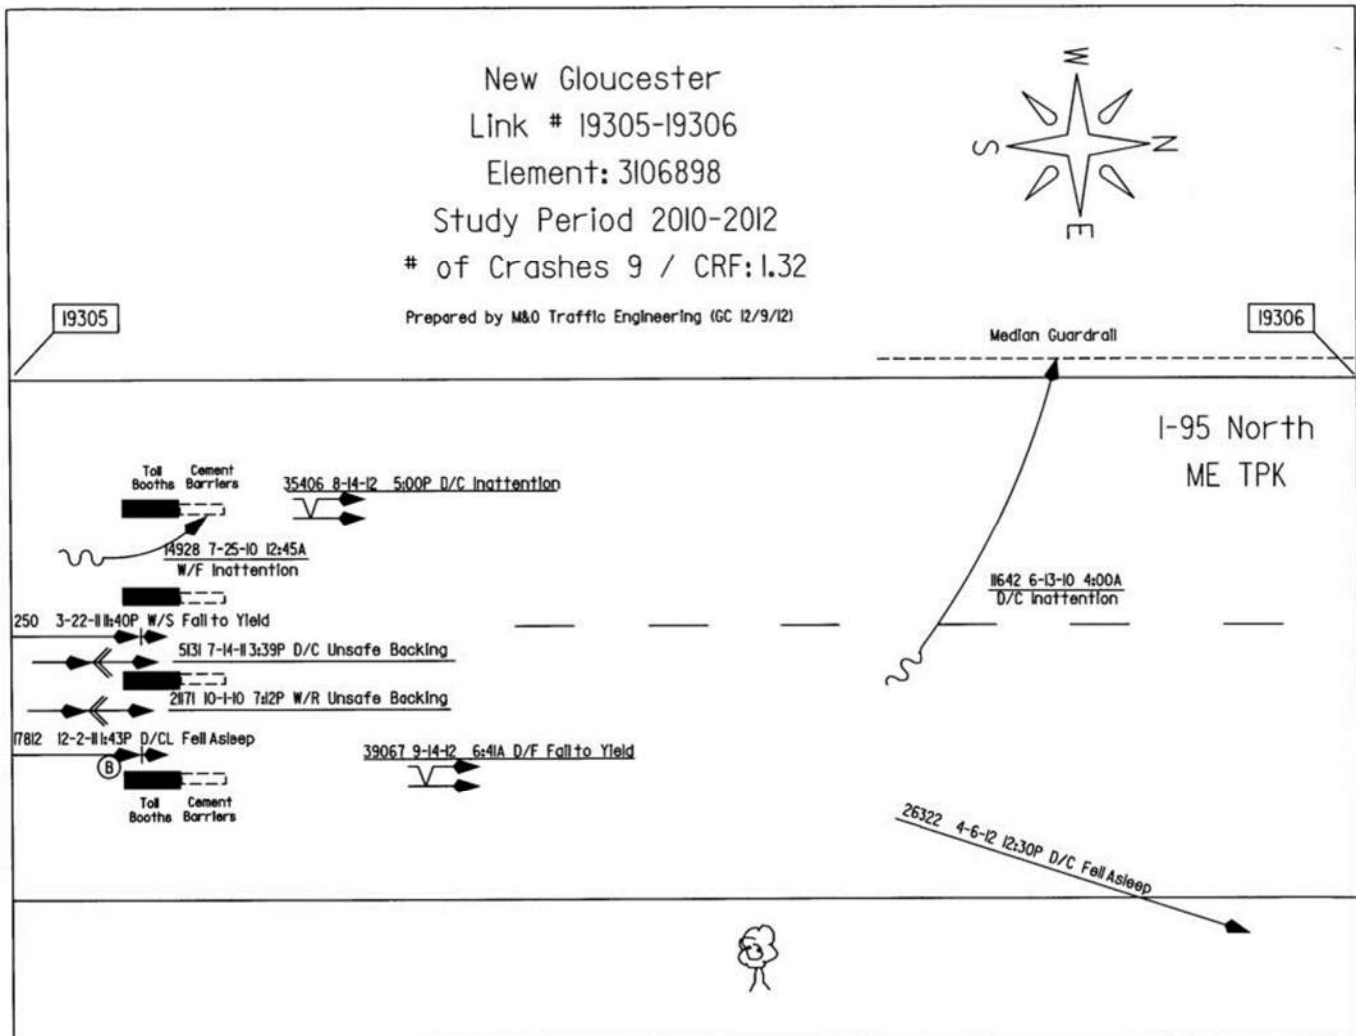
**Figure 2: 2010-2012 NB Toll Plaza Crash Diagram**

As shown in **Figure 2**, there were 9 crashes resulting in a 11.1% injury rate during this analysis period.

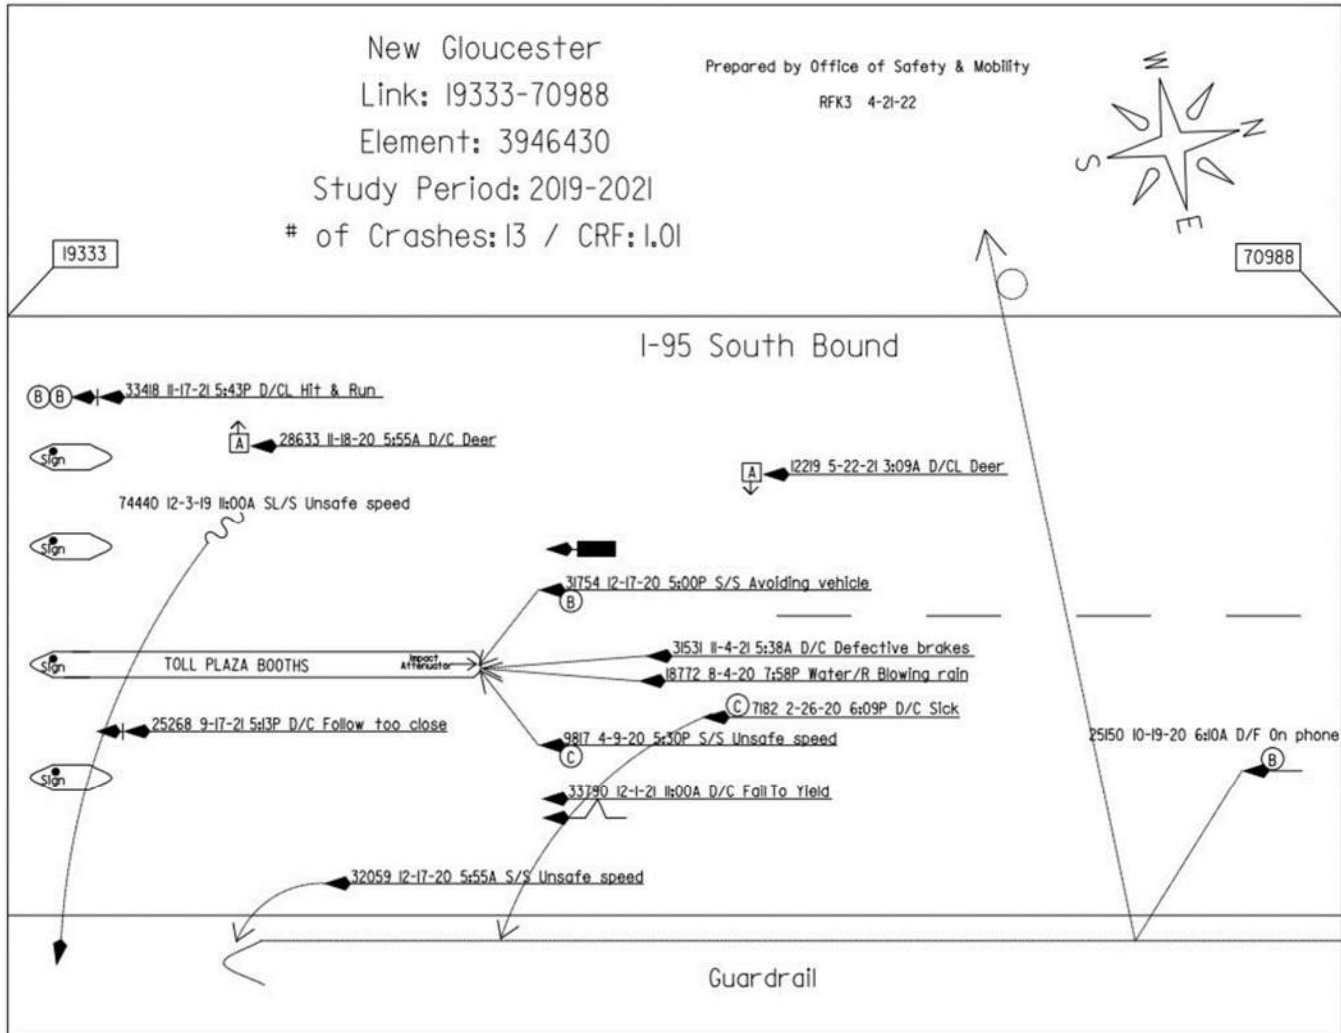
**Figure 3: 2019-2021 New Gloucester Toll Plaza SB Crash Diagram**

As shown in **Figure 3**, there were 13 crashes resulting in a 38.5% injury rate during this analysis period.

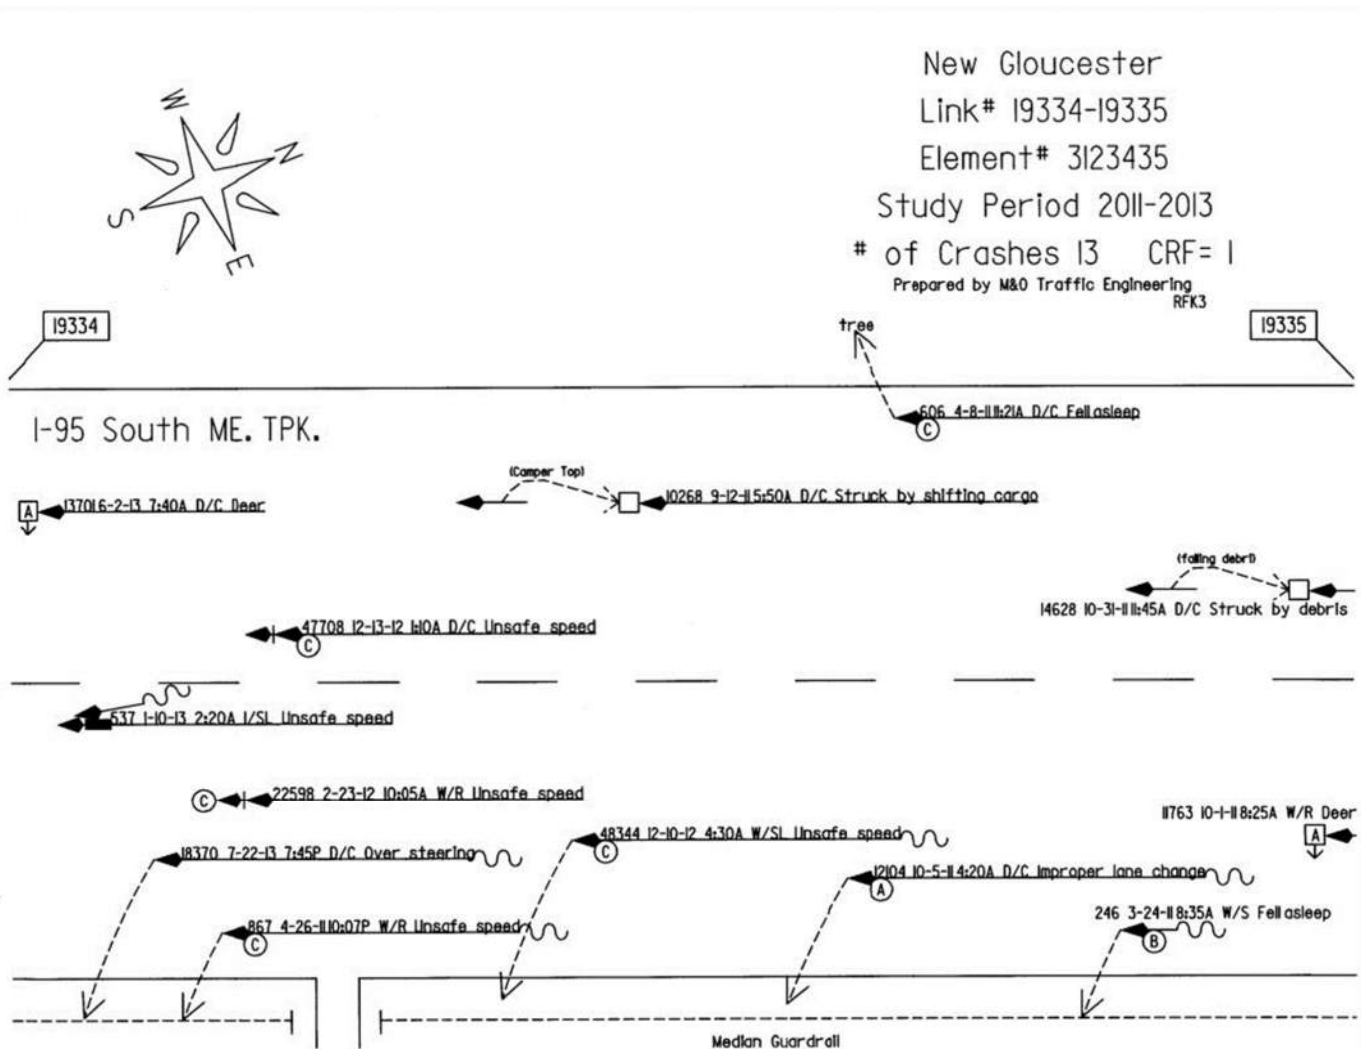
**Figure 4: 2011-2013 SB North of Toll Plaza Crash Diagram**

As shown in **Figure 4**, there were 13 crashes resulting in a 53.8% injury rate during this analysis period.

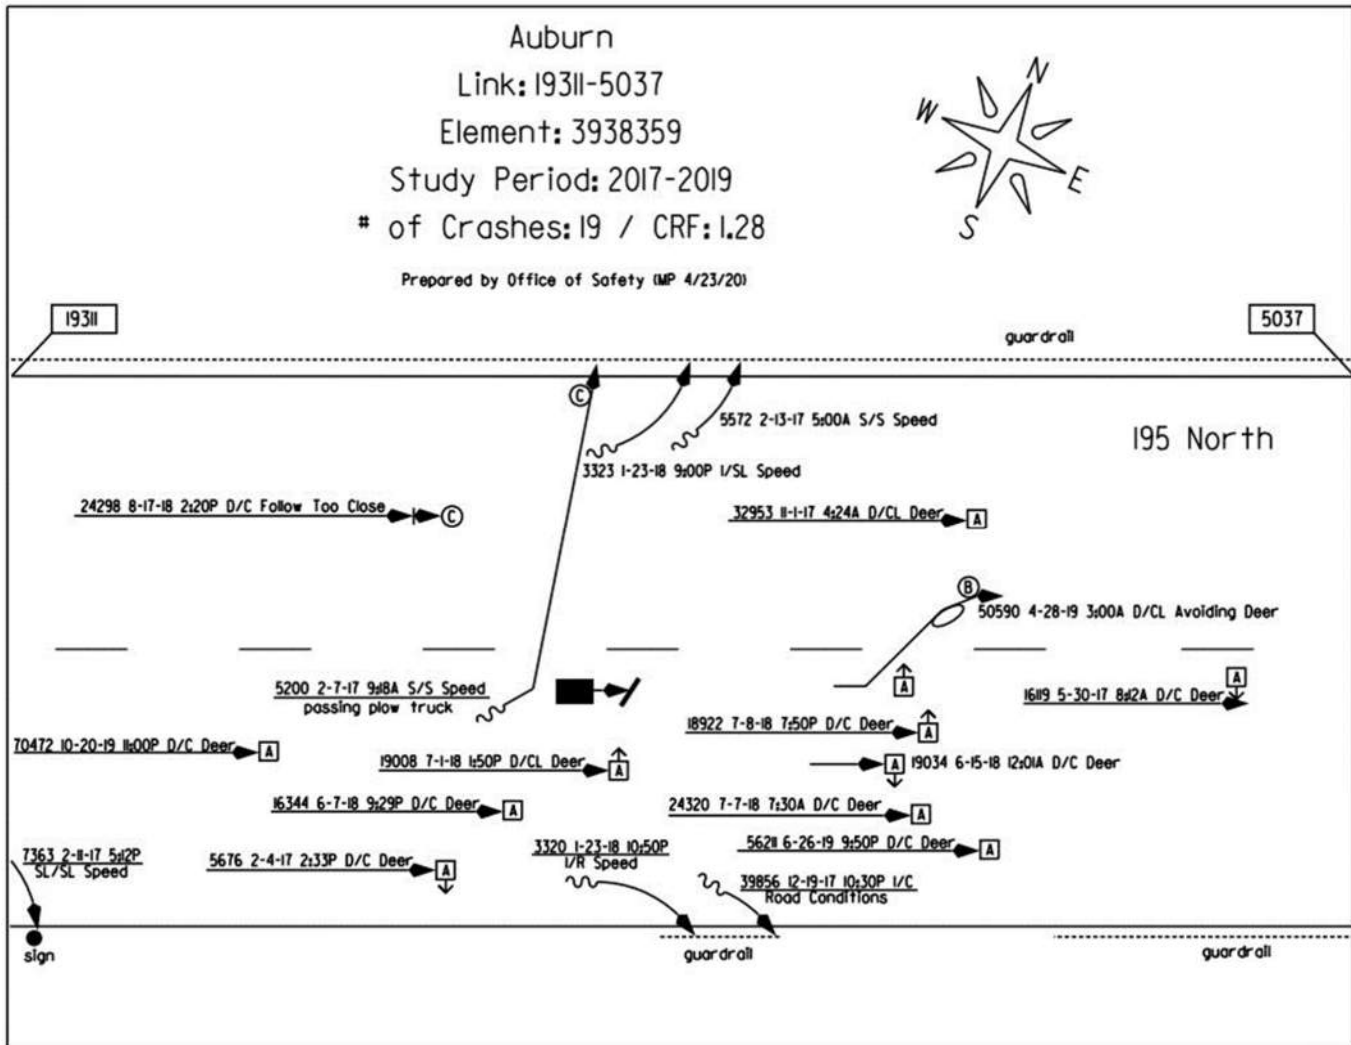
Figure 2: 2017-2019 NB Segment over Poland Springs Bridge Crash Diagram

As shown in Figure 2, there were 19 crashes resulting in a 15.8% injury rate during this analysis period.

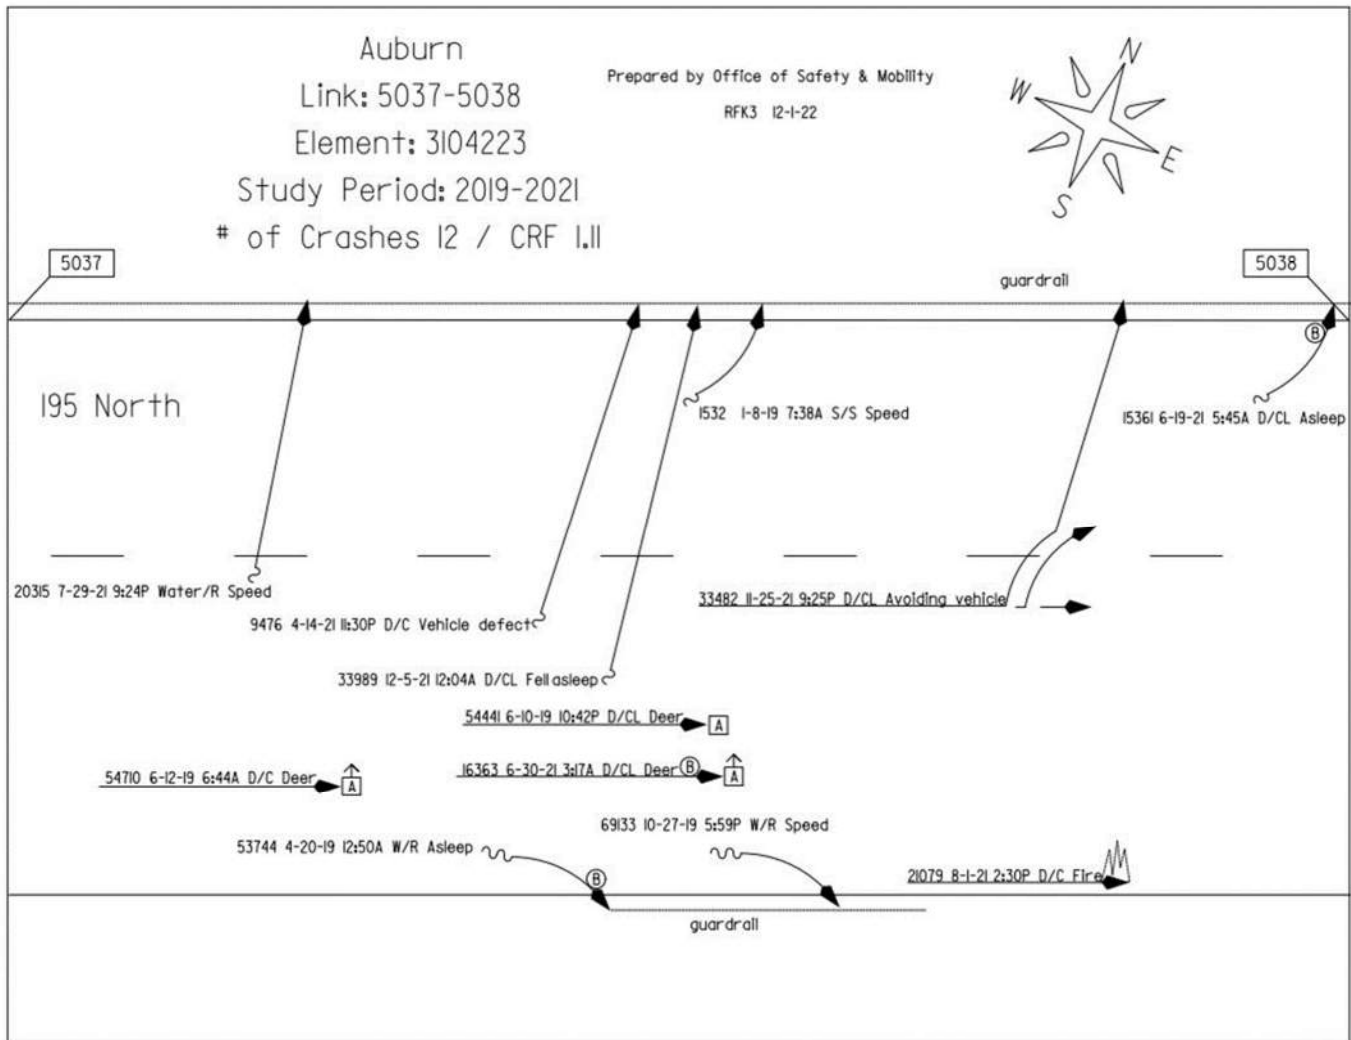
**Figure 3: 2019-2021 I-95 NB South of Exit 75 Crash Diagram**

As shown in **Figure 3**, there were 12 crashes resulting in a 25% injury rate during this analysis period.

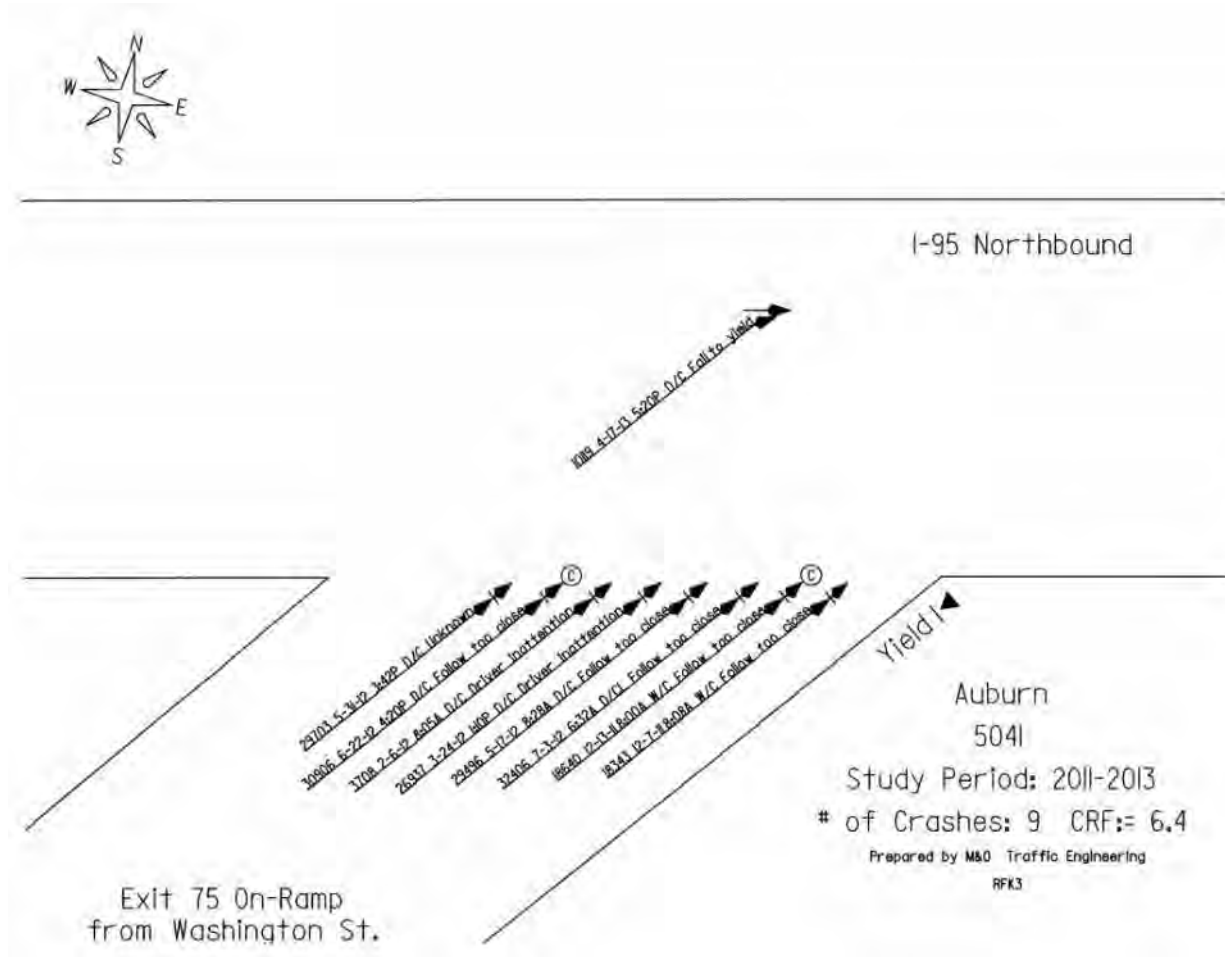
**Figure 2: 2011-2013 Exit 75 NB On Ramp Merge Crash Diagram**

As shown in **Figure 2**, there were 9 crashes resulting in a 22.2% injury rate during this analysis period.

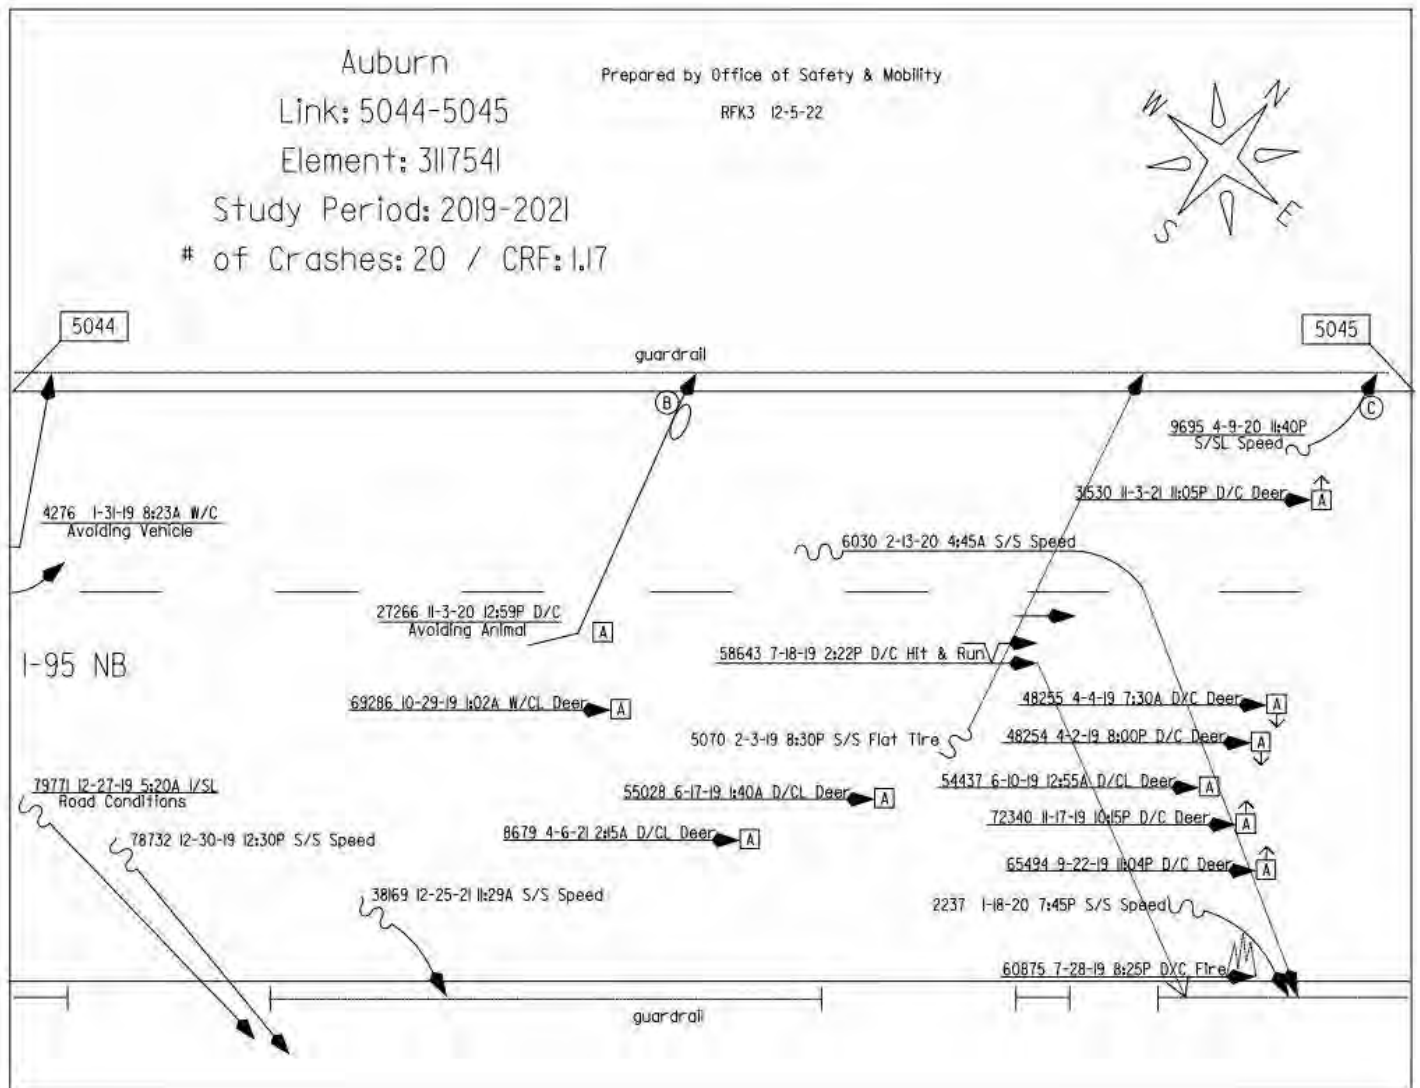
**Figure 2: 2019-2021 I-95 NB Crash Diagram**

As shown in **Figure 2**, there were 20 crashes resulting in a 10% injury rate during this analysis period.
