UNDERWATER BRIDGE INSPECTION REPORT

BRIDGE 0086 AND 1494

**MAINE TURNPIKE (I-95) OVER THE ANDROSCOGGIN RIVER
(2) 6-SPAN BRIDGES (NB AND SB)**

INSPECTED ON: MAY 26, 2016

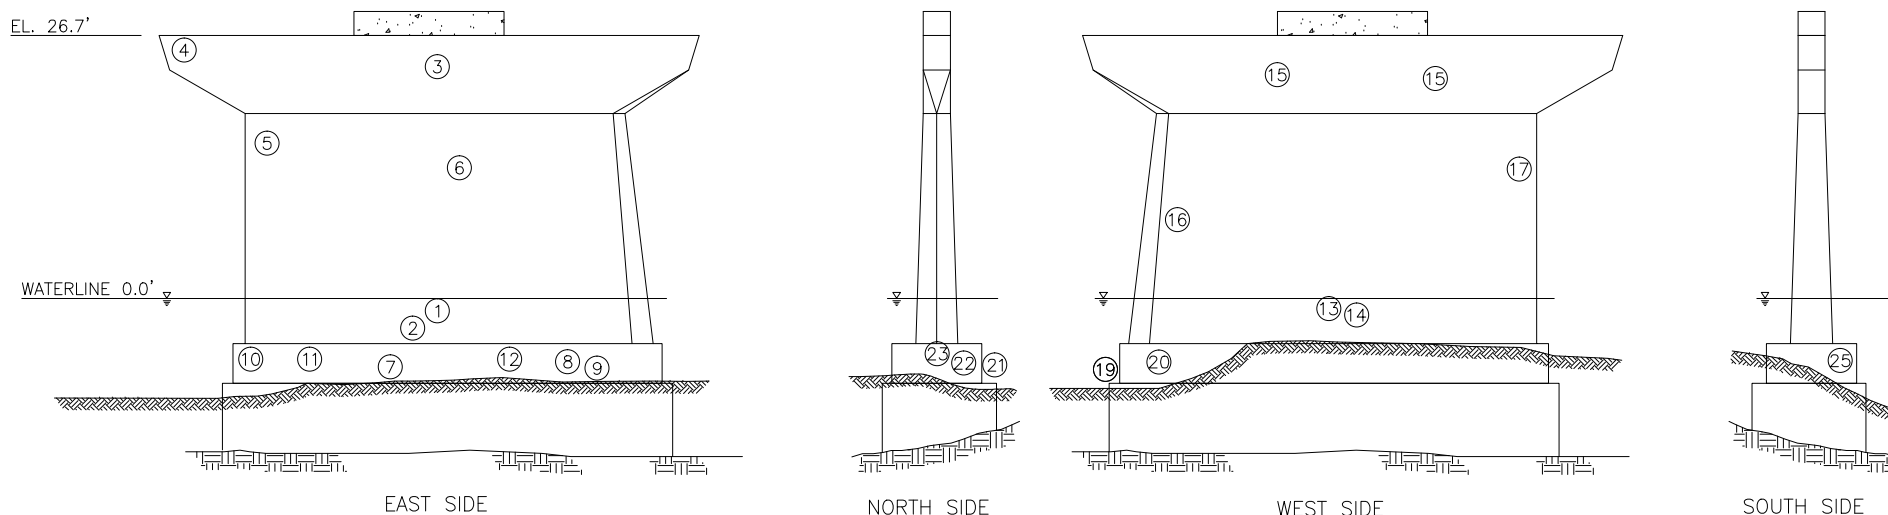
ELEVATIONS - PIER 2
(Scale: 1/32" = 1'-0")

1. HORIZONTAL CRACK: 1/8"W X FULL LENGTH OF THE PIER, LOCATED APPROXIMATELY 5' BELOW THE WATERLINE.
2. HORIZONTAL CRACK: 55'L X 1/16"W, STARTING AT THE SOUTH END OF THE PIER EXTENDING TO THE NORTH, LOCATED APPROXIMATELY 3' BELOW THE WATERLINE.

3. DIAGONAL CRACK: 12'L X 1/16"W EXTENDING DOWN TOWARDS THE NORTH, LOCATED AT THE TOP OF THE PIER NEAR THE CENTERLINE ON THE EAST FACE
4. SPALL: 2 SF
5. SPALL: 10 SF

6. PREVIOUS REPAIR WITH HAIRLINE MAP CRACKING: 30 SF.
7. FOOTING IS EXPOSED ALONG THE EAST FACE, DOWN TO THE TOP OF THE SEAL
8. ON THE EAST FACE, THERE IS A 25'L X 1/4"W HORIZONTAL CRACK LOCATED APPROXIMATELY 3' BELOW THE TOP OF THE FOOTING, EXTENDING FROM THE NORTH END OF THE PIER, WITH TWO INTERSECTING 3' X 1/8"W CRACKS EXTENDING TO THE TOP OF THE FOOTING

9. HORIZONTAL CRACK: 18'L X 1/8"W, LOCATED APPROXIMATELY 4' FROM THE TOP OF THE FOOTING NEAR THE NORTH END OF THE PIER.
10. HORIZONTAL CRACK: 10'L X 1/4"W, LOCATED APPROXIMATELY 4' BELOW THE TOP OF THE FOOTING, EXTENDING FROM THE SOUTH END OF THE PIER,

11. VERTICAL CRACK: 3.5'L X 1/4", LOCATE APPROXIMATELY 4' FROM THE TOP OF THE FOOTING.
12. NEAR THE PIER CENTERLINE, THERE IS A 2 SF AREA OF HONEY COMBING APPROXIMATELY 1 1/2"D, LOCATED APPROXIMATELY 4' BELOW THE TOP OF THE FOOTING.

13. HORIZONTAL CRACKS (2): 1/8"W X FULL LENGTH OF THE PIER, LOCATED APPROXIMATELY 1' AND 3' BELOW THE WATERLINE.
14. HORIZONTAL CRACK: 20'L X 1/8"W EXTENDING FROM THE NORTH END OF THE PIER, LOCATED APPROXIMATELY 5' BELOW THE WATERLINE ON THE WEST FACE.

15. DIAGONAL CRACKS (2): 12'L X 1/8"W AT EITHER ENDS OF THE CONCRETE PEDESTAL, EXTENDING DOWN TOWARDS THE CENTER OF THE PIER.
16. SPALL: 3 SF, LOCATED TOWARDS THE NORTH END OF THE PIER, APPROXIMATELY 10' ABOVE THE WATERLINE.

17. SPALL: 4 SF, LOCATED AT THE SOUTH END OF THE PIER, APPROXIMATELY 15' ABOVE THE WATERLINE.
18. SPALL: 1'H X 1.5'W, LOCATED JUST BELOW THE PIER HEAD.
19. FOOTING IS EXPOSED ON THE WEST FACE AT THE NORTH END OF THE PIER, APPROXIMATE 15' LONG,
20. HORIZONTAL CRACK: 14'L X 1/4"W, LOCATED APPROXIMATELY 2' BELOW THE TOP OF THE FOOTING, EXTENDING BACK FROM THE NORTH END OF THE PIER.
21. FOOTING IS EXPOSED ON THE NORTH FACE OF THE PIER, DOWN TO THE SEAL.
22. HORIZONTAL CRACK: UP TO 1" WIDE X FULL LENGTH, LOCATED APPROXIMATELY 2' BELOW THE TOP OF THE FOOTING.
23. HORIZONTAL CRACK: 2'L X 1/2"W, EXTENDING DOWN FROM THE TOP OF THE FOOTING AT THE CENTER OF THE PIER.
24. A 5' LENGTH OF THE FOOTING IS EXPOSED AT THE SOUTH END OF THE PIER.

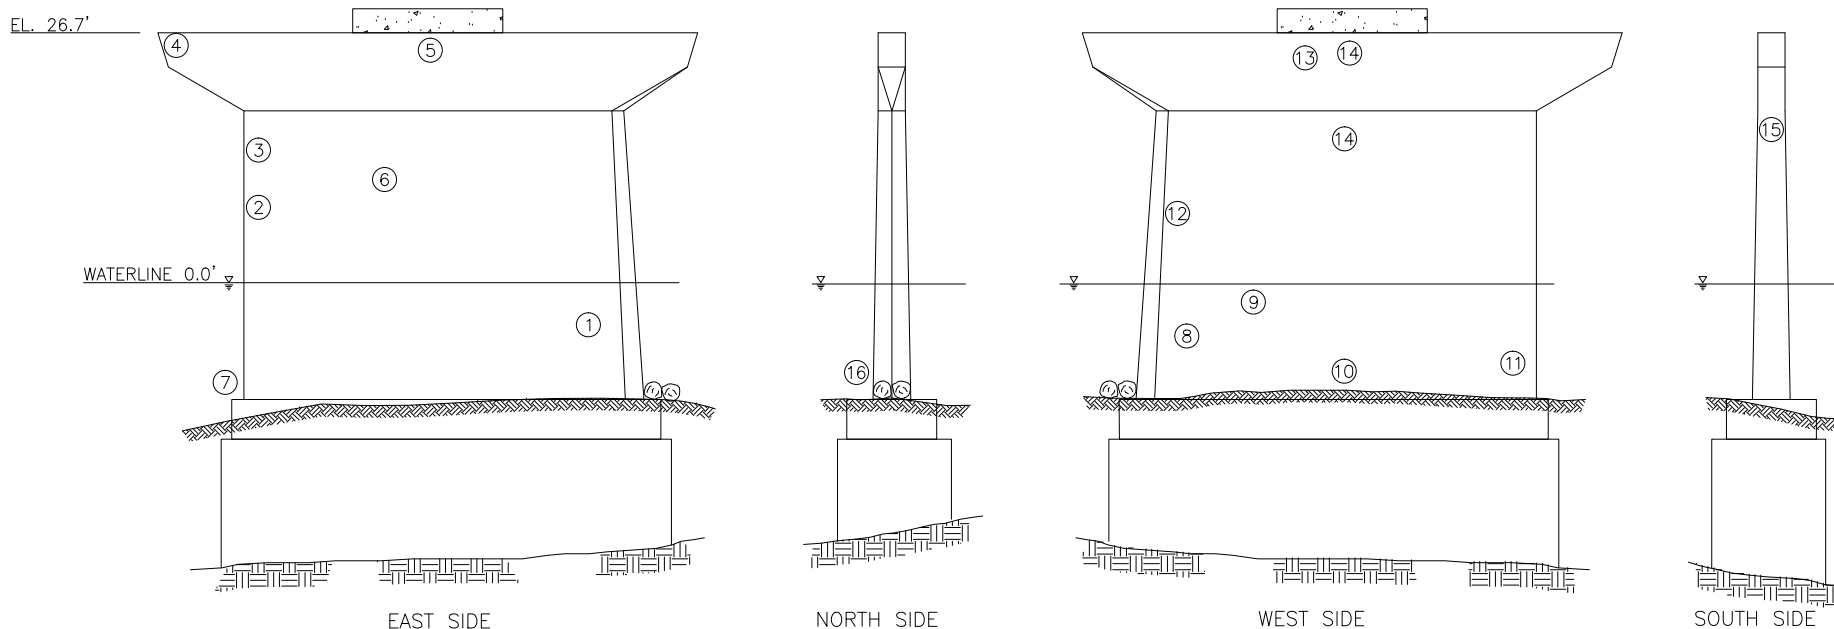
ELEVATIONS - PIER 3
(Scale: 1/32" = 1'-0")

1. HORIZONTAL CRACK: 10'L X 1/16", EXTENDING FROM THE NORTH END OF THE PIER, LOCATED APPROXIMATELY 10' BELOW THE WATERLINE
2. VERTICAL CRACK: 15'L X 1/16"W AT THE SOUTH END OF THE PIER, EXTENDING FROM THE WATERLINE UP

3. SPALL: 2'L X 2'H X 4"D, AT THE SOUTH END OF THE PIER, LOCATED APPROXIMATELY 15' ABOVE THE WATERLINE
4. SPALL: 2'L X 2'H X 4"D, AT THE SOUTH END OF THE PIER, LOCATED AT THE TOP OF THE PIER HEAD

5. MAP CRACKING: 300 SF, AT THE TOP OF THE PIER HEAD NEAR THE CENTERLINE
6. REPAIRED AREA EXHIBITED MAP CRACKING: 130 SF NEAR THE SOUTH END OF THE PIER
7. THE FOOTING IS EXPOSED ON THE EAST FACE OF THE PIER WITH UP TO 3' OF VERTICAL EXPOSURE, EXTENDING FROM THE SOUTH END OF PIER APPROXIMATELY 20'. THE REMAINDER OF THE FOOTING ALONG THE EAST FACE IS EXPOSED INTERMITTENTLY, WITH UP TO 8" OF VERTICAL EXPOSURE. LARGE BOULDERS UP TO 4' IN DIAMETER WERE OBSERVED AGAINST THE EXPOSED FOOTING ALONG THE EAST FACE.

8. VERTICAL CRACK: 15'L X 1/8", LOCATED APPROXIMATELY 6' FROM THE NORTH END OF THE PIER, EXTENDING UP FROM THE MUDLINE.
9. VERTICAL CRACK: 6'L X 1/16"W, LOCATED APPROXIMATELY 20' FROM THE NORTH END OF THE PIER, EXTENDING DOWN FROM THE WATERLINE

10. HORIZONTAL CRACK: 2'L X 1/4"W, LOCATED NEAR THE CENTER OF THE PIER APPROXIMATELY 3' ABOVE THE MUDLINE

11. HORIZONTAL CRACK: 6'L X HAIRLINE, EXTENDING FROM THE SOUTH END OF THE PIER, LOCATED APPROXIMATELY 3' ABOVE THE MUDLINE
12. SPALL: 4"L X 4"W X 1"D WITH EXPOSED REINFORCING, LOCATED APPROXIMATELY 10' ABOVE THE WATERLINE NEAR THE NORTH END OF THE PIER
13. SPALL: 3'L X 2'H X 6"D WITH EXPOSED REINFORCING, LOCATED APPROXIMATELY 5' BELOW THE TOP OF THE PIER NEAR THE CENTERLINE
14. PREVIOUS REPAIRS WITH MAP CRACKING: APPROXIMATELY 150 SF
15. SPALLS: TOTALING APPROXIMATELY 70 SF, ONE OF WHICH HAS EXPOSED REINFORCING STEEL
16. 10"Ø X 4' LONG TIMBER TREE TRUNK AGAINST PIER NOSE

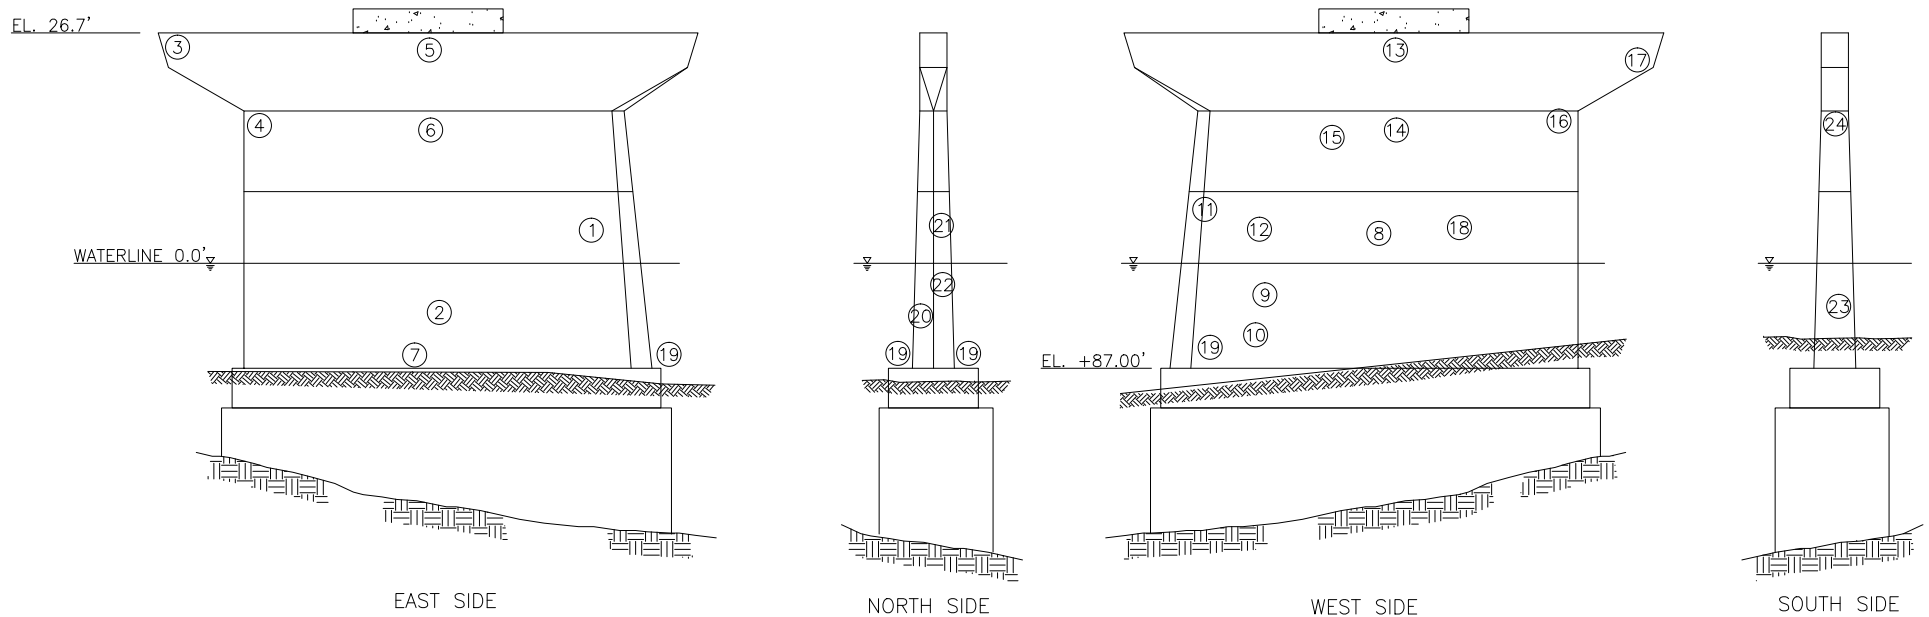
ELEVATIONS - PIER 4
(Scale: 1/32" = 1'-0")

| <ol style="list-style-type: none"> 1. HORIZONTAL CRACK: 30'L X 1/8"W, EXTENDING FROM THE NORTH END OF THE PIER, LOCATED APPROXIMATELY 10' ABOVE THE WATERLINE 2. COLD JOINT, SURROUNDING CONCRETE IS SOUND. 3. SPALLS (4): EACH MEASURING APPROXIMATELY 1'L X 1'W X 2"D WITH EXPOSED REINFORCING STEEL, LOCATED AT THE TOP OF THE PIER HEAD, NEAR THE SOUTH END OF THE PIER 4. SPALL: 6'H X 8"W X 2"D WITH EXPOSED REINFORCING STEEL, LOCATED AT THE BOTTOM OF THE PIER HEAD, NEAR THE SOUTH END OF THE PIER 5. DIAGONAL CRACKS (3): 10'L X 1/8"W NEAR THE CENTER OF THE PIER, EXTENDING DOWN FROM THE TOP OF THE PIER HEAD 6. VERTICAL CRACKS (2): 10'L X 1/8"W NEAR THE CENTER OF THE PIER, EXTENDING DOWN FROM THE BOTTOM OF THE PIER HEAD 7. THE TOP OF THE FOOTING IS EXPOSED INTERMITTENTLY ALONG THE EAST FACE, WITH UP TO 2" OF VERTICAL EXPOSURE. 8. HORIZONTAL CRACK: HAIRLINE X FULL LENGTH OF THE PIER, LOCATED APPROXIMATELY 6' ABOVE THE WATERLINE 9. HORIZONTAL CRACK: 25'L X 1/8"W, EXTENDING FROM THE NORTH END OF THE PIER, LOCATED APPROXIMATELY 3' BELOW THE WATERLINE 10. HORIZONTAL CRACK: 20'L X 1/16"W, EXTENDING FROM THE NORTH END OF THE PIER, LOCATED APPROXIMATELY 6' BELOW THE WATERLINE 11. VERTICAL CRACK: 10'L X 1/8"W, EXTENDING UP FROM THE WATERLINE NEAR THE NORTH END OF THE PIER. 12. VERTICAL CRACK: 3'L X 1/16"W, EXTENDING UP FROM THE WATERLINE NEAR THE NORTH END OF THE PIER. 13. DIAGONAL CRACKS (3): 10'L X 1/8"W NEAR THE CENTER OF THE PIER, EXTENDING DOWN FROM THE TOP OF THE PIER HEAD 14. VERTICAL CRACKS (4): 10'L X 1/8"W NEAR THE CENTER OF THE PIER, EXTENDING DOWN FROM THE BOTTOM OF THE PIER HEAD. WITH RUST STAINING 15. SPALL: 1'L X 1'H SPALL NEAR THE CENTER OF THE PIER, LOCATED APPROXIMATELY 3' BELOW THE PIER HEAD. | <ol style="list-style-type: none"> 16. SPALL: 2'L X 1'H SPALL AT THE SOUTH END OF THE PIER, LOCATED JUST BELOW THE PIER HEAD. 17. SPALL: 3'H X 1.5'W X 2"D WITH EXPOSED REINFORCING STEEL, LOCATED AT THE TOP OF THE PIER HEAD NEAR THE SOUTH END. 18. SPALL: 4' X 3', LOCATED APPROXIMATELY 5' ABOVE THE WATERLINE NEAR THE SOUTH END OF THE PIER 19. THE FOOTING IS EXPOSED AT THE NORTH FACE, WITH UP TO 3' OF VERTICAL EXPOSURE. THE FOOTING EXPOSURE CONTINUES AROUND THE NORTHWEST AND NORTHEAST CORNERS, EXTENDING APPROXIMATELY 30' ALONG THE WEST FACE AND 10' ALONG THE EAST FACE. 20. HORIZONTAL CRACK: 1/4"W X FULL LENGTH, LOCATED APPROXIMATELY 10' BELOW THE WATERLINE. 21. VERTICAL CRACKS: (2) 5'L X HAIRLINE CRACK, EXTENDING UP FROM THE WATERLINE NEAR THE NORTHEAST AND NORTHWEST CORNER OF THE BRIDGE. 22. SPALL: 1'L X 1'W, LOCATED APPROXIMATELY 2' BELOW THE WATERLINE 23. HORIZONTAL CRACK: 1/16"W X FULL LENGTH, LOCATED APPROXIMATELY 8' BELOW THE WATERLINE ON THE SOUTH END OF THE PIER. 24. SPALL 3'L X 1.5'W X 2"D WITH EXPOSED REINFORCING, LOCATED JUST BELOW THE PIER HEAD. |

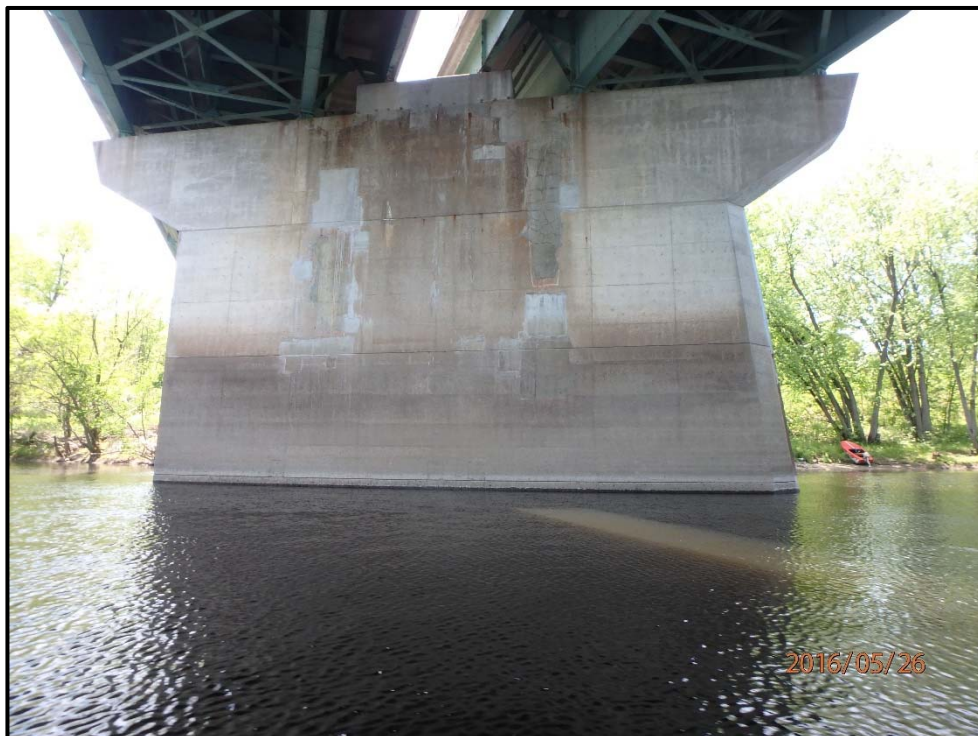
Photo 2 – Typical Pier Configuration (Pier 2 Shown, Looking West)

Piers	Condition Rating: 5
<p>Findings</p>	<p>The concrete piers are in Fair condition overall (See Photo 2). The piers typically have a 4' wide band of moderate abrasion located at the waterline up to 1/4" deep (See Photo 3), and the outer concrete is soft and can be easily removed with a hammer, up to 1/4" deep at the waterline and up to 1/2" deep in submerged areas. Additionally, the piers have widespread cracking and with intermittent areas of spalling with expose reinforcing steel. Some repairs have been completed since the previous inspection, consisting of isolated spall repairs. The following is a list of additional deficiencies observed:</p> <p><u>Pier 1 and 5</u></p> <p>Pier 1 and 5 are located on dry land and therefore were not part of the underwater inspection contract.</p> <p><u>Pier 2</u></p> <ul style="list-style-type: none"> • There are 3'L to 5'L vertical hairline cracks spaced at 2' on-center on all sides of the pier, located in the band of abrasion just above the waterline. • There is a 1/8"W horizontal crack running the full length of the pier, located approximately 5' below the waterline on the east face. • There is a 1/16"W horizontal crack starting at the south end of the pier extending 55' to the north, located approximately 3' below the waterline on the east face. • There is a 12'L x 1/16"W diagonal crack extending down towards the north, at the top of the pier near the centerline on the east face • There is approximately 12 SF of spalling, and one 30 SF area that was previously repaired and has map cracking throughout on the east face. • There are two 1/8"W horizontal cracks running the full length of the pier, located approximately 1' and 3' below the waterline on the west face. • There is a 20'L x 1/8" horizontal crack extending from the north end of the pier, located approximately 5' below the waterline on the west face. • At the top of the pier, there are two 12'L x 1/8"W diagonal cracks at either ends of the concrete pedestal, extending down towards the center of the pier on the west face. • There is a 3 SF spall towards the north end of the pier, located approximately 10' above the waterline on the west face. • There is a 4 SF spall at the south end of the pier, located approximately 15' above the waterline on the west face. • On the north end of the pier, there is a 1'H x 1.5'W spall located just below the pier head.

The timber debris should be removed to limit local scour. All cracks 1/16" and greater should be repaired with epoxy injection. Spalls and areas of map cracking should be repaired by removing loose and deleterious material down to sound concrete, cleaning reinforcing steel, and placing a marine grade concrete or patching compound.

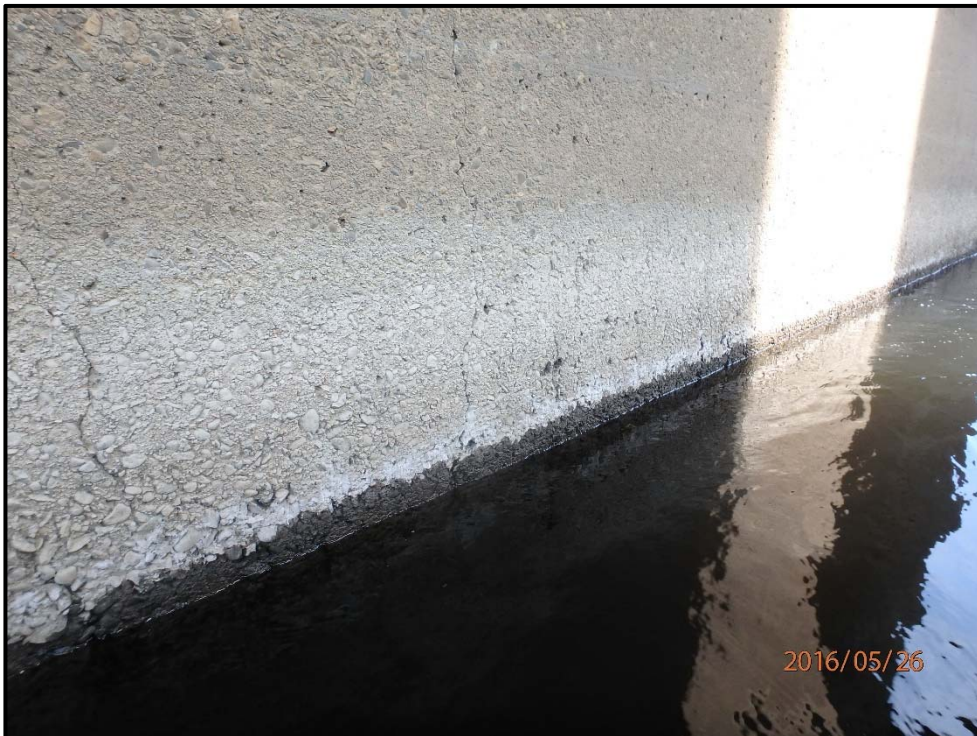
Photo 4 – Typical Vertical Cracking in Abrasion Band (Pier 3 Shown, West Face)

- There are 3'L to 5'L vertical hairline cracks, spaced at 2'-3' on-center on all sides of the pier, located in the band of abrasion just above the waterline (See Photo 4).

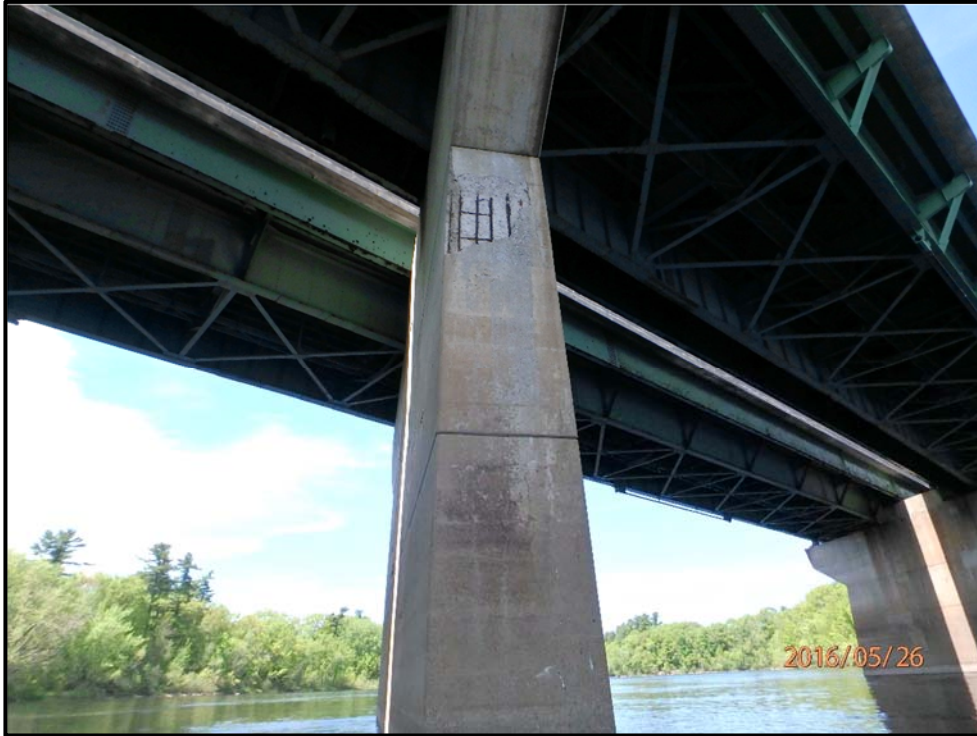
Photo 5 – Typical Spall with Exposed Reinforcing Steel (Pier 3 Shown, South Face)

- On the south end of the pier there are three areas of spalling, totaling approximately 70 SF of spalls, one of which has exposed reinforcing steel (See Photo 5).

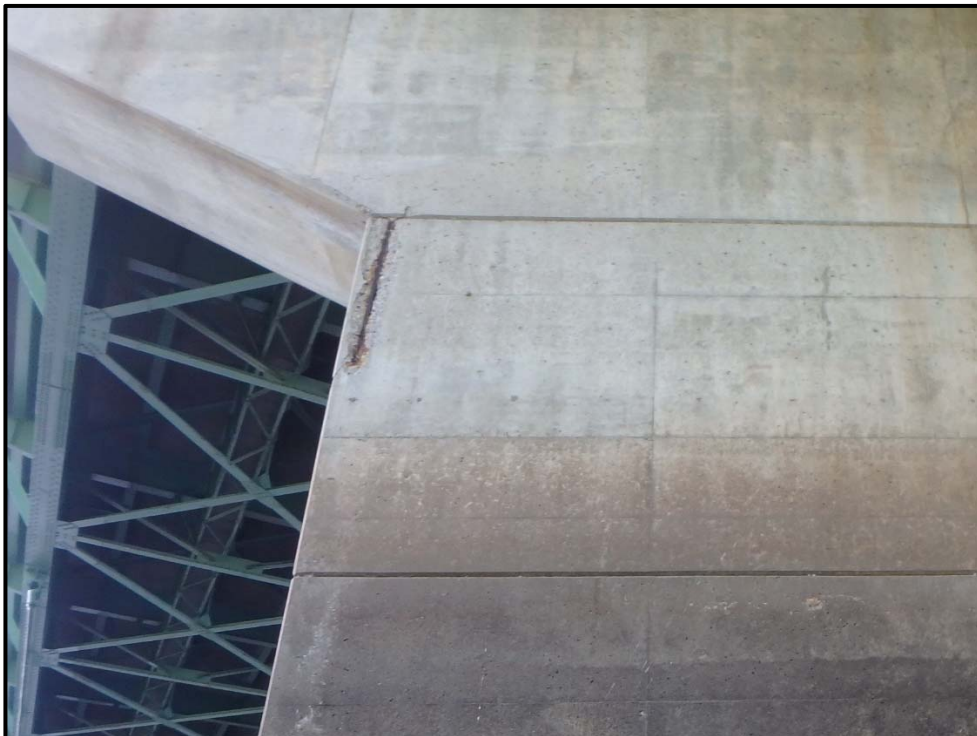
Photo 6 – Typical Spall with Exposed Reinforcing (Pier 4 Shown, East Face)

<ul style="list-style-type: none">• At the bottom of the pier head, near the south end of the pier on the east face, there is a 6'H x 8"W x 2"D spall with exposed reinforcing steel (See Photo 6).• Near the center of the pier, there are three 10'L x 1/8"W diagonal cracks extending down from the top of the pier head on the east face.• Near the center of the pier, there are two 10'L x 1/8"W vertical cracks extending down from the bottom of the pier head on the east face.• There is a hairline horizontal crack running the full length of the pier, located approximately 6' above the waterline on the west face.• There is a 25'L x 1/8"W crack extending from the north end of the pier on the west face, located approximately 3' below the waterline.• There is a 20'L x 1/16"W crack extending from the north end of the pier on the west face, located approximately 6' below the waterline (See Photo 7).• There are two vertical cracks near the north end of the pier on the west face, the first 10'L x 1/8"W, and the second 3'L x 1/16"W, both extending up from the waterline.• Near the center of the pier, there are three 10'L x 1/8"W diagonal cracks extending down from the top of the pier head on the west face.• Near the center of the pier, there are two 10'L x 1/8"W vertical cracks with rust staining extending down from the bottom of the pier head on the west face.• There is a 1'L x 1'H spall near the center of the pier on the west face, located approximately 3' below the pier head.• There is a 2'L x 1'H spall at the south end of the pier on the west face, located just below the pier head.• There is 3'H x 1.5'W x 2"D spall with exposed reinforcing steel located on the west face, at the top of the pier head near the south end.• There is a 4' x 3' spall located approximately 5' above the waterline near the south end of the pier on the west face.• There is a 1/4"W horizontal crack extending the entire width of the nose, located approximately 10' below the waterline on the north end of the pier.• There are two vertical 5'L hairline cracks on the north end of the pier, extending up from the waterline.• There is a 1'L x 1'W spall on the north end of the pier, located approximately 2' below the waterline.• There is a 1/16"W horizontal crack extending the entire width of the nose, located approximately 8' below the waterline on the south end of the pier.• There is a 3'L x 1.5'W x 2"D spall with exposed reinforcing on the south end of the pier, located just below the pier head.

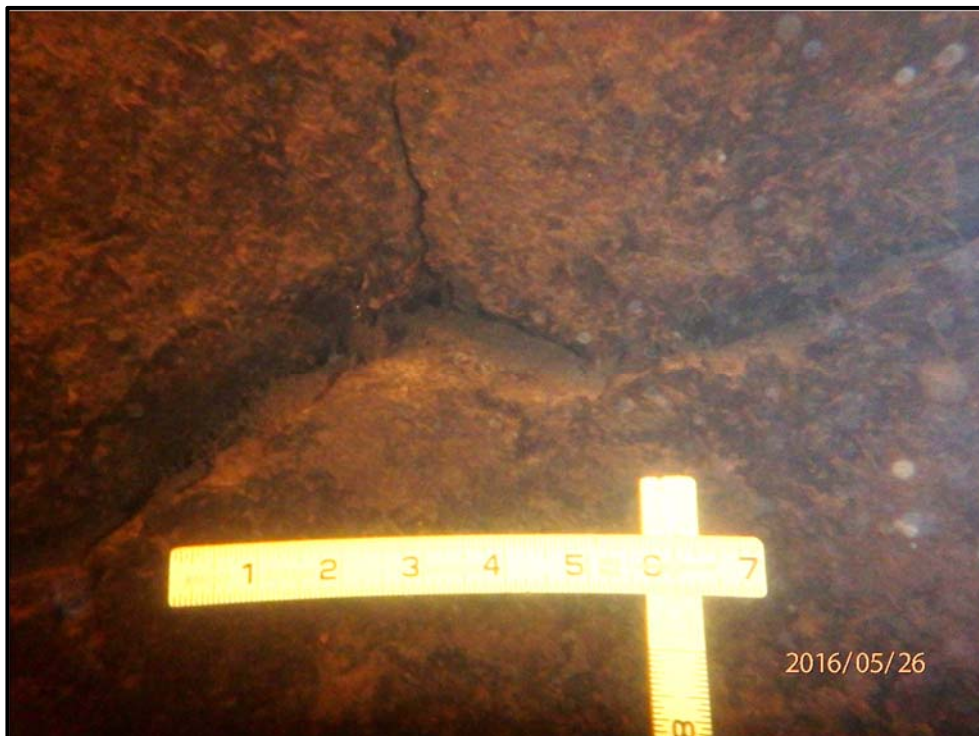
Photo 8 – Typical Horizontal Crack in Exposed Footing (Pier 2 Shown, East Nose)

Footings	Condition Rating: 6
<p>Findings</p>	<p>Per the previous inspection report, based on available record drawings, the footings are cast on a concrete seal which is bearing directly on bedrock. The footings had partial exposure at various locations, however the concrete seal was completely buried at all piers. The following is specific information on the footing exposure observed, and defects identified in the exposed areas of the footings.</p> <p><u>Pier 2</u></p> <p>The entire footing along the east face is exposed down to the top of the seal, and an approximate 15' length of the footing is exposed on the west face at the north end of the pier, and a 5' length at the south end of the pier.</p> <ul style="list-style-type: none"> • On the east face, there is a 25'L x 1/4"W horizontal crack located approximately 3' below the top of the footing, extending from the north end of the pier, with two intersecting 3' x 1/8"W cracks extending to the top of the footing (See Photo 8). • There is an 18'L x 1/8"W crack located approximately 4' from the top of the footing near the north end of the pier on the east face. • There is also a 10' x 1/4"W crack located approximately 4' below the top of the footing on the east face, extending from the south end of the pier, with an adjacent 3.5'L x 1/4"W vertical crack at the north end (See Photo 9). • Near the pier centerline, there is a 2 SF area of honey combing approximately 1 1/2"D, located approximately 4' below the top of the footing on the east face. • There is a 14'L x 1/4"W horizontal crack located approximately 2' below the top of the footing extending back from the north end of the pier on the west face. • On the north end of the pier, there is a horizontal crack that extends across the entire face, up to 1" wide, and located approximately 2' below the top of the footing. • There is a 2'L x 1/2"W crack extending down from the top of the footing in the center of the north end of the pier. <p><u>Pier 3</u></p> <p>The footing is exposed on the east face of the pier with up to 3' of vertical exposure, extending from the south end of pier approximately 20'. The remainder of the footing along the east face is exposed intermittently, with up to 8" of vertical exposure. Large boulders up to 4' in diameter were observed against the exposed footing along the east face.</p> <p><u>Pier 4</u></p> <p>The footing is exposed from the northwest corner, extending approximately 30' along the west face, with up to 3' of vertical exposure. On the east face, the top of the footing is exposed at the northeast corner, with up to 2" of vertical exposure.</p>
