Project Summary

Project Name:		HNTB MTA						
US MH	DS MH	Pipe ID	Date	Street	Material	Size	Total	Insp
Left In	Left Out	Left In - Left Out	4/20/2018	Exit 36 N On Ramp	Corrugated Metal Pipe	42	0	311.3

Project Name:		Maine Turnpike Authority Culvert Under I-95 Saco						
US MH	DS MH	Pipe ID	Date	Street	Material	Size	Total	Insp
Culvert Outlet	Culvert Inlet		7/28/2015	I 95	Corrugated Metal Pipe	36	0	335.9

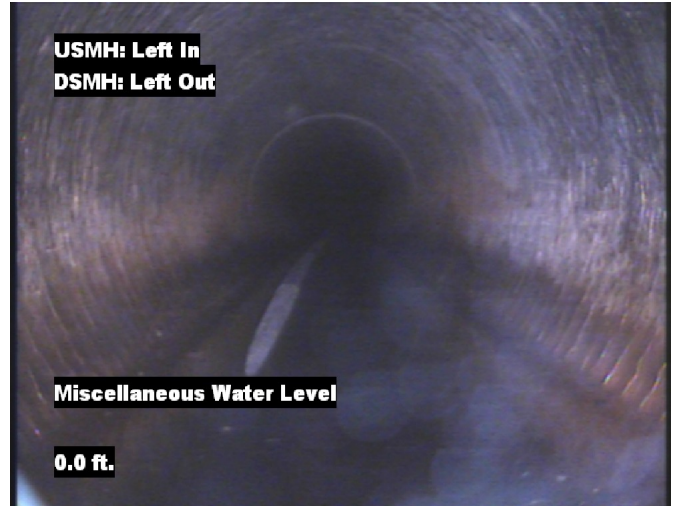
Distance: 0.0 ft. Grade: 0
Condition: Miscellaneous Water Level
Remarks: N/A

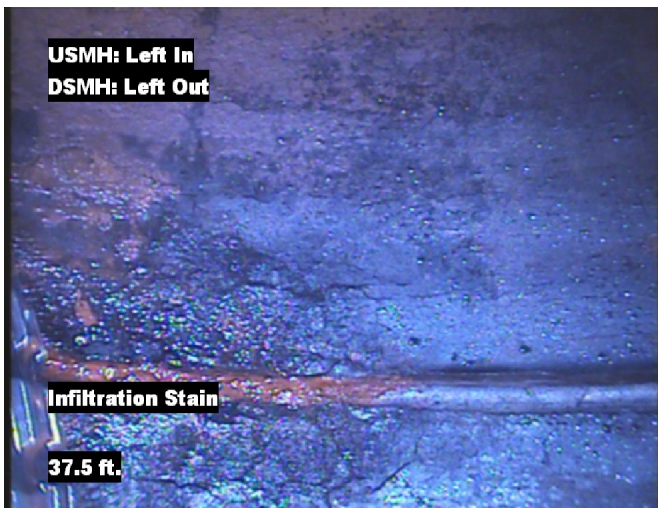
Distance: 37.5 ft. Grade: 1
Condition: Infiltration Stain
Remarks: N/A

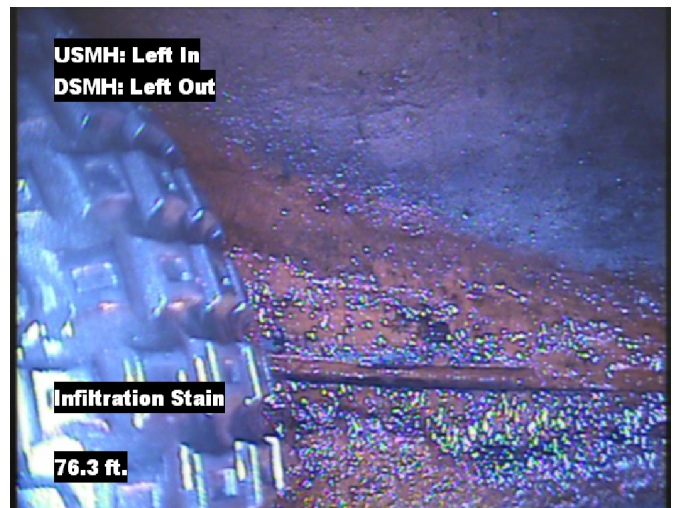
Distance: 76.3 ft. Grade: 1
Condition: Infiltration Stain
Remarks: N/A

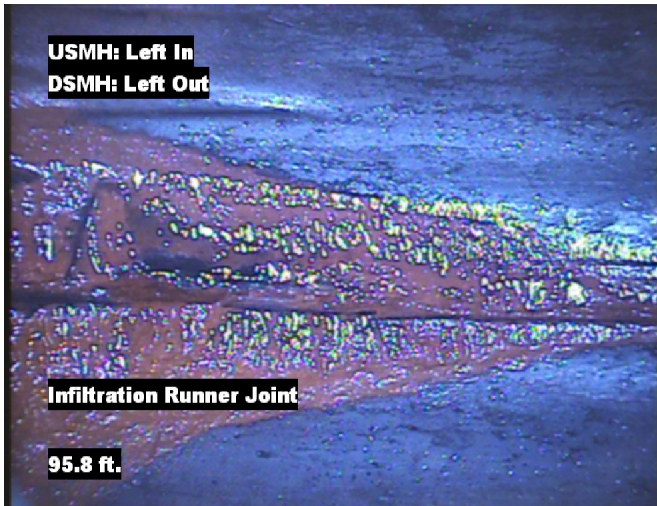
Distance: 95.8 ft. Grade: 4
Condition: Infiltration Runner Joint
Remarks: N/A

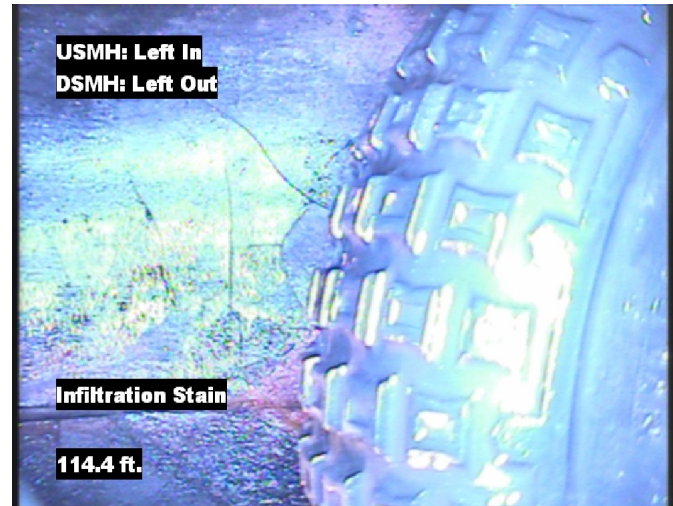
Distance: 114.4 ft. Grade: 1
Condition: Infiltration Stain
Remarks: N/A

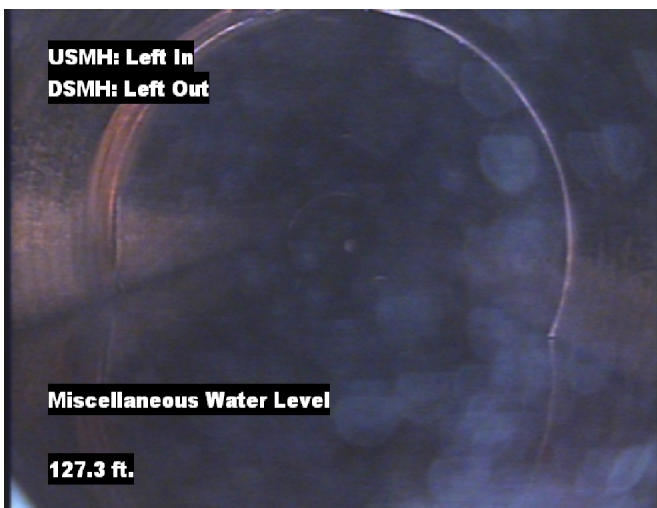
Distance: 127.3 ft. Grade: 0
Condition: Miscellaneous Water Level
Remarks: N/A

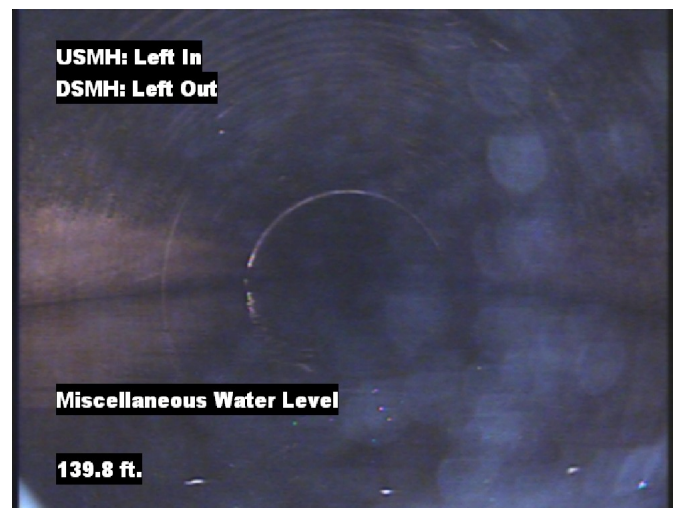
Distance: 139.8 ft. Grade: 0
Condition: Miscellaneous Water Level
Remarks: N/A

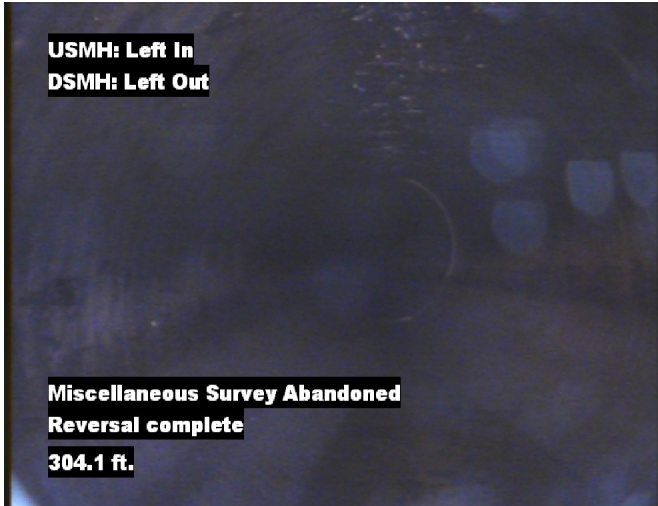
Distance: 304.1 ft. Grade: 0
 Condition: Miscellaneous Survey Abandoned
 Remarks: Reversal complete

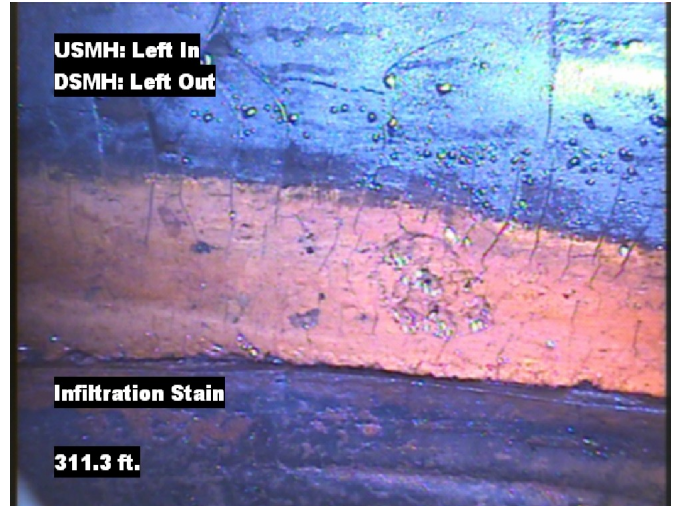
Distance: 311.3 ft. Grade: 1
 Condition: Infiltration Stain
 Remarks: N/A

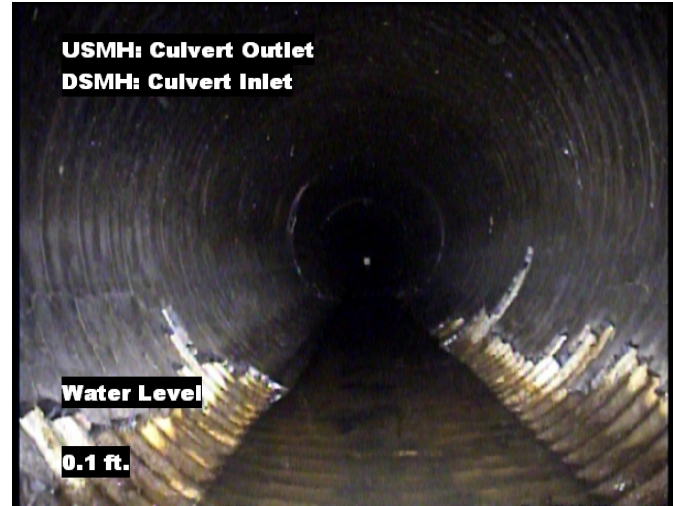
Distance: 0.1 ft. Grade: 0
Condition: Water Level
Remarks: N/A

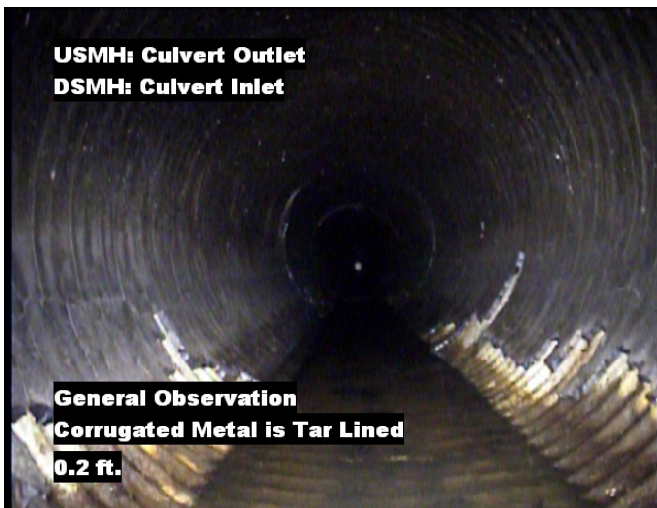
Distance: 0.2 ft. Grade: 0
Condition: General Observation
Remarks: Corrugated Metal is Tar Lined

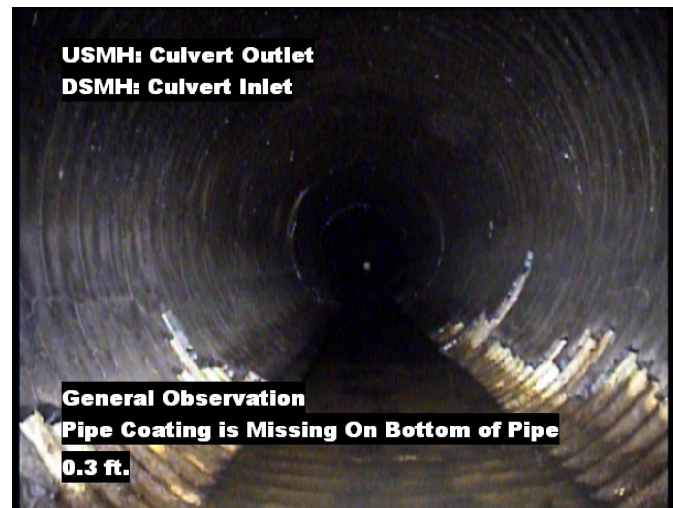
Distance: 0.3 ft. Grade: 0
Condition: General Observation
Remarks: Pipe Coating is Missing On Bottom of Pipe

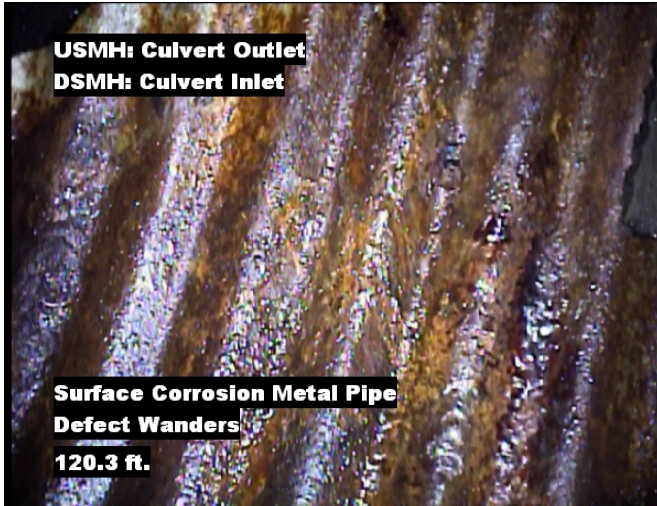
Distance: 0.4 ft. Grade: 3
Condition: Surface Corrosion Metal Pipe
Remarks: Defect Wanders

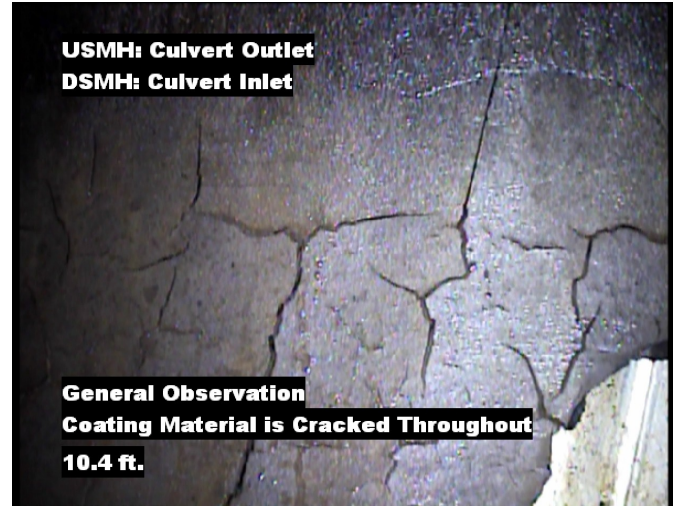
Distance: 10.4 ft. Grade: 0
Condition: General Observation
Remarks: Coating Material is Cracked Throughout

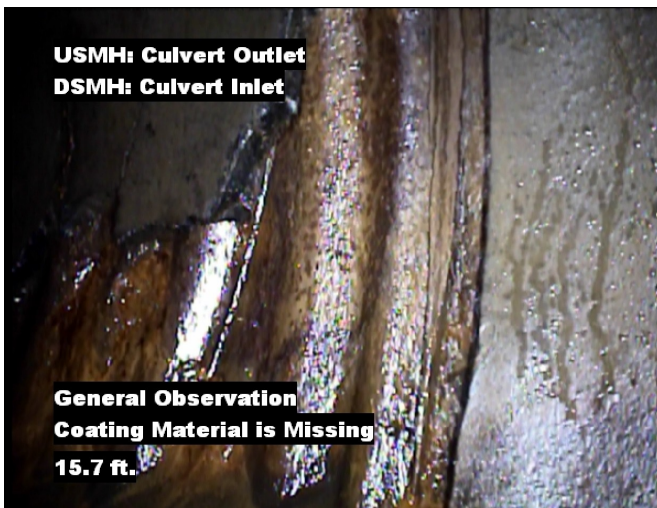
Distance: 15.7 ft. Grade: 0
Condition: General Observation
Remarks: Coating Material is Missing

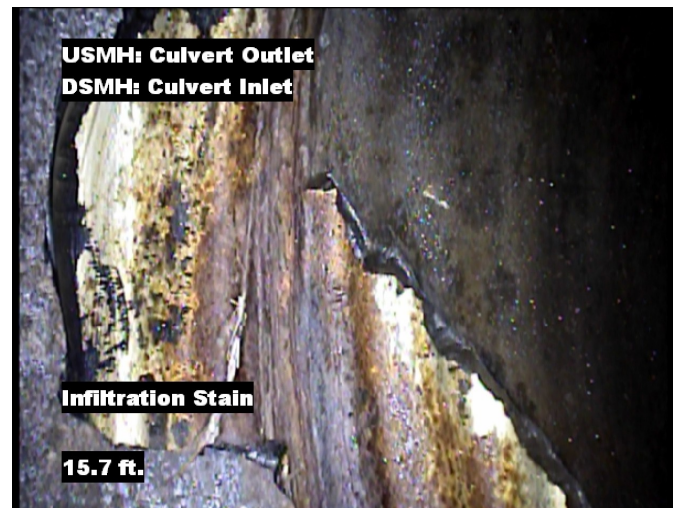
Distance: 15.7 ft. Grade: 0
Condition: Infiltration Stain
Remarks: N/A

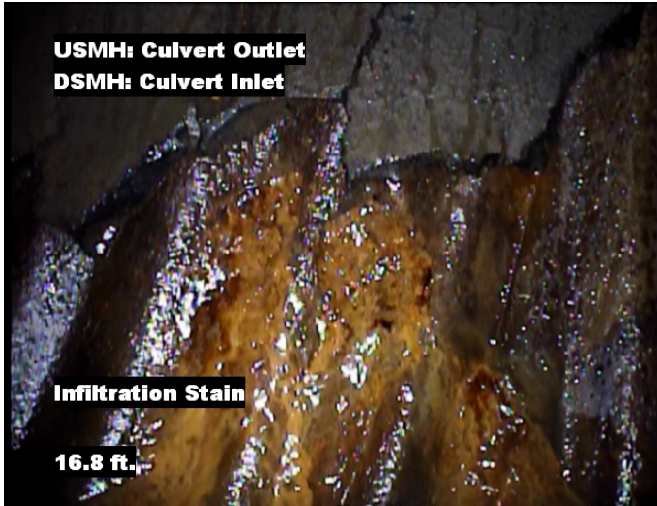
Distance: 16.8 ft. Grade: 0
Condition: Infiltration Stain
Remarks: N/A

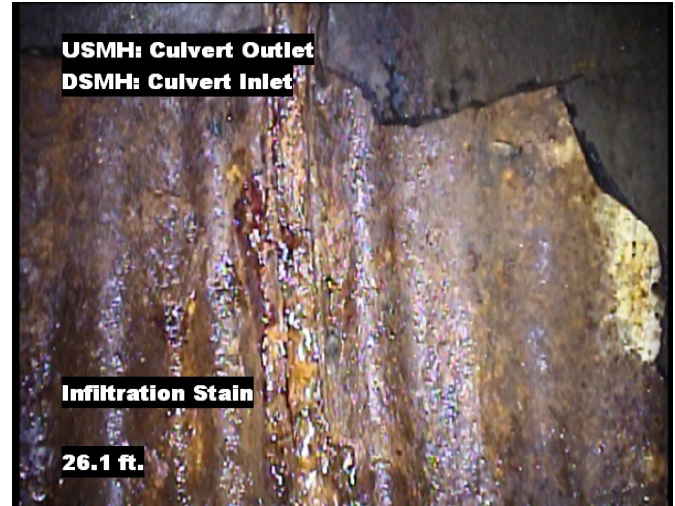
Distance: 26.1 ft. Grade: 0
Condition: Infiltration Stain
Remarks: Also at 3

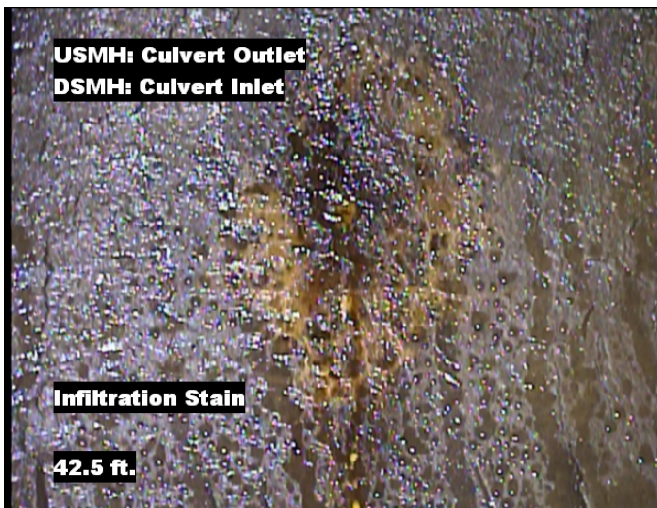
Distance: 42.5 ft. Grade: 0
Condition: Infiltration Stain
Remarks: N/A

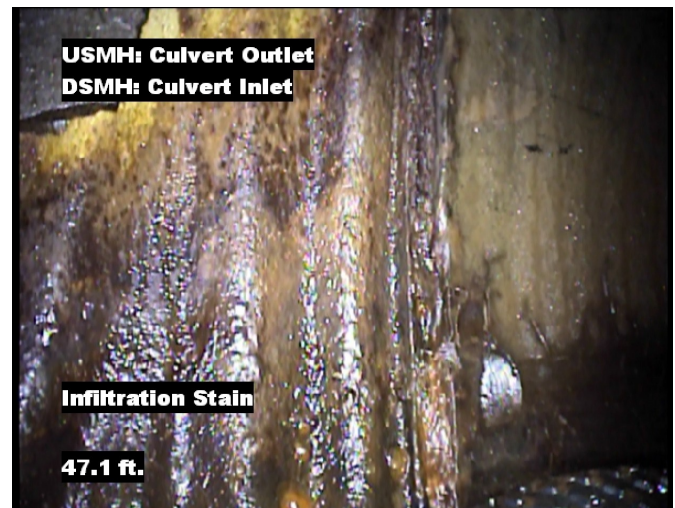
Distance: 47.1 ft. Grade: 0
Condition: Infiltration Stain
Remarks: N/A

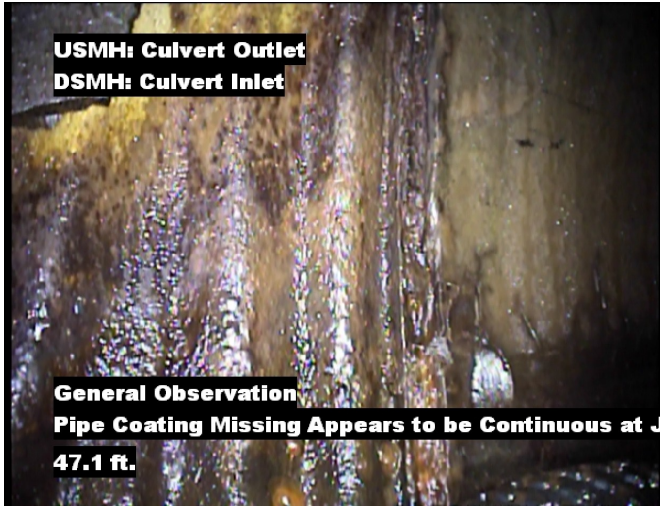
Distance: 47.1 ft. Grade: 0
 Condition: General Observation
 Remarks: Pipe Coating Missing Appears to be Continuous at Joints Throughout Pipe

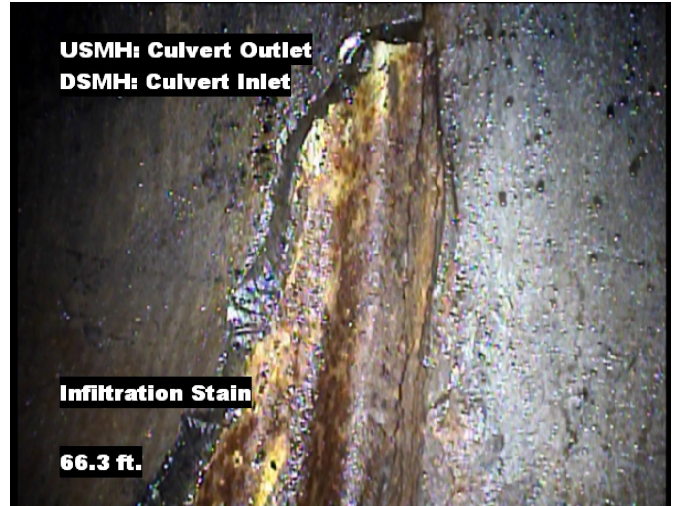
Distance: 66.3 ft. Grade: 0
 Condition: Infiltration Stain
 Remarks: N/A

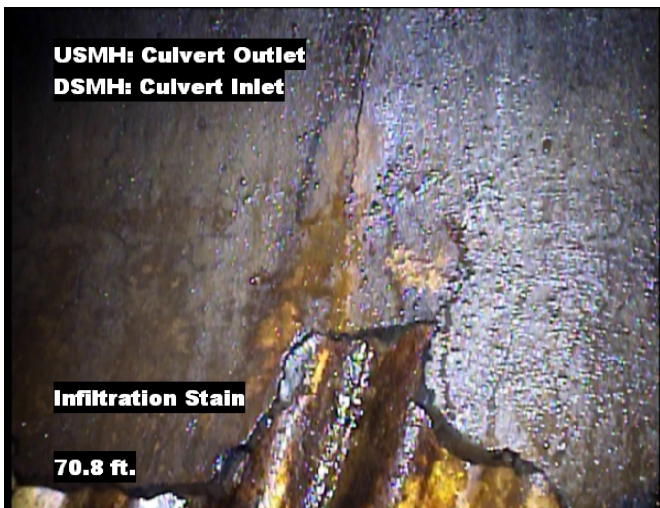
Distance: 70.8 ft. Grade: 0
 Condition: Infiltration Stain
 Remarks: N/A

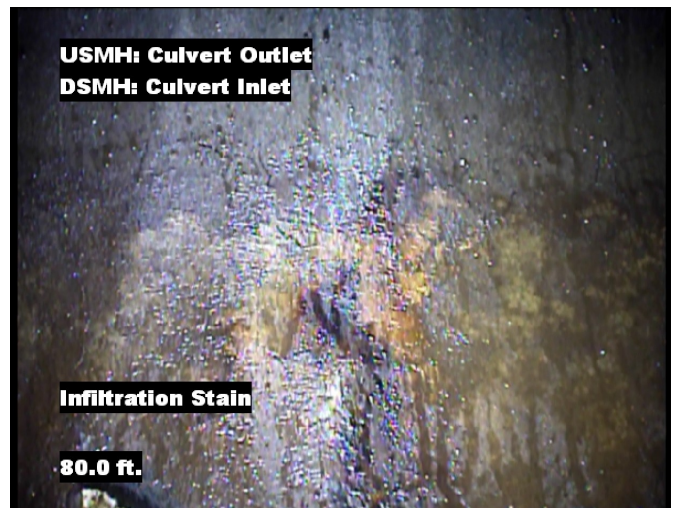
Distance: 80.0 ft. Grade: 0
 Condition: Infiltration Stain
 Remarks: N/A

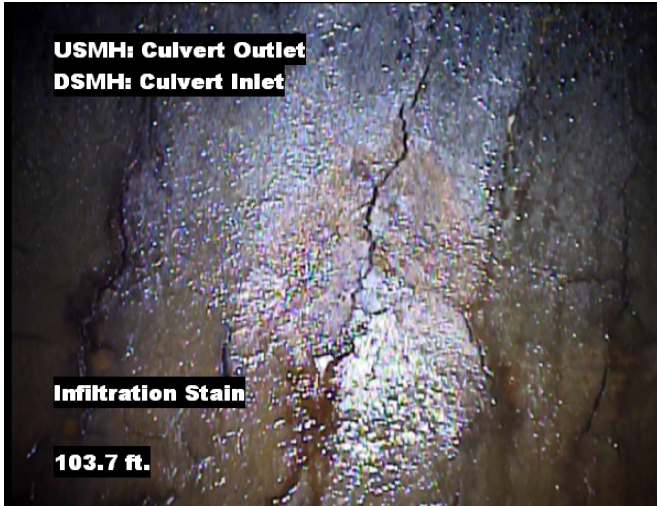
Distance: 103.7 ft. Grade: 0
Condition: Infiltration Stain
Remarks: N/A

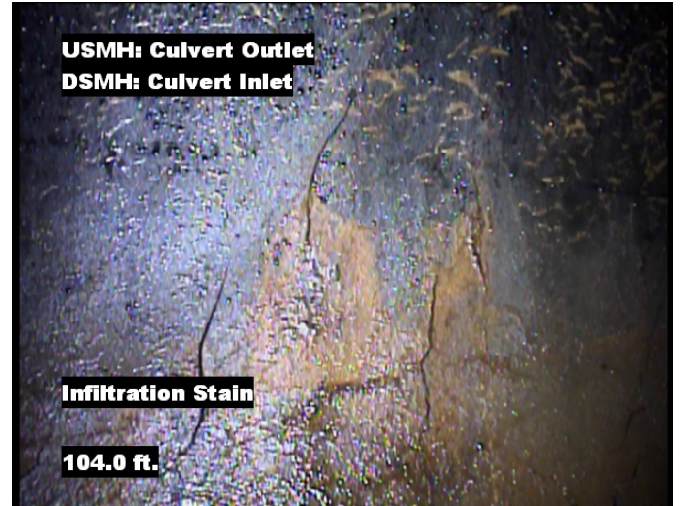
Distance: 104.0 ft. Grade: 0
Condition: Infiltration Stain
Remarks: N/A

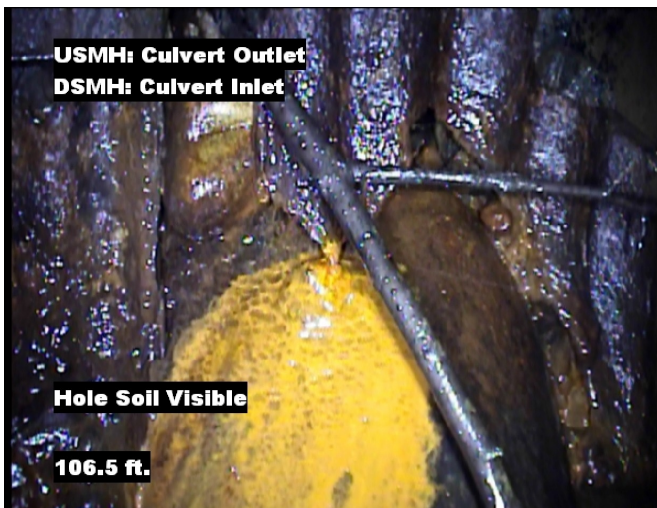
Distance: 106.5 ft. Grade: 5
Condition: Hole Soil Visible
Remarks: N/A

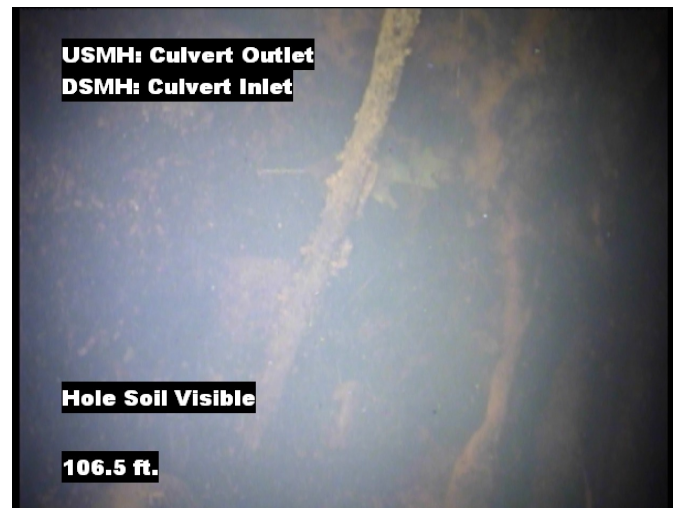
Distance: 106.5 ft. Grade: 5
Condition: Hole Soil Visible
Remarks: N/A

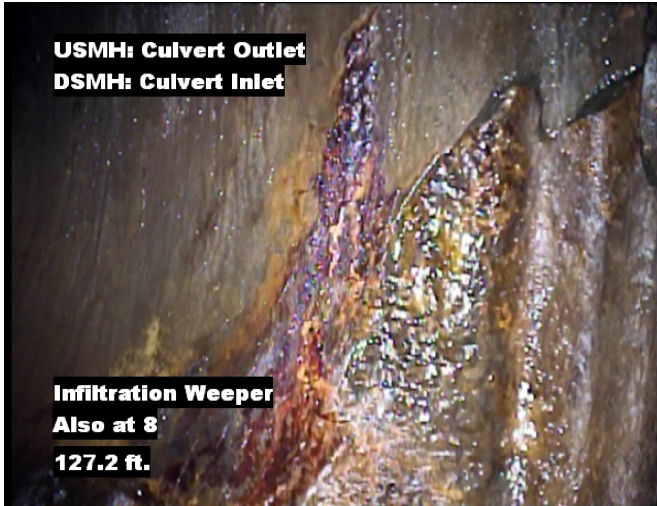
Distance: 127.2 ft. Grade: 2
Condition: Infiltration Weeper
Remarks: Also at 8

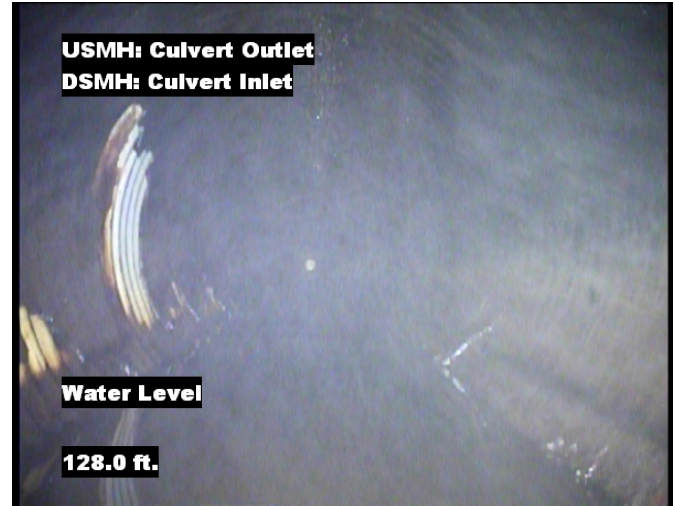
Distance: 128.0 ft. Grade: 0
Condition: Water Level
Remarks: N/A

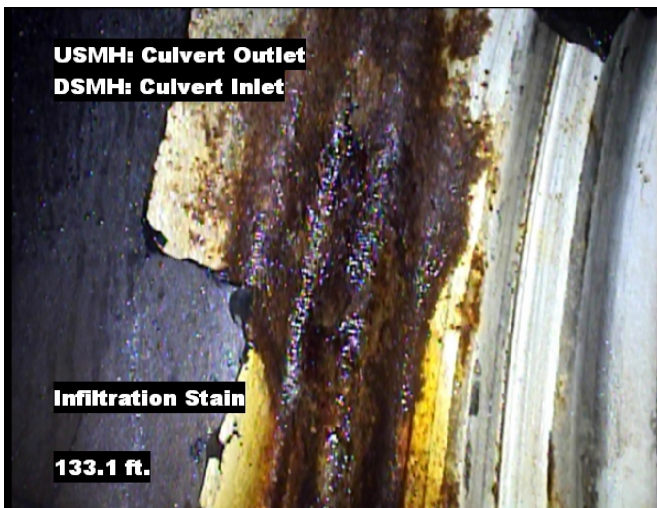
Distance: 133.1 ft. Grade: 0
Condition: Infiltration Stain
Remarks: N/A

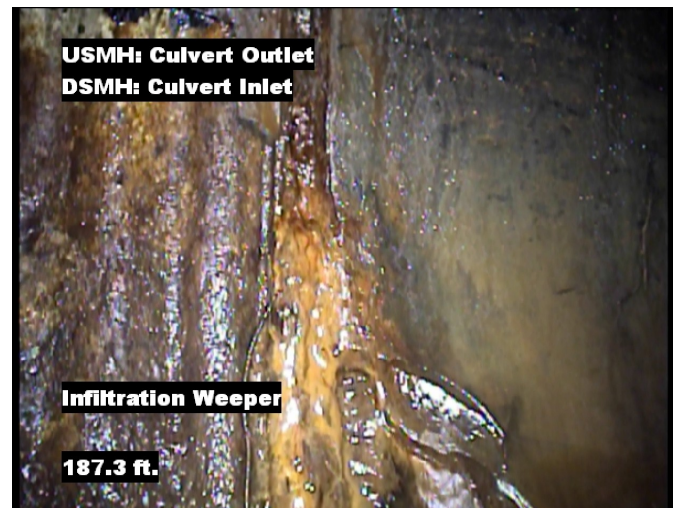
Distance: 187.3 ft. Grade: 2
Condition: Infiltration Weeper
Remarks: N/A

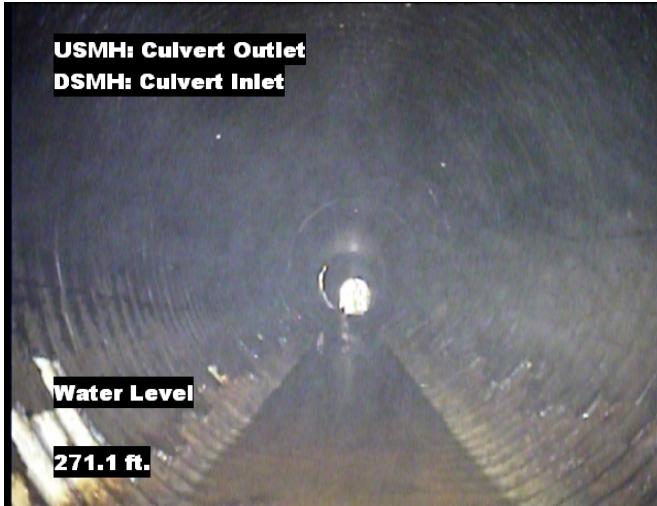
Distance: 271.1 ft. Grade: 0
Condition: Water Level
Remarks: N/A

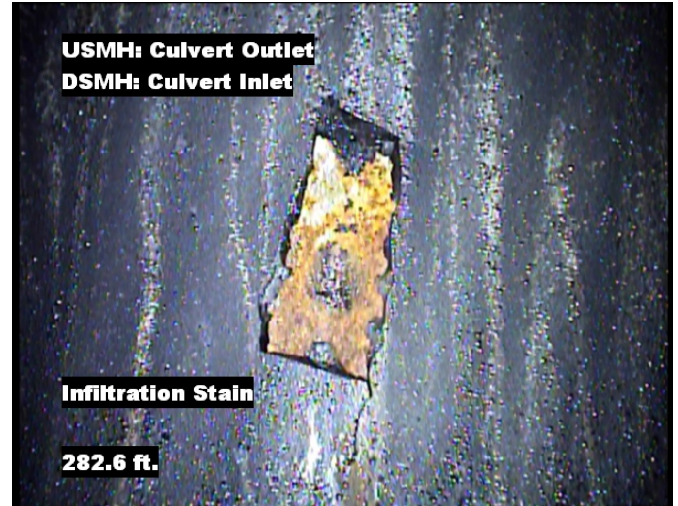
Distance: 282.6 ft. Grade: 0
Condition: Infiltration Stain
Remarks: N/A

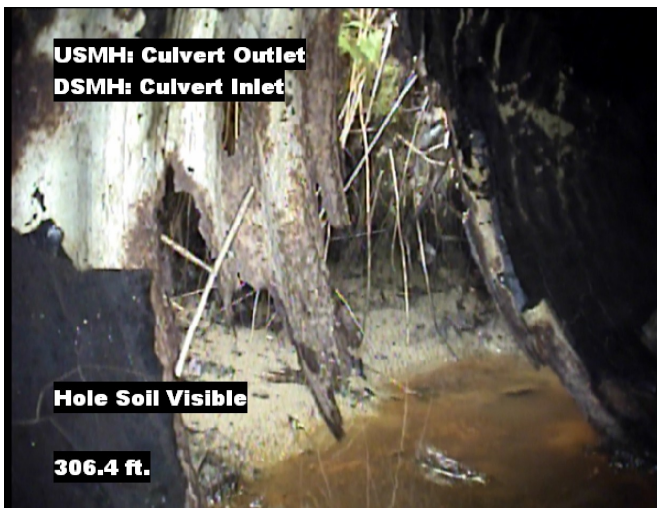
Distance: 306.4 ft. Grade: 5
Condition: Hole Soil Visible
Remarks: N/A

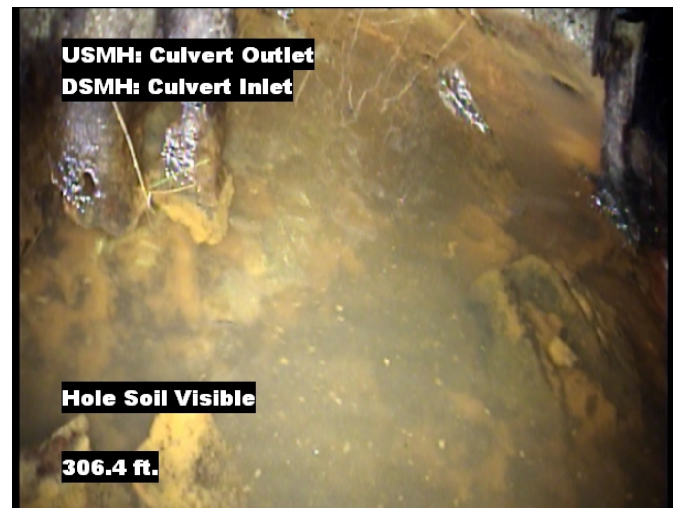
Distance: 306.4 ft. Grade: 5
Condition: Hole Soil Visible
Remarks: N/A

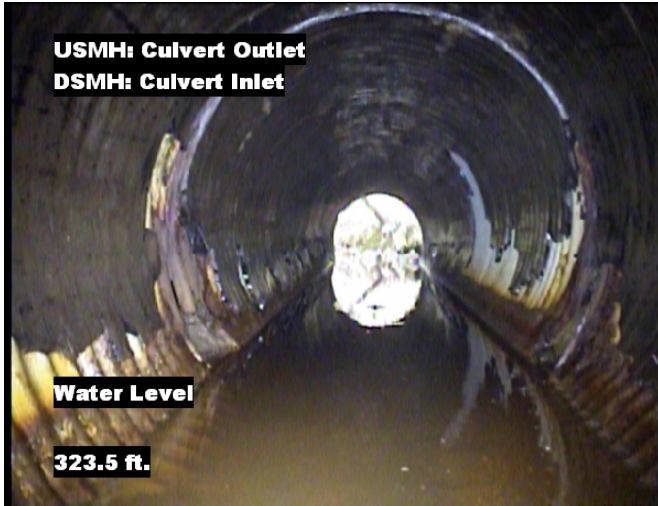
Distance: 323.5 ft. Grade: 0
Condition: Water Level
Remarks: N/A

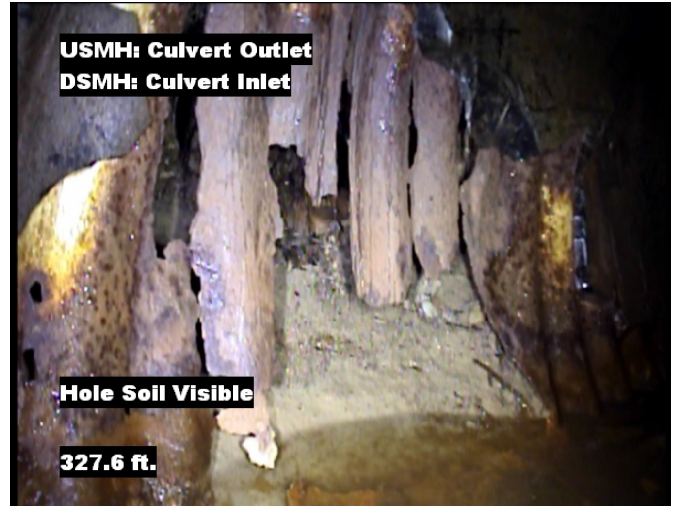
Distance: 327.6 ft. Grade: 5
Condition: Hole Soil Visible
Remarks: N/A

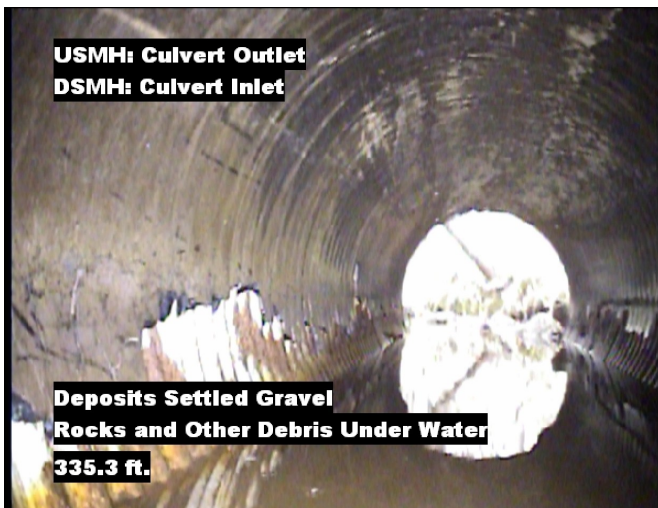
Distance: 335.3 ft. Grade: 2
Condition: Deposits Settled Gravel
Remarks: Rocks and Other Debris Under Water

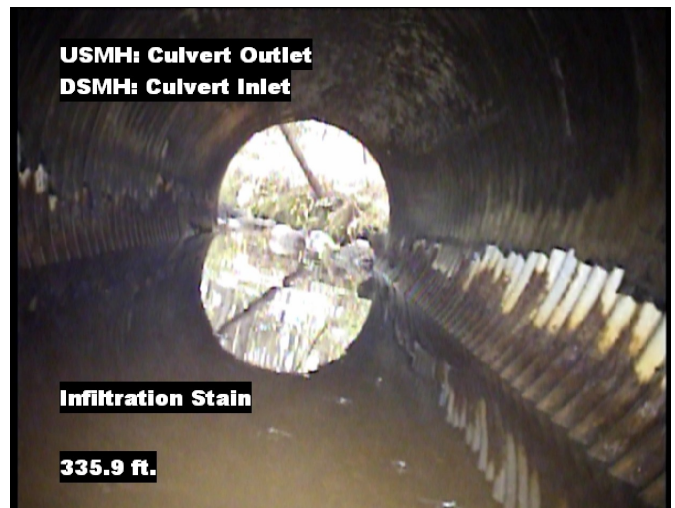
Distance: 335.9 ft. Grade: 0
Condition: Infiltration Stain
Remarks: N/A

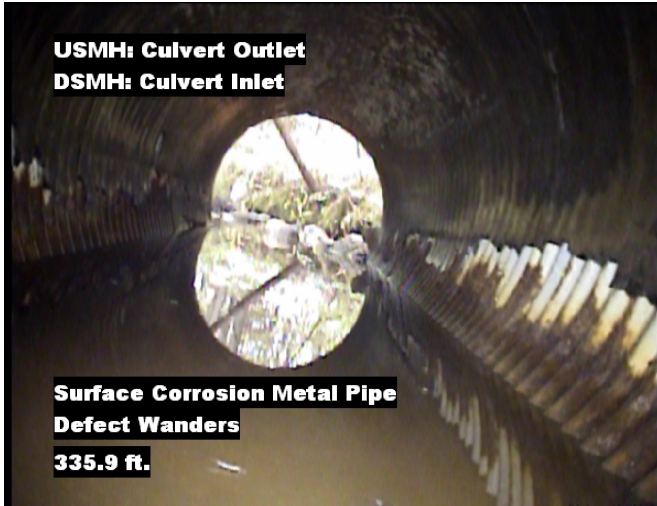
Distance: 335.9 ft. Grade: 3
 Condition: Surface Corrosion Metal Pipe
 Remarks: Defect Wanders

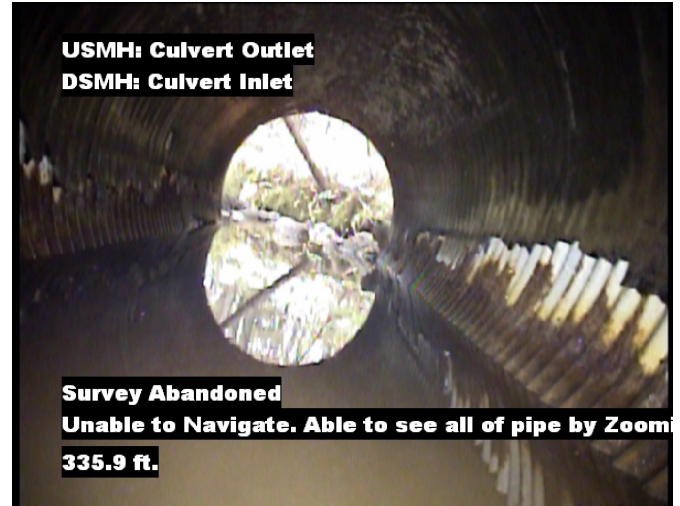
Distance: 335.9 ft. Grade: 0
 Condition: Survey Abandoned
 Remarks: Unable to Navigate. Able to see all of pipe by Zooming in.
