2024 OPERATION AND MAINTENANCE ANNUAL REPORT

PRESENTED BY: HNTB CORPORATION
PRESENTED TO: MAINE TURNPIKE AUTHORITY

October 9, 2024

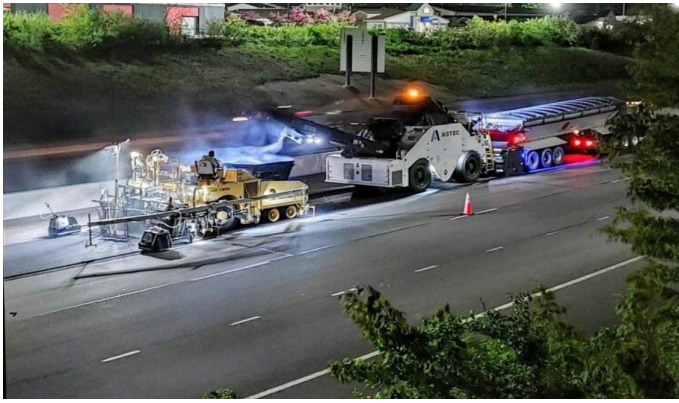
PHOTO 1: PAVEMENT REHABILITATION

For calendar year 2024, several mainline pavement rehabilitation and drainage improvement projects are underway, including sections from mile markers 1.3 to 6.8, 20.0 to 23.3, and 42.0 to 49.3 Southbound. Interchange paving at Exits 1, 2, 3, and 75 is also underway. Additionally, Park and Ride pavement repairs are being performed at Biddeford and Kennebunk. All projects are expected to be completed by the end of 2024.

For the 2025 construction season, we recommend mainline pavement rehabilitation between mile markers 15.3 to 20.3, 42.0 to 49.3 Northbound, and 51.2-54.5. These sections should be milled and repaved as described.

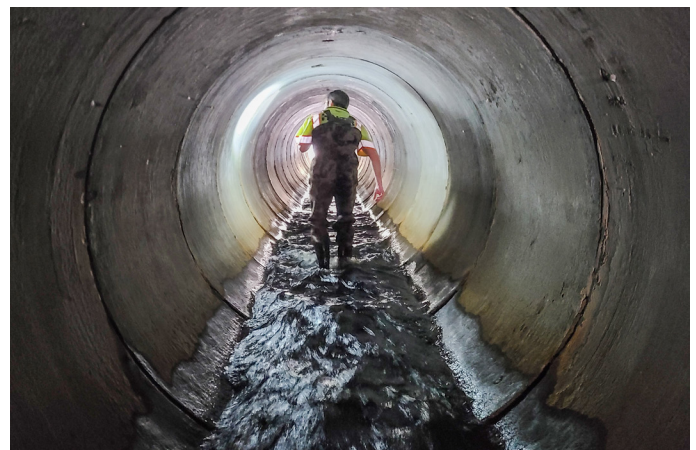
PHOTO 2: CULVERT INSPECTION

All box culverts and pipes with spans or diameters between 60 inches and ten feet, totaling 34 crossings, are inspected annually. Culverts between 36" and 54" in diameter are inspected every five years, with the last inspection in 2023 and the next scheduled for 2028. Cross culverts 30" and smaller are inspected on a rotating five-year cycle, with inspections between mile

HNTB inspects the inside of all larger culverts by walking through them when conditions allow. Culverts that cannot be accessed safely are inspected visually from each end. In cases where a reasonable visual inspection cannot be completed from each culvert end, or where conditions warrant, the structure is flagged for periodic special inspections using robotic cameras. The last special inspection was completed in 2018 and included 18 culverts 60" or greater in diameter. The results of the 2024 annual inspection, and the last special inspection completed in 2018, determined culverts 60" or greater in diameter were in generally satisfactory condition. In some locations culvert ends are deteriorating and separating from adjacent sections. These locations have been flagged for repair.

The 2023 annual inspection found culverts ranging from 36" to 54" in diameter were in fair to satisfactory condition. The 2024 inspection concluded culverts measuring 30-inch in diameter or less ranged from good to poor condition.

We recommend the continued repair of culvert end locations rated in poor condition, as detailed in the Annual Inspection Report and identified through notable finding recommendations, with a goal of completing this effort by 2026. Once complete, these repairs will reduce the potential for more significant and costly improvements in the future. Eight circular culvert end locations remain in poor condition. The number of poor condition culverts has improved significantly since 2021 with the total number of poor condition culverts reduced by more than two thirds.

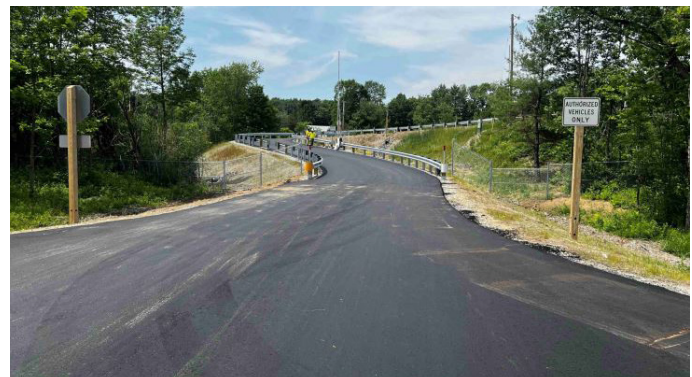
PHOTO 4: HIGH STREET EVR

and modernizing existing access gates at existing EVR locations to provide authorized vehicles with efficient access to and from the mainline, and to prohibit access by unauthorized users. A total of eight access gate locations were upgraded in 2023 and six in 2024.

Turnpike. Additionally, the maintenance or replacement of the gate systems installed at existing ramp locations should continue as required to provide safe and efficient access for authorized users, and to preclude unauthorized use. Potential locations for future EVRs include Captain Thomas Road in Ogunquit and Route 26 in Gray. These locations should be assessed based on need and, if appropriate, included in the MTA's capital program.

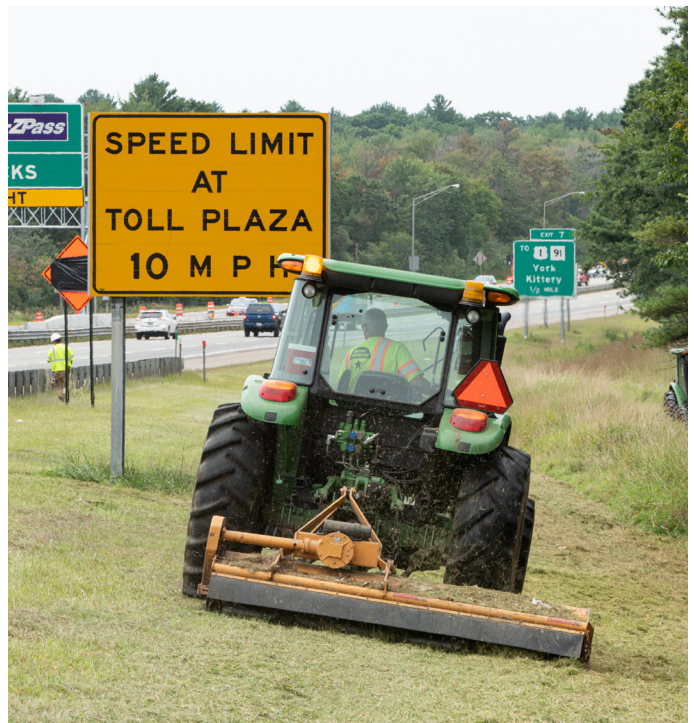
PHOTO 6: MOWING OPERATIONS

Most roadway side slopes are stable and well-vegetated, but some areas have minimal vegetation, leading to erosion. The Annual Inspection Report details locations needing minor corrective action, including winter sand buildup, localized sloughing (especially around structures), and erosion from roadway runoff. Corrective measures are also needed where gravel shoulders are too low compared to paved shoulders and for minor erosion that could worsen over time. The MTA's Maintenance forces should continue to handle these repairs as required, with larger-scale repairs integrated into adjacent paving contracts or bid as separate projects.

The MTA should continue completing berm drop-off corrections with maintenance forces, or by incorporating them into pavement rehabilitation projects. Additionally, where feasible and funding allows, efforts toward completing additional median safety and modernization improvements should continue. The

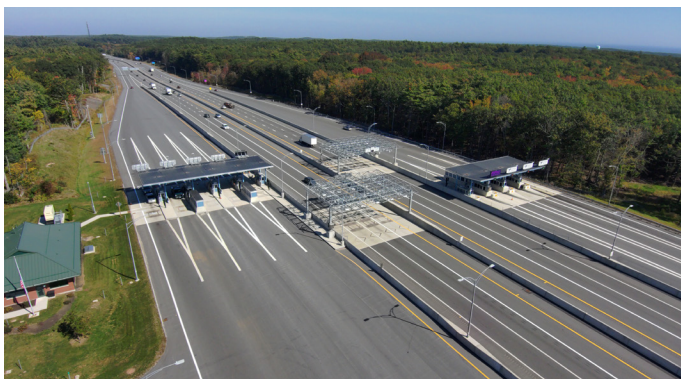
PHOTO 8: YORK TOLL PLAZA

The York Toll Plaza is an open road toll (ORT) plaza at Mile 8.8, approximately one mile north of Turnpike Exit 7. The facility features three ORT lanes in each direction as well as five southbound and four northbound cash lanes. It was completed in 2022 and is in new condition.

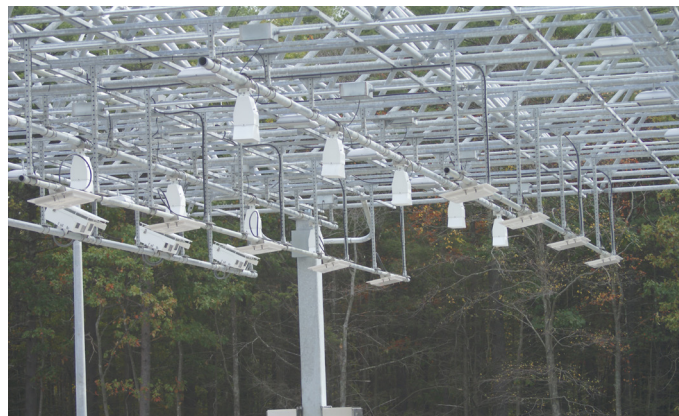
PHOTO 9: SPACE-FRAME TOLL SYSTEM

In April 2013, the MTA opened the reconstructed New Gloucester Toll Plaza featuring three cash lanes and one ORT lane in each direction. The cash booths, slabs and toll collection equipment were also replaced or rehabilitated. As a result of the recent expansion and improvements, this plaza is rated in good condition. The plaza received additional improvements in 2020, including equipment upgrades related to the Infinity System and rehabilitation of the concrete roadway slabs serving the ORT lanes. The tunnel beneath the Turnpike, primarily used for utility infrastructure and foot traffic by toll booth attendants, exhibits

moderate moisture and water ponding due to failed drainage systems. Routine maintenance and repairs to address these issues are programmed, and repair solutions are currently under investigation.

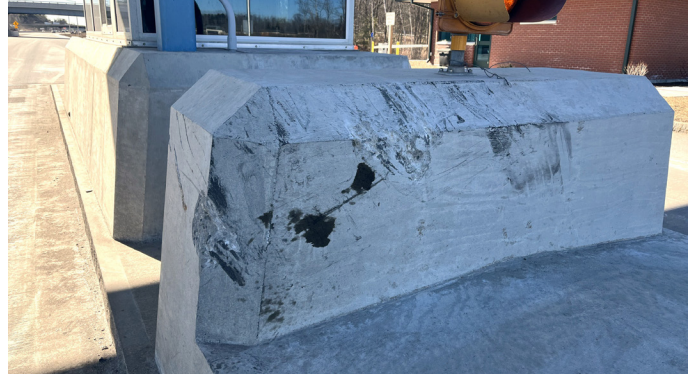
PHOTO 10: EXIT 45 TOLL PLAZA CRASH DAMAGE

In June 2024, a trash truck impacted the Exit 46 Northbound Toll Canopy. An inspection revealed that the crash damaged the canopy ceiling panels, bracketry, and hardware supporting toll equipment. MTA maintenance successfully repaired and reinstalled the bracketry and damaged antenna.

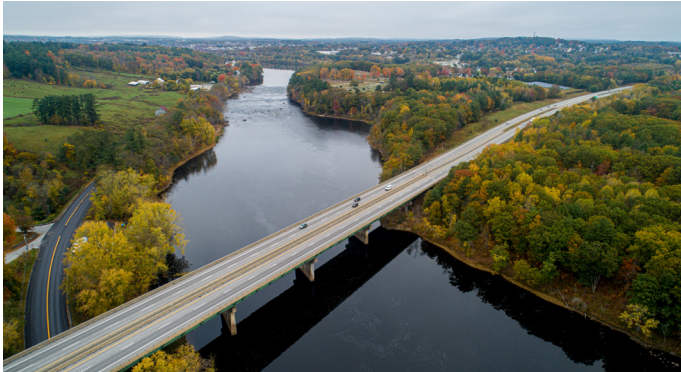
PHOTO 14: ANDROSCOGGIN RIVER BRIDGES

Bridges, require detailed inspections. The Androscoggin River Bridges, each measuring 850 feet long, consist of roadway surfaces supported on stringer and floor beam framing systems. The loads from these roadway framing systems are carried almost entirely by two primary girders.

Because these structures are carried by only two primary girders, the bridge has insufficient redundancy to prevent a progressive collapse of all, or part of, the bridge if one of the primary girders were to fail. As a result, these structures are classified as “fracture critical” and are subject to more rigorous inspection requirements as outlined in FHWA’s National Bridge Inspection Standards. To achieve compliance with these inspection standards, the Androscoggin River Bridges receive a fracture critical inspection completed once every 24 months.

A fracture critical inspection was completed in May 2023. Several existing and new deficiencies were noted during the inspection, including numerous cracked welds. The cracks were not located on the primary girders and are not judged to pose a significant safety risk. Continued monitoring will be completed

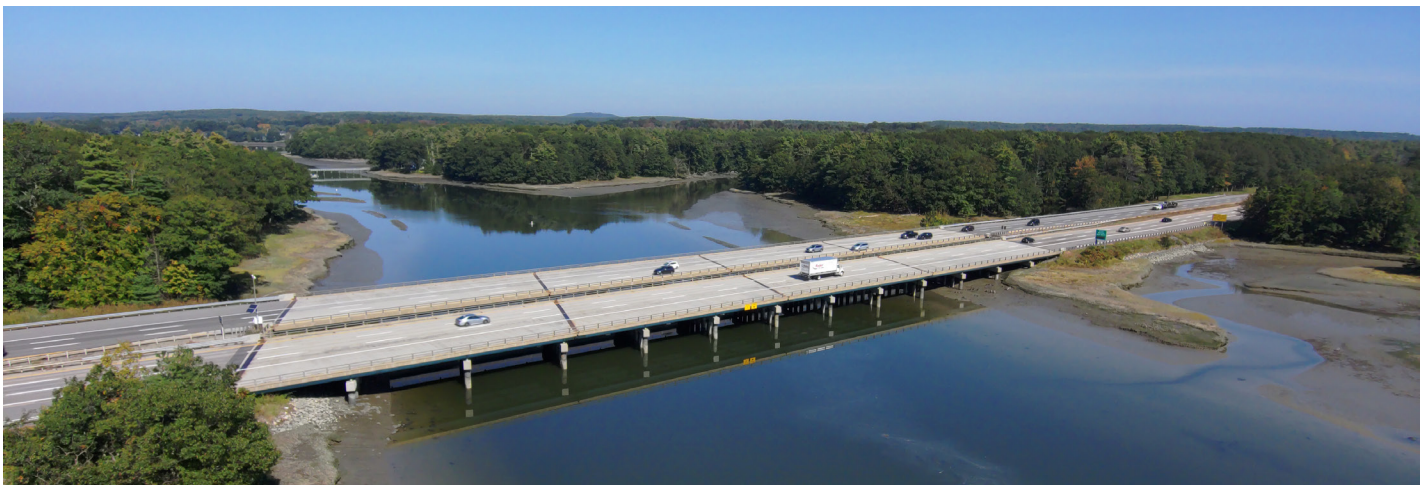
PHOTO 15: YORK RIVER BRIDGES

in future inspections and, if crack sizes increase over time, the issuance of a repair contract will be recommended. The next fracture-critical inspection of these structures is scheduled for 2025.

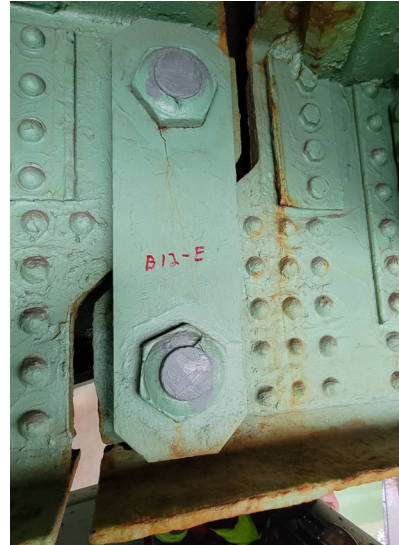
**PHOTO 16: YORK RIVER BRIDGES
PIN-AND-LINK CONNECTION**

At the York River Bridges, the girder framing system includes pin-and-link assemblies. Because routine inspection procedures are insufficient to identify defects in the pins, ultrasonic testing of these elements is necessary. A five-year inspection frequency for ultrasonic testing is suggested. This frequency is based on engineering judgment

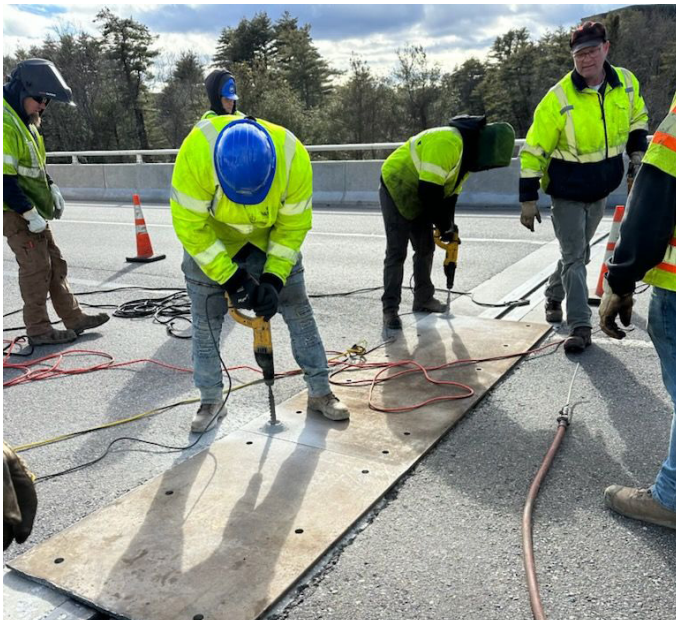
PHOTO 18: STROUDWATER RIVER SOUTHBOUND

On March 11, 2024, a portion of the northern armored bridge joint armor fractured at the field splice and became unattached from the concrete backwall. The lane with the section of failed joint was immediately closed, and a temporary steel plate was installed so the lane could be reopened to traffic.

Subsequently, a repair contract was developed, and permanent repairs were substantially completed in April 2024.

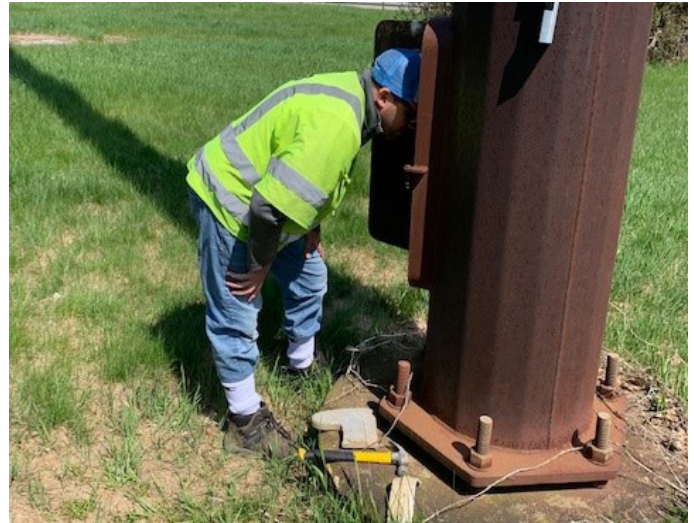
PHOTO 19: HML INSPECTION

Sign structures, high-mast light poles, mast arms, and other ancillary structures located over or immediately adjacent to roadways require hands-on inspections every six years per FHWA guidance. In 2020, hands-on inspections were performed for the 81 MTA-owned assets meeting this criterion. The inspection concluded that these assets are in generally good condition. No significant deficiencies were observed.

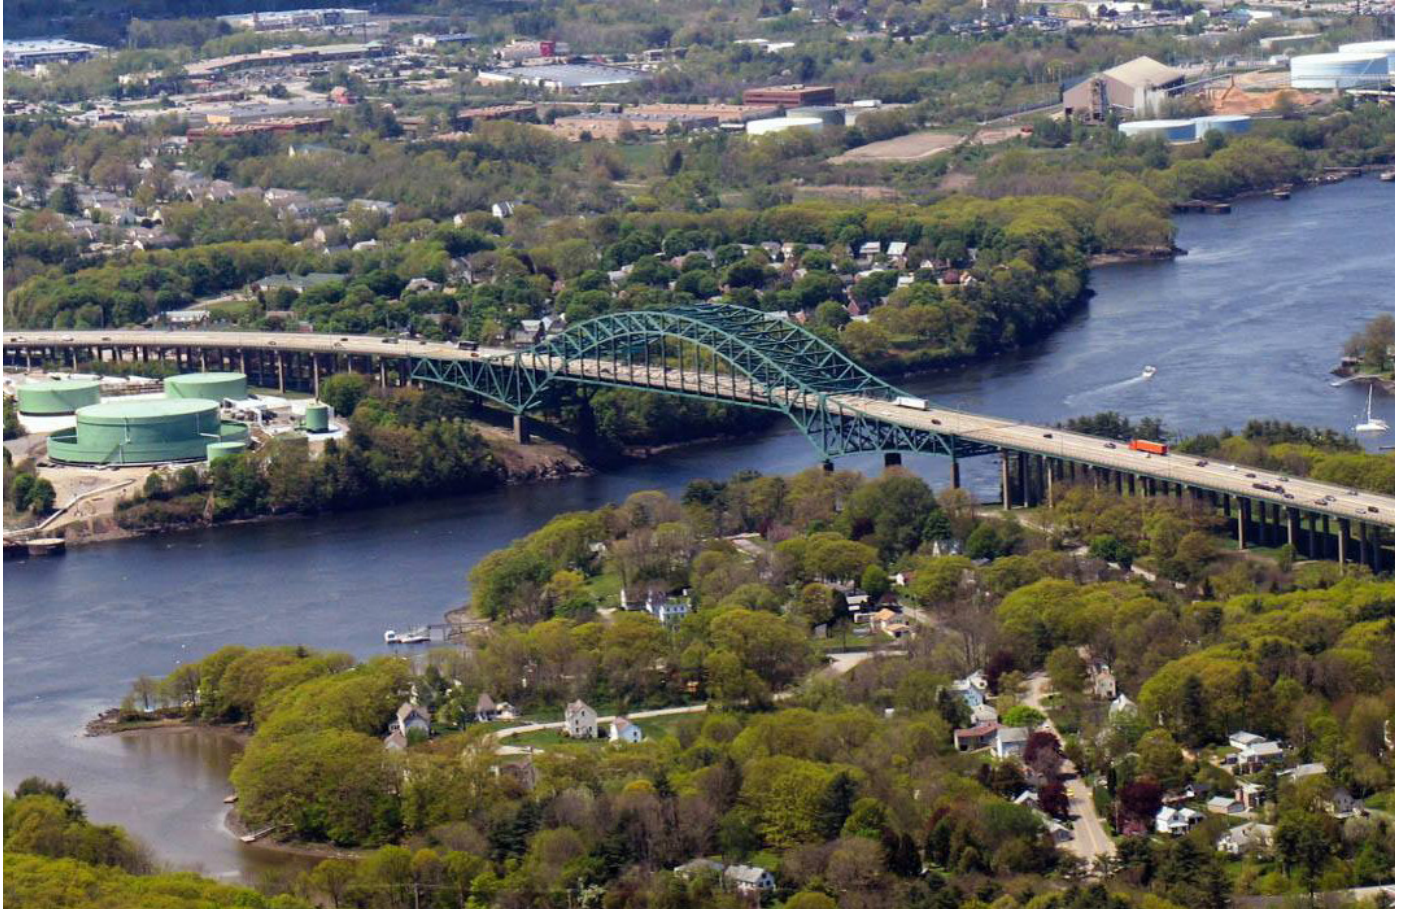
PHOTO 27: PISCATAQUA RIVER BRIDGE

With construction now complete, the agencies can display messaging on the roadway on an as-needed basis, allowing vehicles to travel on the outside shoulders between Exit 3 in New Hampshire and Exit 2 in Maine. When activated, part-time shoulder use helps relieve congestion and improves mobility.
