PRESENTED TO THE MAINE TURNPIKE AUTHORITY

OPERATION AND MAINTENANCE ANNUAL REPORT

2019

HNTB

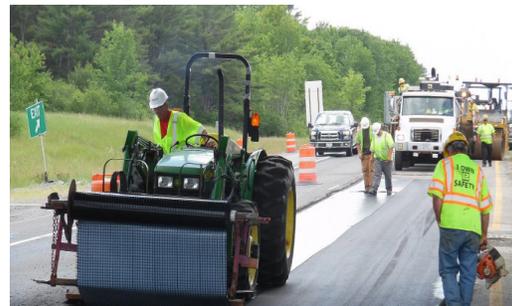
FIGURE 2 - PAVEMENT LIFE CYCLE

FIGURE 2 illustrates the rate of deterioration and relative cost of rehabilitation at various times throughout the Life Cycle of a section of pavement. Evidence that pavement requires rehabilitation includes wheel rutting, excessive cracking, and poor ride quality.

HNTB recommends MTA continue with the annual maintenance paving program of addressing approximately ten centerline miles per year and the use of polymer modified asphalt surface pavement. With the current priority of adding a third lane north and southbound from Exit 44 to Warren Avenue, and median improvements south to Holmes Road at Mile 43.0, the pavement rehabilitation sequence in this area is being addressed over multiple years.

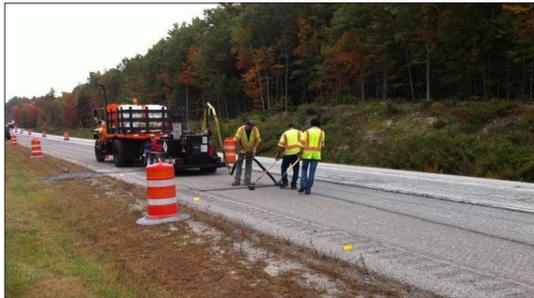
DISPENSED AT OVER 350 DEGREES THE RUBBERIZED ASPHALT SEALANT IS INJECTED DIRECTLY INTO THE PAVEMENT CRACKS

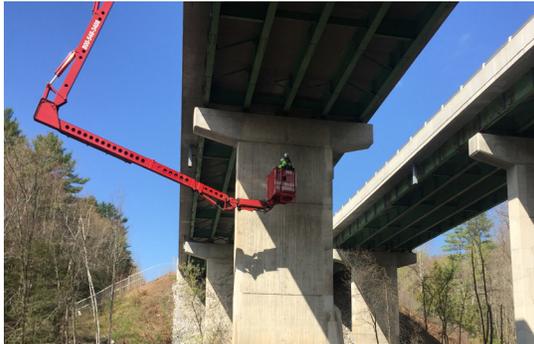
[PRESUMPSCOT RIVER BRIDGE HANDS-ON INSPECTION](#)

All Authority-owned bridges and minor spans undergo routine inspections on an annual basis. The purpose of these inspections is to identify potential safety concerns, document areas of deterioration and to record condition ratings for key bridge components. The 2019 routine inspection by HNTB identified that the bridges and minor spans along the turnpike range from fair to very good condition. Structures that have been rehabilitated or reconstructed during the past 20 years were found to be in fair to very good condition, while those that have not been recently rehabilitated were generally noted to be in fair condition.

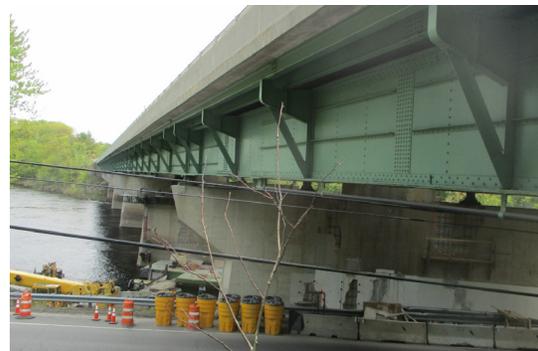
[ANDROSCOGGIN RIVER BRIDGE](#)

The Androscoggin River Bridges, each measuring 850 feet long, consist of roadway surfaces supported on stringer and floor beam framing systems. The loads from these roadway framing systems are carried almost entirely by two primary girders.

Because these structures are carried by only two primary girders, the bridge has insufficient redundancy to prevent a progressive collapse of all, or part of, the bridge if one of the primary girders were to fail. As a result, these structures are classified as “fracture critical” and are subject to more rigorous inspection requirements as outlined in FHWA’s Bridge Inspection Standards. To achieve compliance with these inspection standards, the Androscoggin River Bridges

The last fracture critical inspection was completed in summer 2017 and identified several minor deficiencies. To address these items, a contract was issued that included repairs to the substructure, bridge deck expansion joints, post-tensioning conduit, and bearings. This work is currently ongoing. The next fracture critical inspection of this structure is scheduled for September 2019.

should have a fracture critical inspection completed at least once every 24 months.

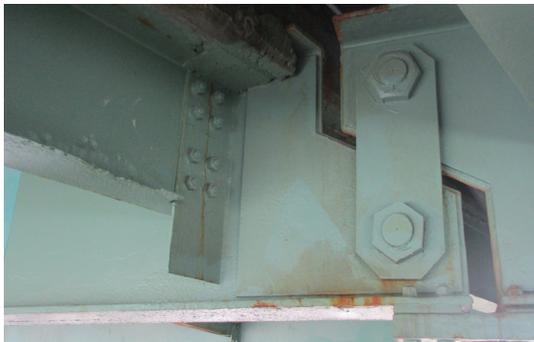
PIN-AND-LINK ASSEMBLY AT THE YORK RIVER BRIDGE

Because routine inspection procedures are insufficient to identify defects in the pins, ultrasonic testing of these elements is necessary. A detailed inspection and ultrasonic testing of the pin-and-link systems at the York River Bridges was completed in December 2011. No serious structural deficiencies were noted during the inspection. The next detailed inspection of the pin-and-link assemblies was scheduled for 2016, however, a 2015 rehabilitation contract involved disassembling, reassembling, and painting the pin-and-links. This was an acceptable detailed inspection procedure and therefore, ultrasonic testing was not performed. The next detailed inspection including ultrasonic testing should be scheduled for summer 2020. The five-year inspection frequency is based on engineering judgement whereas the FHWA does not have a required frequency for these components.

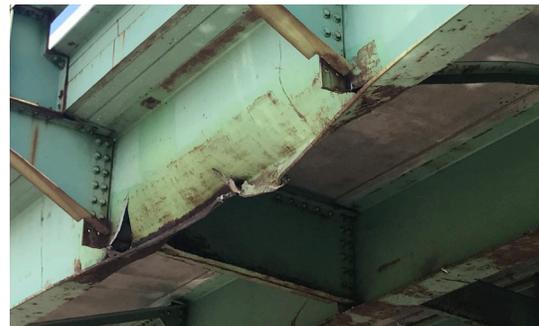
SOUTH PORTLAND INTERCHANGE UNDERPASS, MILE 44.9

The South Portland Interchange Underpass at Mile 44.9 was struck by an articulating boom lift being carried on a flatbed trailer on July 15, 2019. HNTB conducted a special inspection and concluded that the damage significantly reduced the load carrying capacity of the damaged fascia girder.

A temporary maintenance of traffic plan was put in place using drums to shift traffic away from damaged girder. Whereas the bridge is scheduled for replacement beginning in 2020 no repairs are proposed. Instead, the existing temporary steel barrier located along the edge of the bridge deck will be relocated to ensure

traffic remains shifted away from the area of damage until the bridge is removed from service.

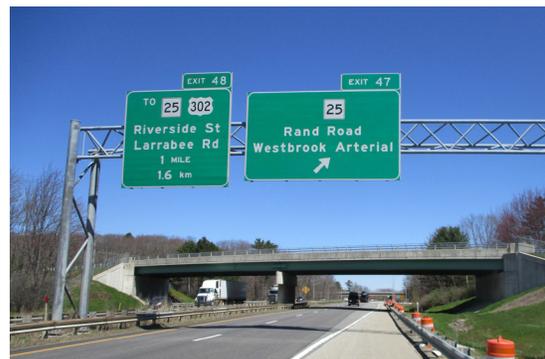
OVERHEAD SIGN BRIDGE MAINLINE NB, MILE 47.0

In addition to the routine inspections, a hands-on inspection of the Authority's 43 overhead sign structures and two space frames was conducted by HNTB in early-2015. A concern noted during these inspections was missing and broken sign clips on multiple sign structures. The sign clips were then incrementally replaced over the 2015 construction schedule.

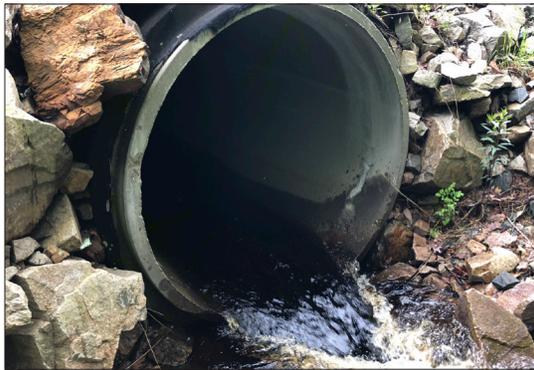
Common issues observed in the metal pipe ends are rusted flow lines, disconnected joints, and disconnected metal flared end sections. Common issues observed in the reinforced concrete pipe ends are inlets and outlets that are either partially or completely obstructed by heavy vegetation or debris and buried inlets and outlets. These conditions lead to erosion issues on the side slope which may eventually impact the roadway.

We recommend the locations rated "Poor" in the detailed Annual Inspection Report be monitored by the Authority. Locations that can reasonably be repaired by the Authority's Maintenance forces should be repaired. Areas that are not feasible for repair by the Authority's Maintenance forces should be programmed for repair. These repairs include the complete removal of the deteriorated metal pipe ends and their replacement with high density polyethylene or reinforced concrete pipe, along with slope and drainage channel stabilization. Drainage repairs should be included in the pavement rehabilitation contracts.

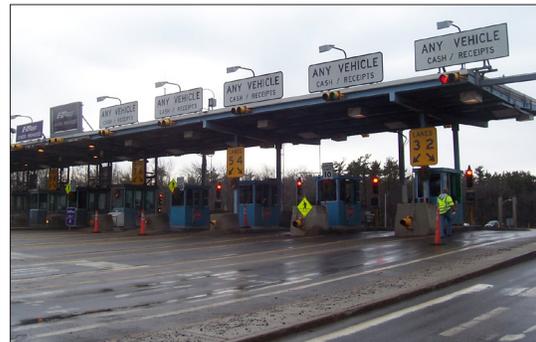
EXISTING YORK TOLL PLAZA - CONSTRUCTED IN 1969

The Authority secured the needed permits to construct a new ORT Plaza at Mile 8.8

approximately one mile north of the existing plaza. Construction of this new plaza began in the fall of 2018 and is scheduled for completion in the summer of 2021.

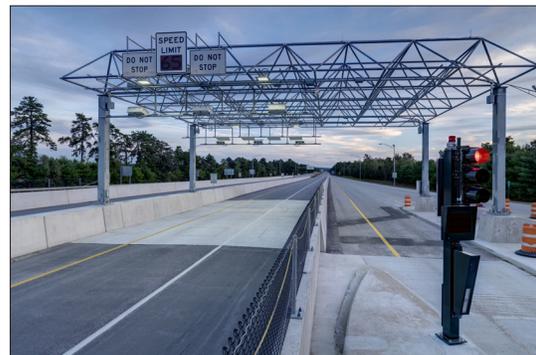
NEW GLOUCESTER TOLL PLAZA ORT, MILE 67.0

In April 2013, the Authority opened the ORT lanes at the New Gloucester Toll Plaza and all the cash toll collection equipment was replaced. Several elements were replaced or rehabilitated as a part of this work including the slabs. As a result, this plaza is rated in good condition.

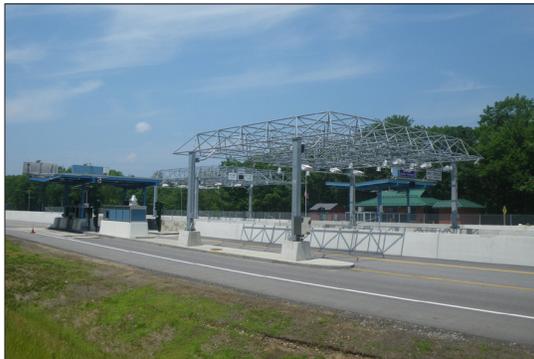
EXIT 44 TOLL PLAZA

In May 2019, the Authority opened a new ORT toll plaza at Exit 44. Exit 44 connects the Maine Turnpike to I-295 south of Portland making it vitally important to the interstate transportation network. This plaza is in new condition.
