# 2022 Systemwide Safety and Capacity Study

June 30, 2023

Maine Turnpike Authority  
2360 Congress Street  
Portland, ME 04102

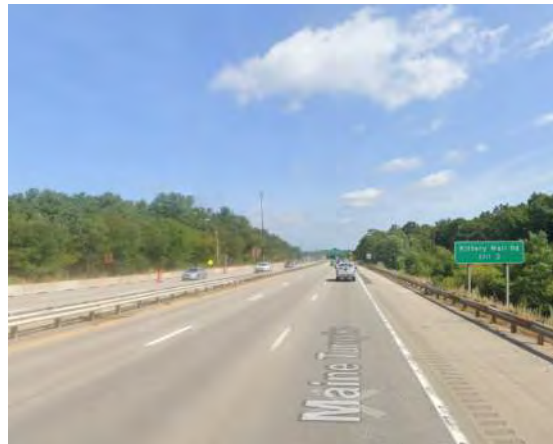
**Photo 1: I-95 NB MM 0-1 (2019)**

**Photo 1: 1-95 NB MM 0-1 (2019)** captured by Google Maps September 2019 depicts the condition of this location at the time that it was most recently noted as an HCL.

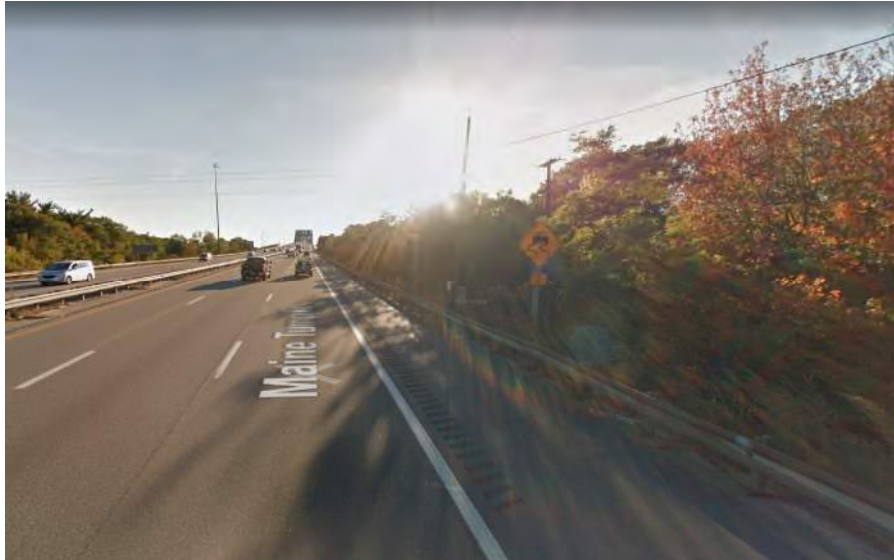
**Photo 2: I-95 SB MM 0-1 (2015)**

**Photo 2: 1-95 SB MM 0-1 (2015)** captured by Google Maps October 2015 depicts the condition of this location at the time that it was most recently noted as an HCL.

Existing Road Audit <sup>2</sup>	
Road alignment and Cross Section	<p>Site distance is adequate.</p> <p>During standard operation, the design speeds are adequate for these and adjacent segments. During PTSU the I-95 Exit 1 NB off Ramp will be closed and the I-95 SB On Ramp will most nearly meet AASHTO Green Book requirements and will be monitored to ensure safe operation.</p> <p>The high tourism base during the summer coupled with the presence of RVs often reduces the capacity during the peak summer period.</p> <p>Cross-sections meet minimum requirements and there are no significant drainage or slope concerns. Side slopes are not recoverable because of the bridge and barrier/guardrail is in place for protection.</p>
Lighting	<p>New lighting is present on the Piscataqua River Bridge and near the interchange.</p>

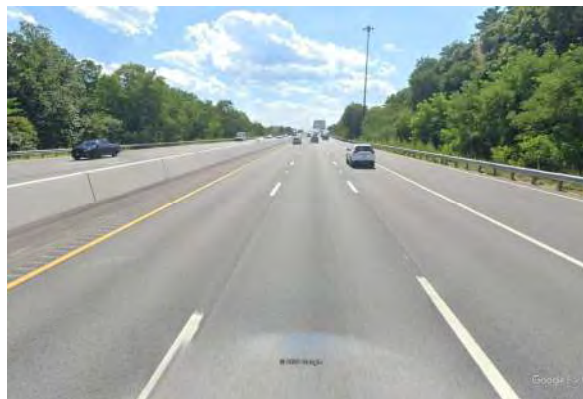
**Photo 3: PTSU<sup>3</sup>**

PTSU will provide some additional capacity and should be monitored when implemented to understand safety concerns and the potential life of this improvement. Because there are no pull off areas, MTA service patrol will need to be present during PTSU activities to ensure mobility is maximized. This will not replace the need for future widening at this location.

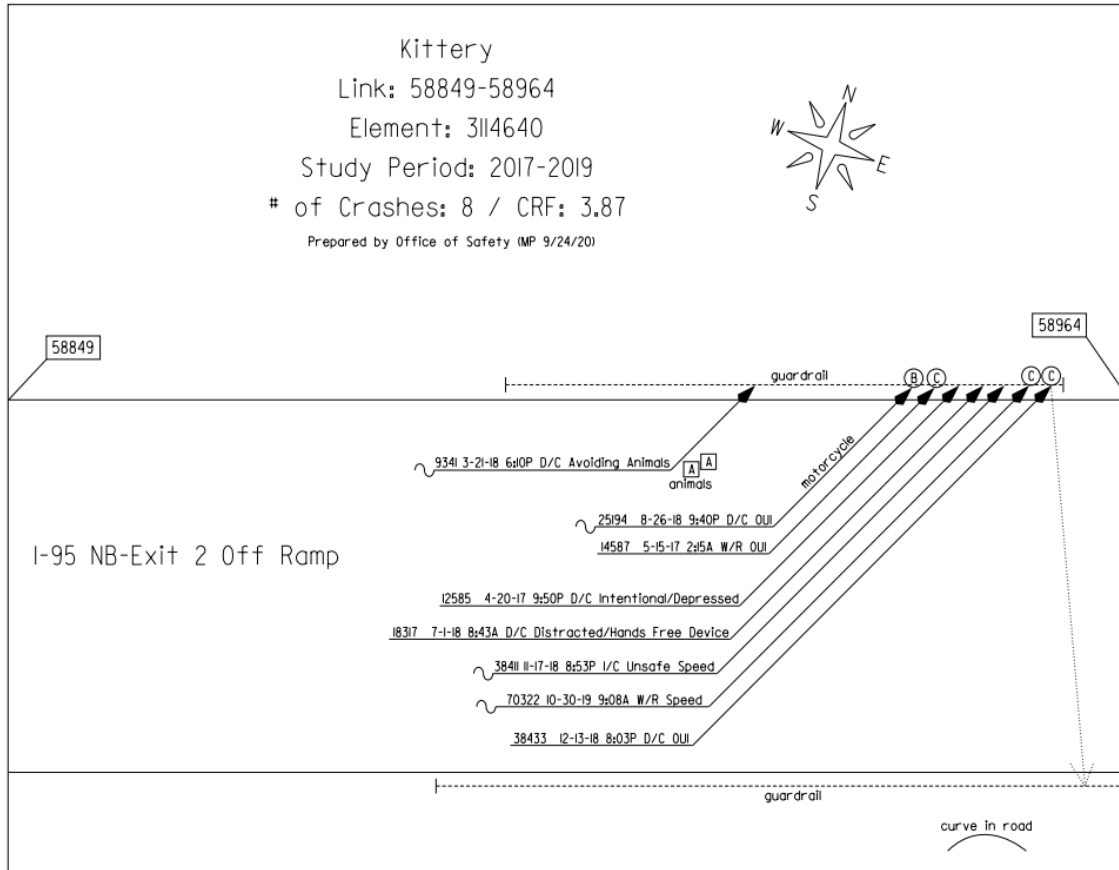
**Figure 2: 2017 – 2019 NB Crash Diagram**

**Figure 2: 2017 – 2019 I-95 Exit 2 NB Off Ramp Crash Diagram** depicts the ramp high crash location. It should be noted this crash pattern, the only time this location was an HCL in the most recent 10-year period occurred overlapped with the rehabilitation efforts of the Piscataqua River Bridge.

As shown in **Figure 2**, there were 8 crashes resulting in a 50% injury rate.

- Most crashes occurred on the curve of the ramp hitting guardrail on the outside of the curve
- Crashes were mostly human contributions – 3 OUIs, 1 distracted driving, and 1 intentional crash; 2 crashes were related to unsafe speeds
- Of those crashes, drivers are most likely to have an injury when OUIs were the cause.
- Most crashes occurred at night

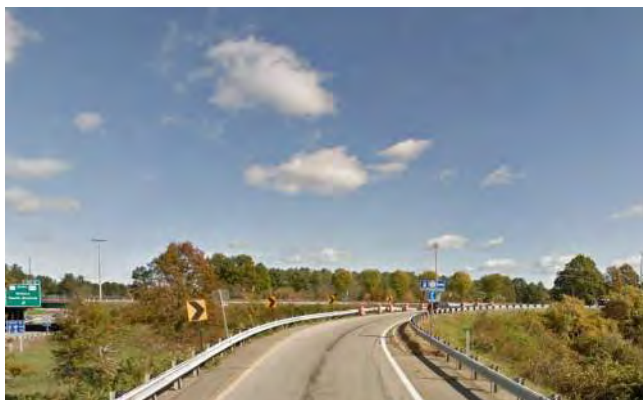
**Photo 1: I-95 Exit 2 NB Off**

**Photos 1 and 2** captured by Google Maps September 2019 depicts the condition during the most recent high crash location designation.

Existing Road Audit <sup>2</sup>	
Road alignment and Cross Section	<p>Site distance and competing movements makes the movement joining Route 236 difficult.</p> <p>Reduced speeds are adequate for design, but vehicles often travel faster than the posted speed, particularly on Route 236.</p> <p>The road alignment of the weave where the ramp joins Route 236 is poor.</p> <p>Some drainage structures are in poor condition.</p> <p>Guardrail is in place for protection on the ramp and passenger side of Route 236.</p>
Lighting	There is little to no lighting.
General Sign Issues	Signage should be re-evaluated.
Barriers and Clear Zones	Guardrail protects all slide slopes.
Pavement	Pavement is in poor condition.

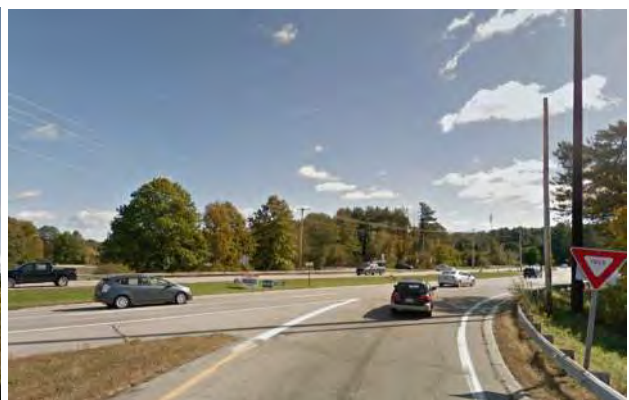
**Photo 2: I-95 Exit 2 NB Off "Merge"**

- All crashes but one were caused by vehicles following too close trying to enter Route 236.
- All crashes but one were rear-end – sideswipe type crashes

Human contributions were responsible for most crashes on the ramp, while following too closely when joining Route 236 is the cause. This is likely caused by vehicles getting ready to make aggressive movements and stopping.

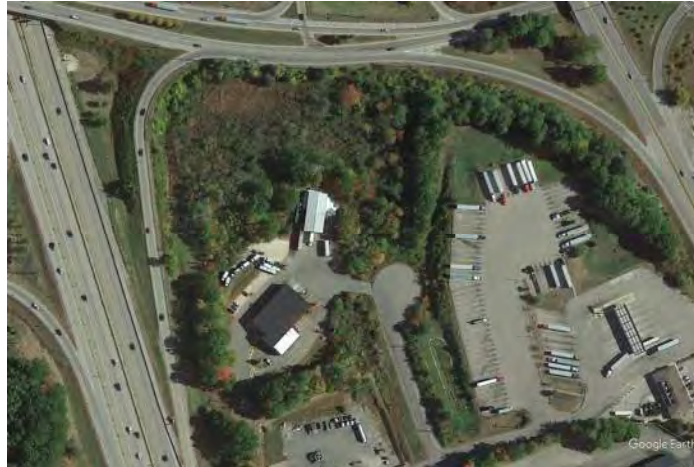
**Photo 3: I-95 NB Exit 2 Area Aerial**

**Photo 3** captured by Google Maps October 2020 provides an overall aerial showing the interaction of movements.

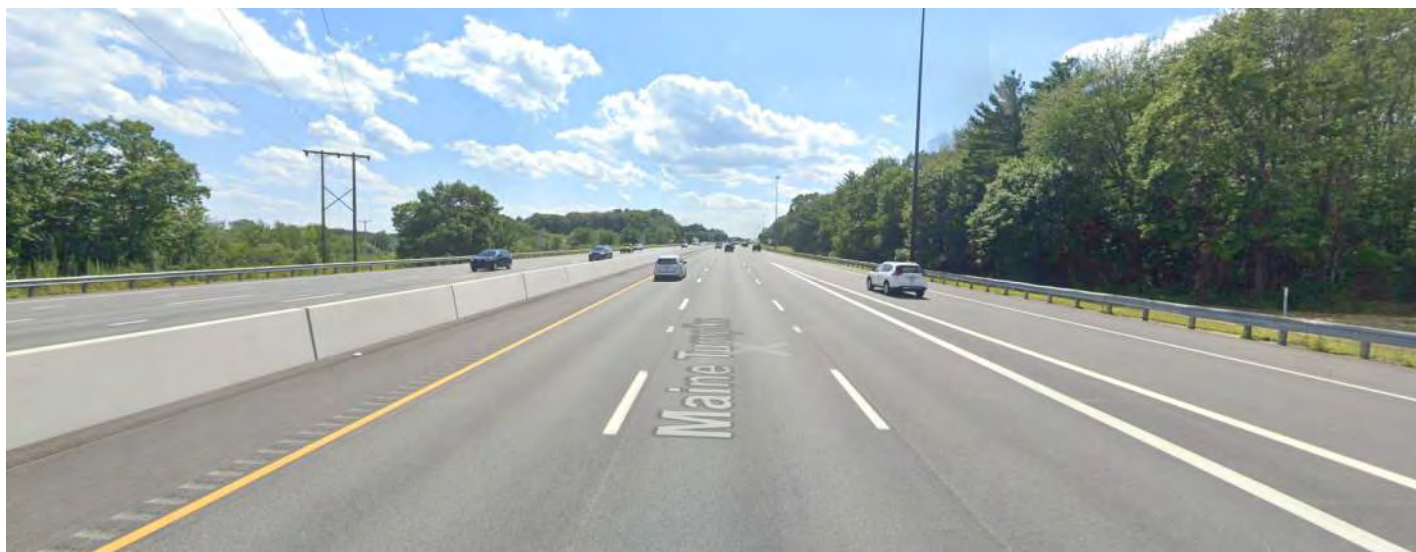
- The crashes during the most recent HCL period were almost exclusively as a result of following too close along the slip ramp (9 crashes)
- The other two crashes were a result of failure to yield
- These crash types are typical in areas of high congestion such as this, especially at yield-controlled movements where vehicles are trying to identify mainline gaps.
- One of these crashes resulted in injury
- While it was nearly an even split between crashes at this location occurring during the morning or afternoon, lighting does not appear to be an impacting factor as all crashes occurred during typical daylight hours

**Photo 1: Exit 2 SB On Ramp Merge Point (July 2022)** captured by Google Maps<sup>2</sup> in July of 2022 depicts the condition of this location at the time that it was most recently noted as an HCL.

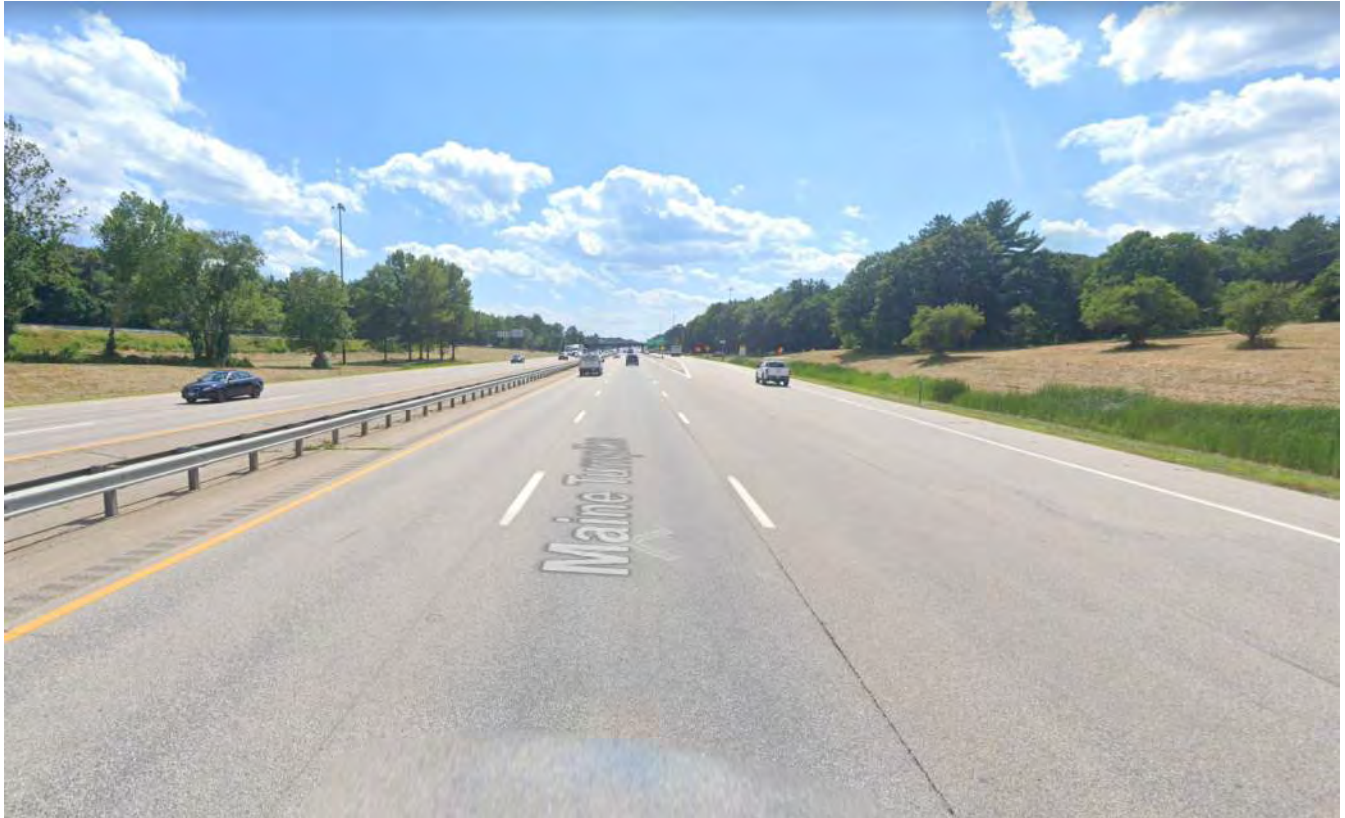
- 8 of the crashes included in the diagram (36%) were a result of vehicles following too close, which is a typical crash cause in locations of high congestion
- 6 crashes (27%) were a result of drivers hitting animals or debris in the roadway
- There was 1 fatality included in this HCL diagram, which was caused by a driver under the influence driving the wrong way on the Turnpike
- The majority of these crashes occurred during the summer months which is when there is the highest percentage of unfamiliar drivers traveling for recreational purposes

**Photo 2: I-95 SB Just North of C-D Split (July 2022)** captured by Google Maps<sup>3</sup> in July of 2022 depicts the condition of this location at the time that it was most recently noted as an HCL.

Following too closely was the primary crash cause along both HCLs in this area. This is likely a result of congestion in this location combined with seasonally high volumes of unfamiliar drivers and a high percentage of heavy vehicles, some of which are RVs and trailers being used by individuals who do not commonly operate these types of vehicles.

PTSU will provide some additional capacity and should be monitored when implemented to understand safety concerns and the potential life of this improvement. Because there are no pull off areas, MTA service patrol will need to be present during PTSU activities to ensure mobility is maximized. This will not replace the need for future widening at this location.

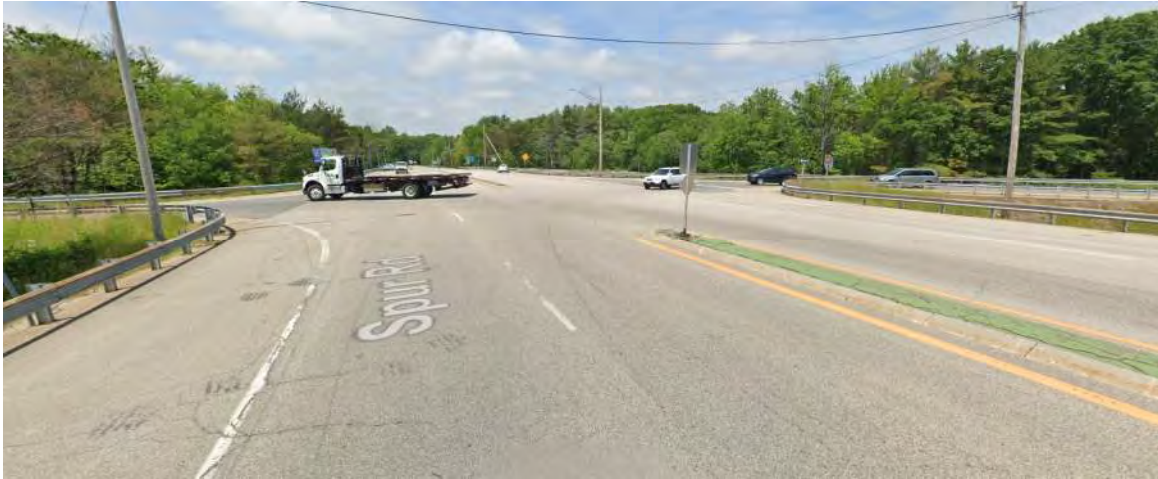
**Photo 1: Spur Road at I-95 SB Exit 7 Ramps (June 2019)**

- All crashes displayed in the diagram were a result of turning movements
- 50% (6 crashes) were a result of failure to yield
  - Half of these were between vehicles traveling eastbound on Spur Road and vehicles turning left towards the on ramp, while the other half were between vehicles traveling eastbound on Spur Road and vehicles turning left off of the off ramp
- Two of the crashes at this location involved heavy vehicles
- 7 of these crashes (58%) occurred between August and October

**Photo 1: Spur Road at I-95 SB Exit 7 Ramps (June 2019) and Photo 2: Exit 7 Ramps Intersection from SB On Ramp (September 2019)** captured by Google Maps<sup>3</sup> depict the condition of this location at the time that it was most recently noted as an HCL.

At the southbound ramp intersection, failure to yield is the primary safety concern. This pattern is present for multiple left-turn movements throughout the intersection. Additionally, this location has been classified as an HCL for 5 of the last 10 years.

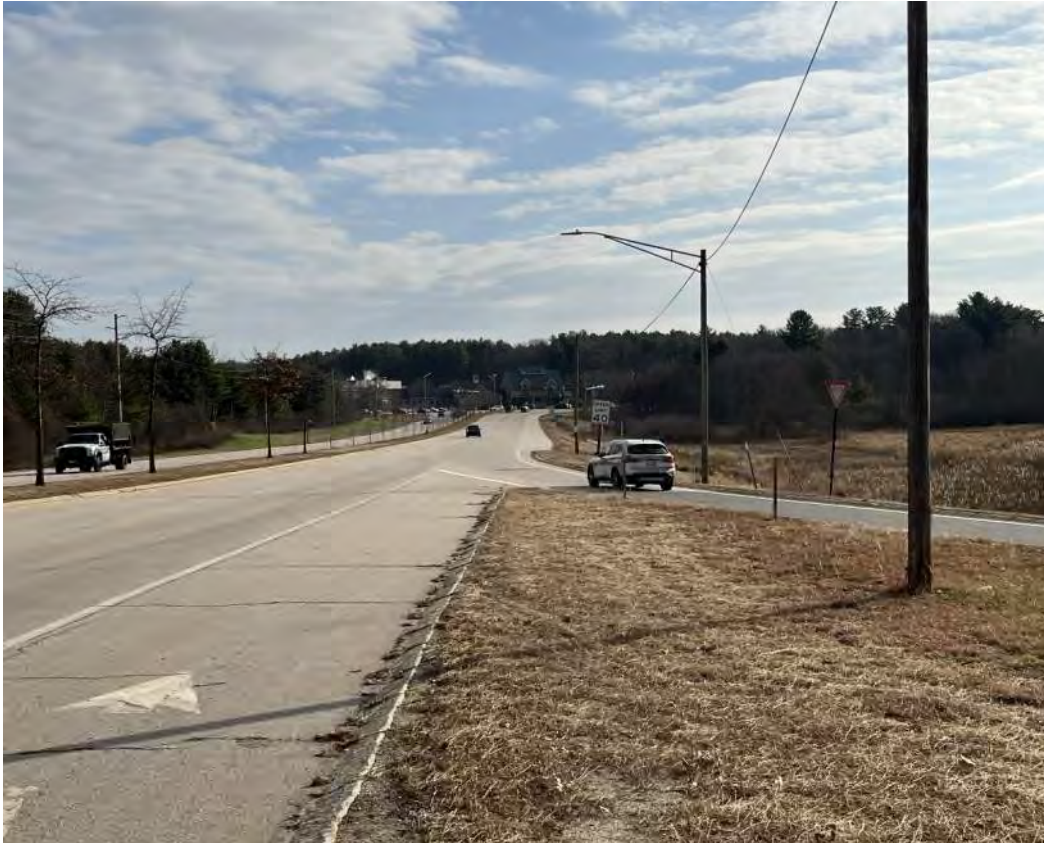
- The crashes represented in this diagram were exclusively a result of vehicles following too close, which is common in areas of high congestion, especially in locations under yield conditions
- 6 of these crashes (75%) occurred between the months of June and August

**Photo 3: Slip Ramp Intersection from Spur Road (November 2022)** captured by HNTB in November of 2022 depicts the condition of this location at the time that it was most recently noted as an HCL.

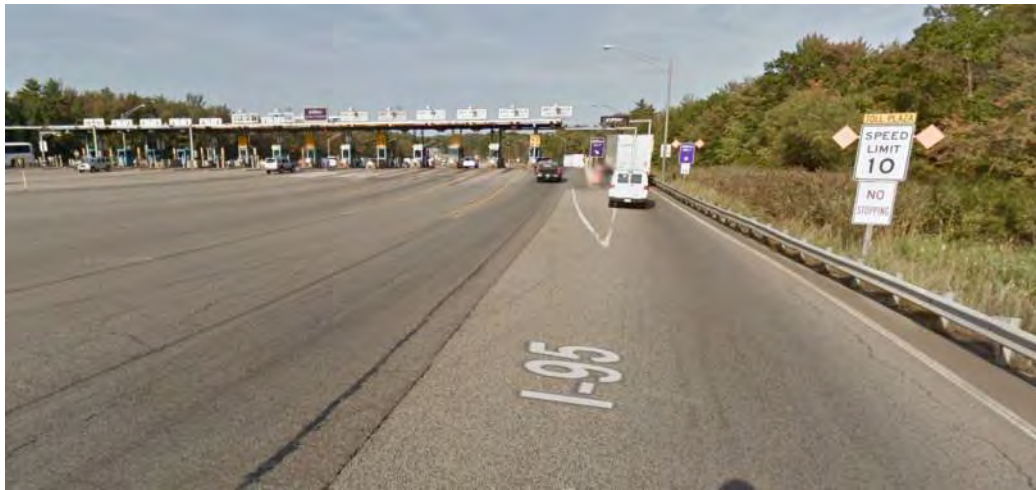
- The most common cause of crash at this location was failure to yield (5 crashes, 50% of the recorded crashes)
- The second most common cause was following too close
- 6 of the 10 crashes at this location occurred between the months of June and August which is the time that this area experiences an increased volume due to tourism
- There does not appear to be a strong correlation between time of day and crashes

**Photo 1: Toll Plaza NB (2011)** captured by Google Maps<sup>2</sup> in September of 2011 depicts the condition of this location at the time that it was most recently noted as an HCL. **Photo 2: Toll Plaza NB (2022)** displays the most recent

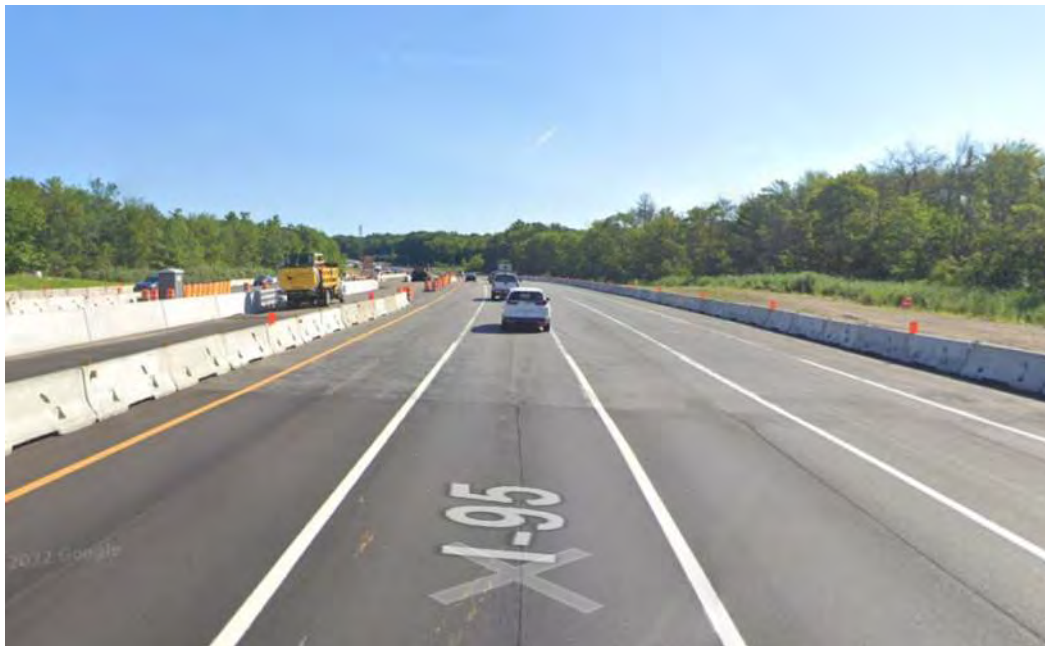
**Photo 2: Toll Plaza NB (2022)**

available Google Street View imagery at the same location. In this photo, the toll plaza construction is active and the old plaza has been removed.

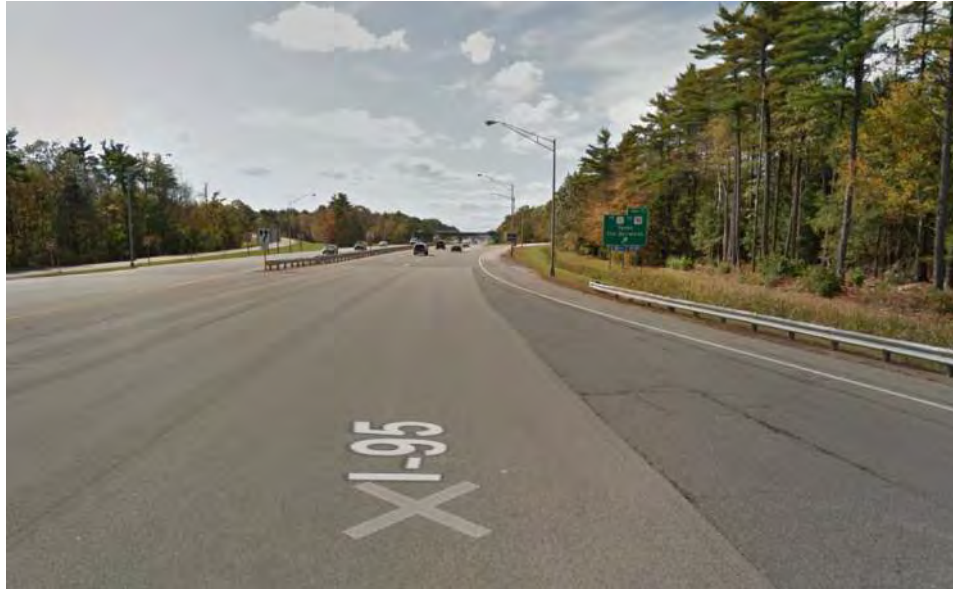
- The primary cause of crash in this location during the most recent HCL period was failure to yield as a result of an attempted lane change (3 crashes)
- Inattention was the next leading cause for crashes in this location, causing 2 of the recorded crashes
- A heavy vehicle was involved in one of the recorded crashes
- While there is not a strong correlation between time of day or year and crash frequency at this location, all but 1 of the crashes that had weather and pavement conditions at time of crash listed occurred on dry pavement when the weather was clear
- None of these crashes resulted in injury

**Photo 3: South of SB Toll Plaza (2011)** captured by Google Maps<sup>3</sup> in October of 2011 depicts the condition of this location at the time that it was most recently noted as an HCL.

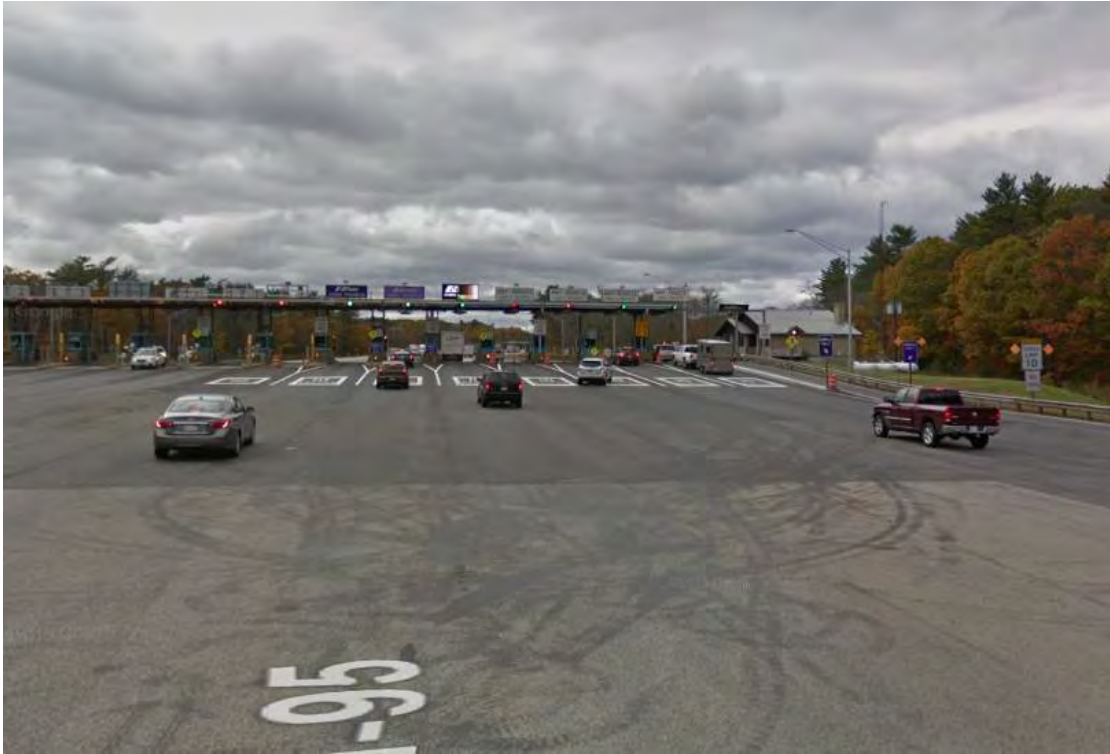
- 4 of these 11 crashes involved heavy vehicles
- Following too close was the most common cause for crashes in this location, causing 3 crashes, closely followed by speed which contributed to 2 crashes at this location
- 5 of these crashes occurred between July and September, which are some of the months in which this area experiences an increased volume and higher number of drivers unfamiliar with the area

**Photo 4: SB Toll Plaza (2018)** captured by Google Maps<sup>4</sup> in October of 2018 depicts the condition of this location at the time that it was most recently noted as an HCL.

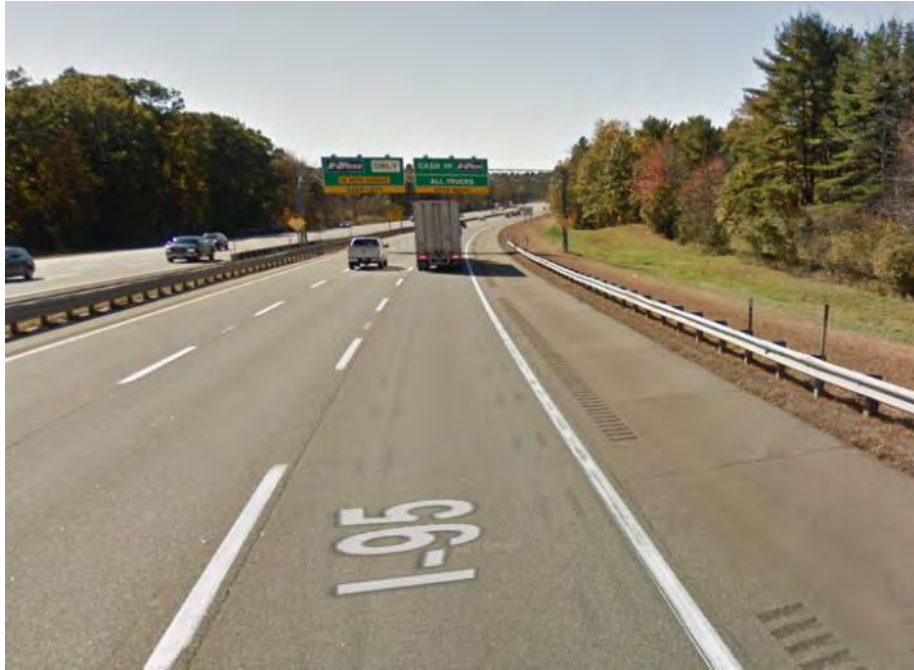
- This is an extremely significant location in regards to safety concerns based on the volume of crashes
- One of these crashes involved a heavy vehicle
- Failure to yield, failure to keep in lane, following too close and speed appear to be the prominent causes of crashes at this location, some of which are common at congested areas especially those such as toll plazas when lane changes are frequently being made
- Recklessness and collisions with animals are the next most observable causes at this location
- The majority of the crashes at this location occurred during the summer months in which there is increased volume and higher numbers of drives who are unfamiliar with the area

**Photo 5: North of SB Toll Plaza** captured by Google Maps<sup>5</sup> in October of 2018 depicts the condition of this location at the time that it was most recently noted as an HCL.

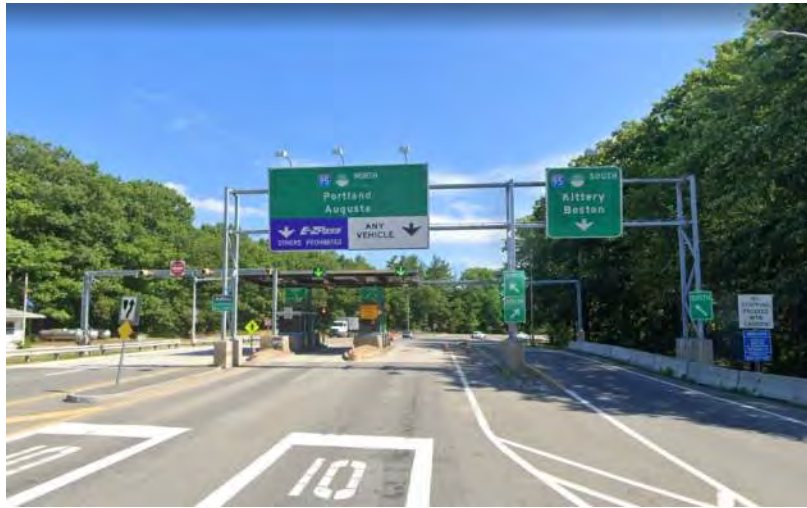
- There are not many strong trends in causes of crash at this location
  - The most common type of crash at this location was improper backing, which contributed to 2 of the 8 recorded crashes at this location
  - Two of the recorded crashes at this location had contributing factors outside of the control of the vehicle operator (1 due to road conditions, 1 due to defective brakes)
- 5 of the 8 recorded crashes at this location happened during the hour of 3:00pm (3 of these 5 occurred during the weekend days of Friday – Sunday)
- All but 1 of the recorded crashes at this location occurred when the pavement was dry and the weather was clear

**Photo 1: HCL 66 – Exit 19 Plaza Segment** captured by Google Maps<sup>3</sup> on August 2022, depicts the condition of this location at the time that it was most recently noted as an HCL. This picture shows the approach to the intersection after the plaza.

The majority of the crashes at the Exit 19 toll plaza during the time in which it was most recently classified as an HCL were due to improper movement or driver recklessness. Separating the ramps is recommended to alleviate some of the confusion on the approach.

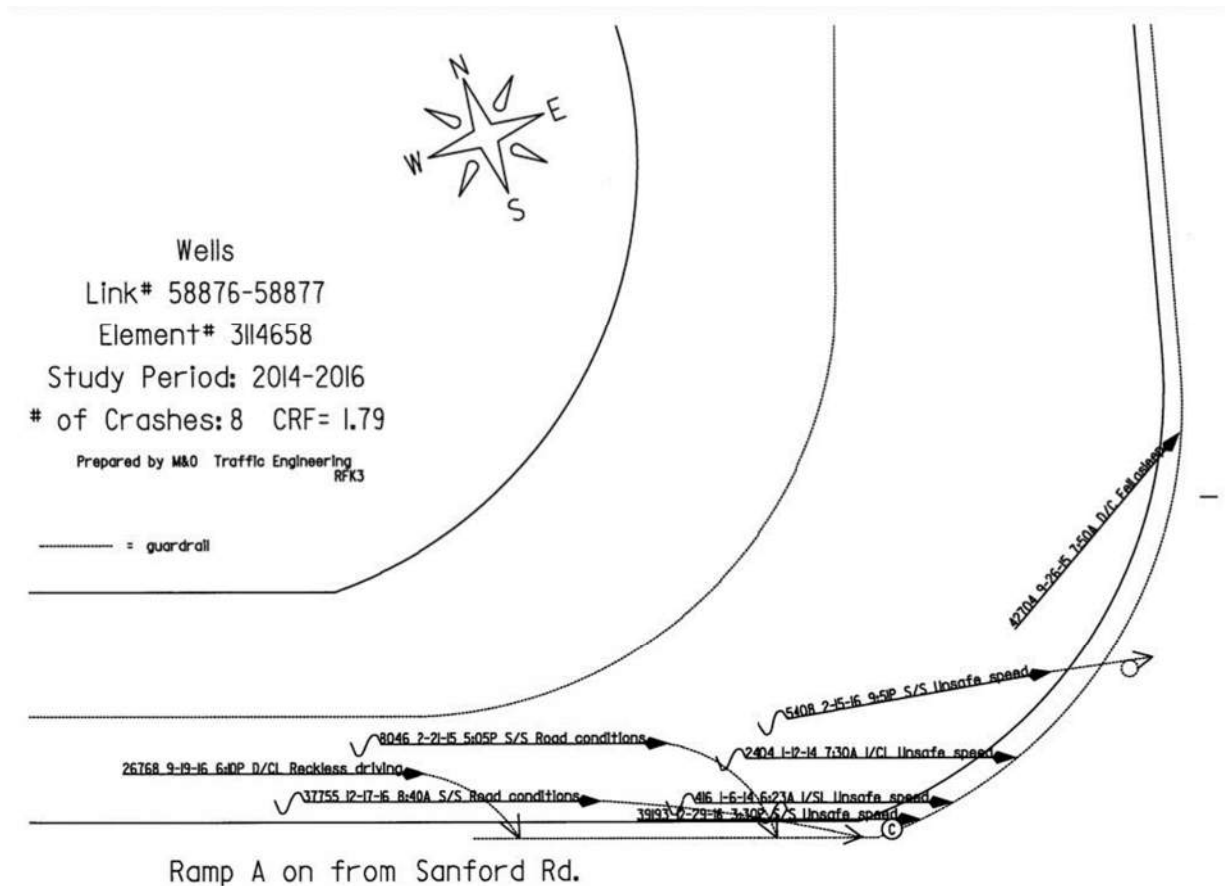
**Figure 3: 2014-2016 Northbound on Ramp Crash Diagram** depicts the HCL at the curve along the Northbound on ramp.

As shown in **Figure 3**, there were 8 crashes resulting in a 12.5% injury rate during this analysis period.

- All recorded crashes at this location involved colliding with the guardrail on the outside of the ramp's curve
- 4 of the crashes (50%) were a result of unsafe speed around the curve
- 2 of the crashes (25%) were due to road conditions
- 6 of the recorded crashes at this location occurred between the months of December – February, including both crashes that were a result of road conditions

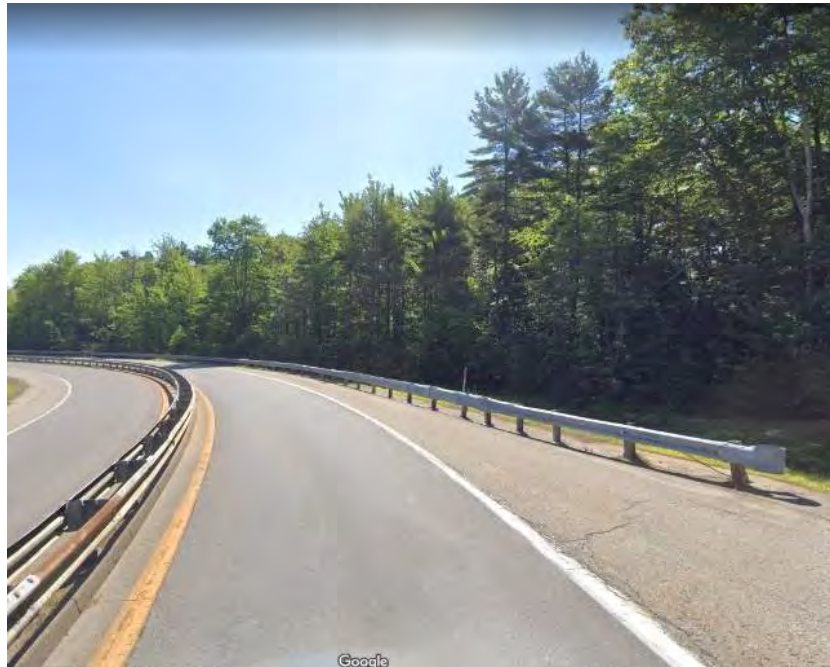
**Photo 2: HCL 78 – Northbound On-Ramp** captured by Google Maps<sup>4</sup> on August 2022 depicts the condition of this location at the time that it was most recently noted as an HCL. The picture shows the northbound on approach approaching the guardrail where most of the crashes occurred.

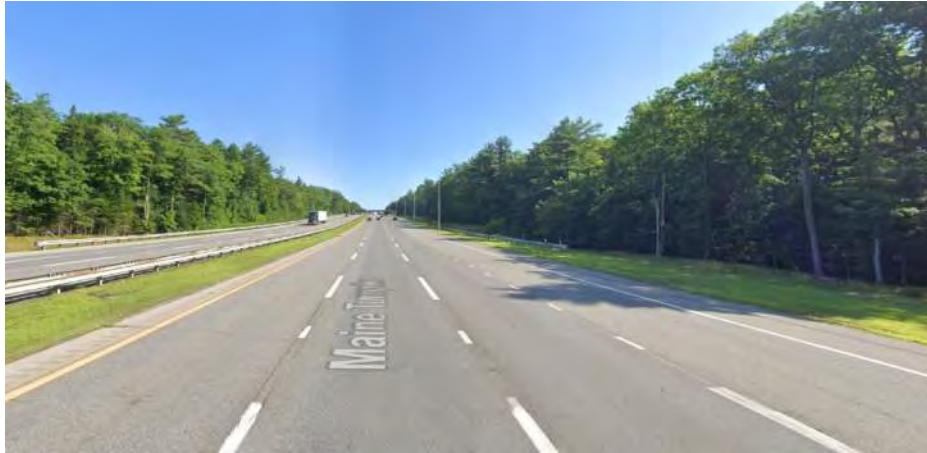
**Photo 1: Exit 19 Northbound Mainline and NB On Merge**

It can be observed from this table that there were 9 crashes at this location with a 11.1% injury rate during this time period.

**Photo 1: HCL 8 – Northbound Mainline and NB On Merge** captured by Google Streetview on July 2022 depicts the condition of this location at the time that it was most recently noted as an HCL.

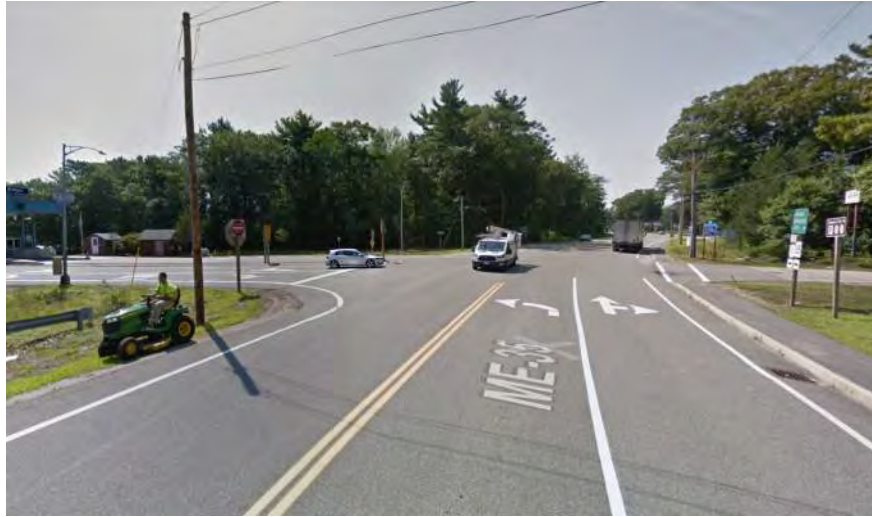
**Photo 1: Exit 25 SB Ramps Intersection – Unsignalized from Alewife Road SB**

**Photo 1** captured by Google Maps<sup>3</sup> in August of 2018 depicts the intersection as it existed at the time that it was most recently noted as an HCL, while **Photo 2**, captured by HNTB on November 23, 2022, depicts the intersection as it currently exists in its signalized condition.

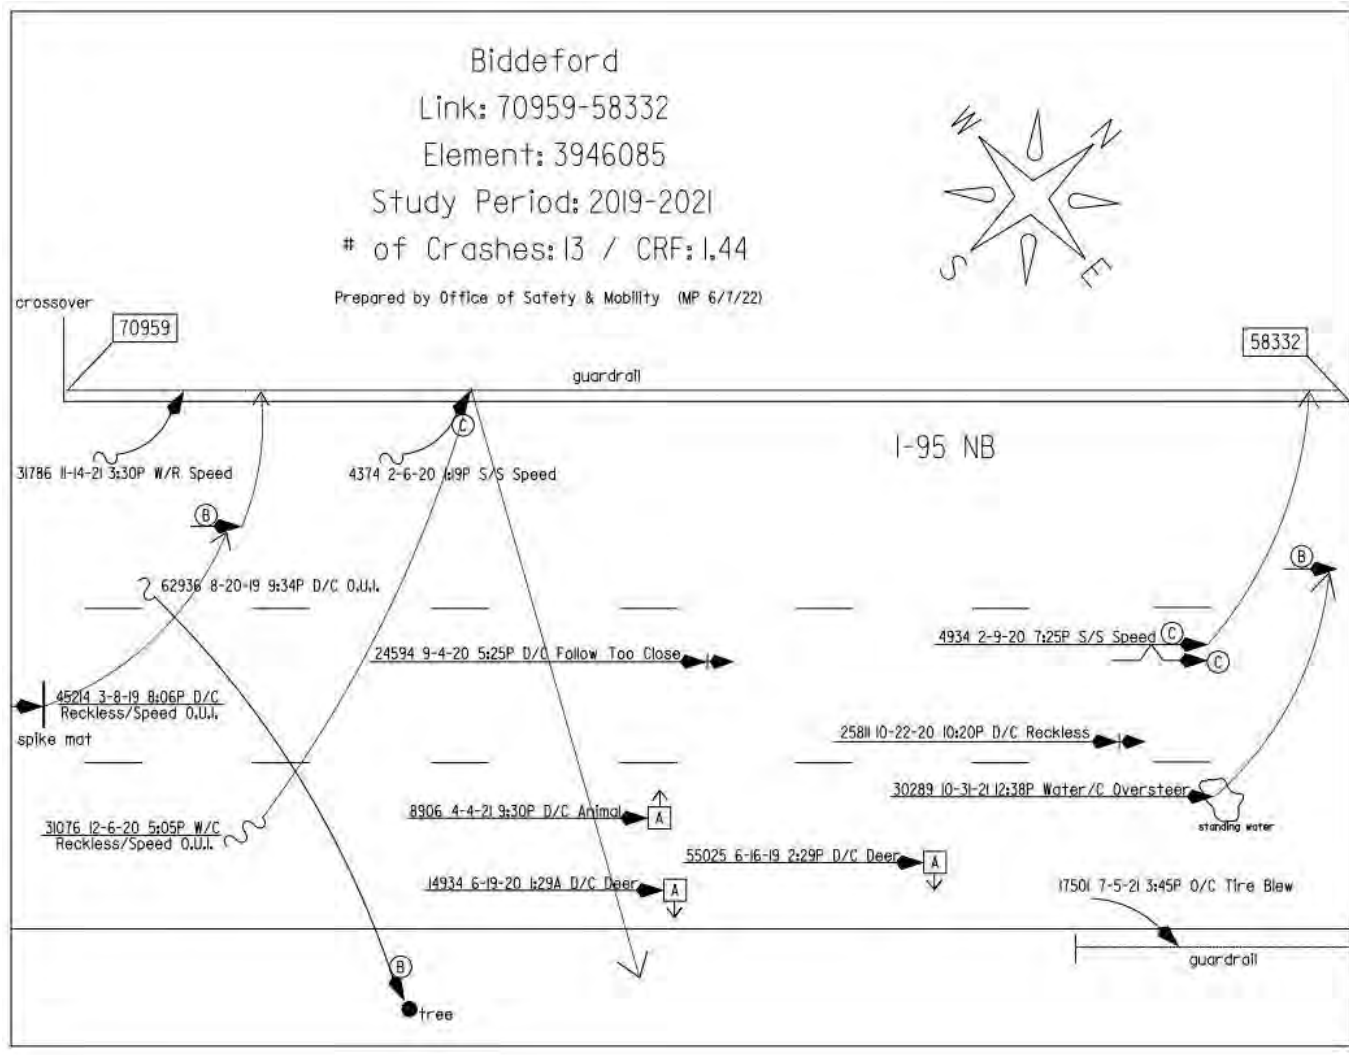
**Figure 1: (2019-2021) Exit 32 NB Off Ramp Approach Crash Diagram** depicts the crash diagram for the location during the time period in which it was most recently identified as an HCL. This location was also classified as an HCL during the 2018-2020 time period.

As shown in **Figure 2**, there were 13 crashes resulting in a 38.5% injury rate during this analysis period.

- 5 of these 13 crashes (38%) had speed as a contributing factor
  - 2 of these 5 speed-related crashes also involved an O.U.I.
  - There was 1 additional O.U.I. crash in this location which did not have speed listed as a contributing factor
- The next most common contributor to crashes at this location was large animal collisions
- 5 of these crashes resulted in vehicles leaving the travel way and colliding with either guardrail or other objects
- One of these crashes involved standing water in the travel way
- 7 of these crashes occurred during the evening hours of 3:00pm – 10:30pm

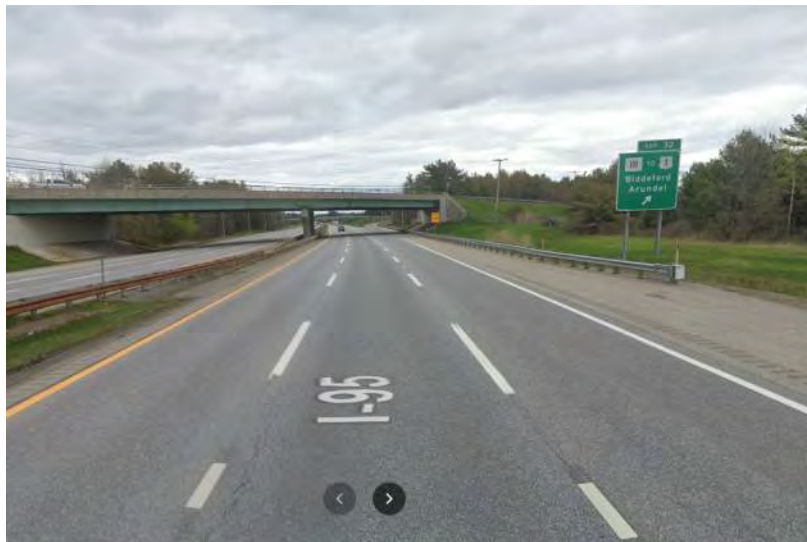
**Photo 1: Exit 32 NB Off Ramp Approach (2019)**

**Photo 1: HCL 9 – Exit 32 NB Off Ramp Approach** captured by Google Maps<sup>1</sup> on June 2019 depicts the condition of this location at the time that it was most recently noted as an HCL.

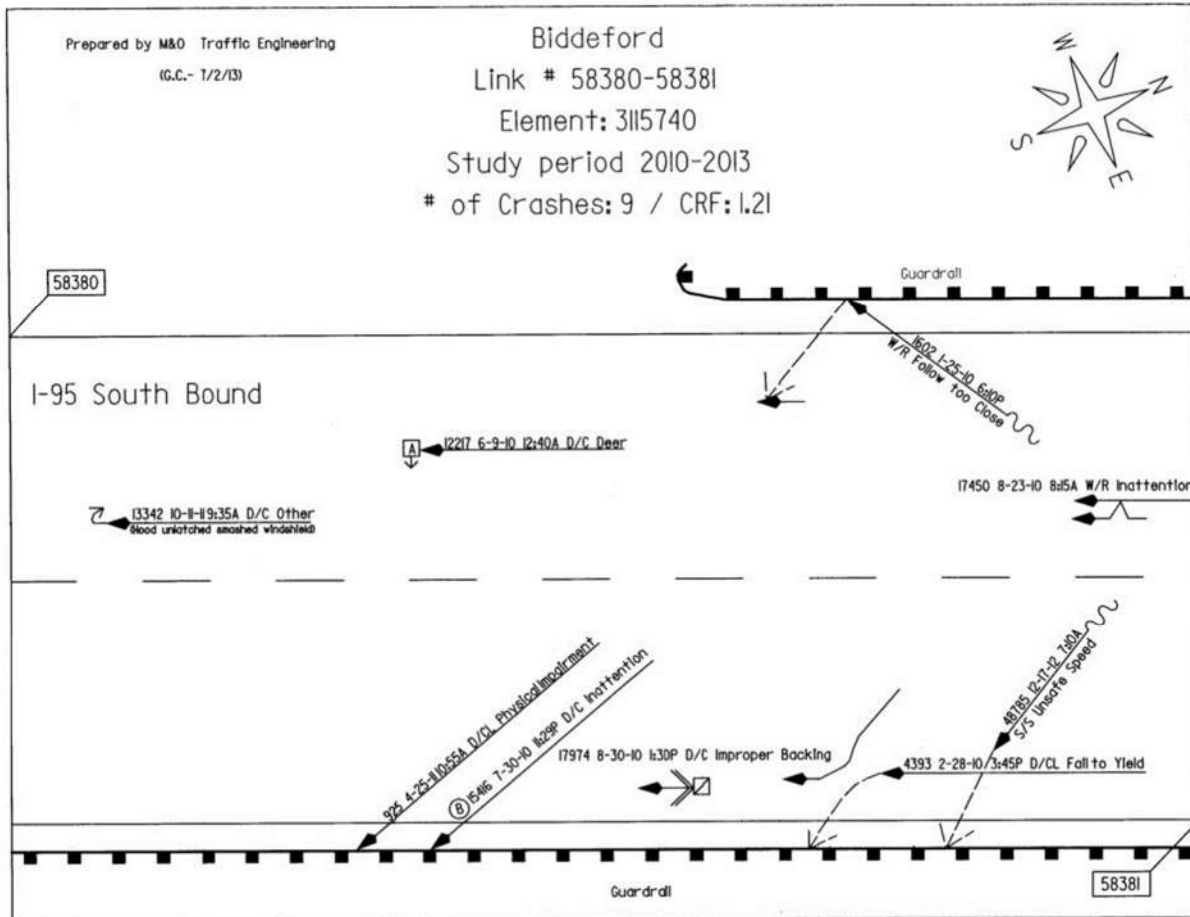
**Figure 3: 2010-2013 Segment after Exit 32 SB On Ramp Crash Diagram** depicts the HCL along the mainline just south of the Exit 32 southbound off ramp. This is the only time period over the last 10 years in which this location was identified as an HCL.

As shown in **Figure 3**, there were 9 crashes resulting in a 11.1% injury rate during this analysis period.

- The only cause that contributed to more than one crash at this location was inattention (contributed to 2 crashes)
- Other than inattention, all crashes recorded at this location had different causes including unsafe speed, following too close, improper backing, deer and physical impairment
- There does not appear to be significant correlation between time of day, time of year nor cause of crash and crash frequency at this location

Since each segment included in this audit has only been noted as an HCL once in the past 10 years and do not appear to have strong correlations or trends related to crash frequency, no recommendations are made at this time.

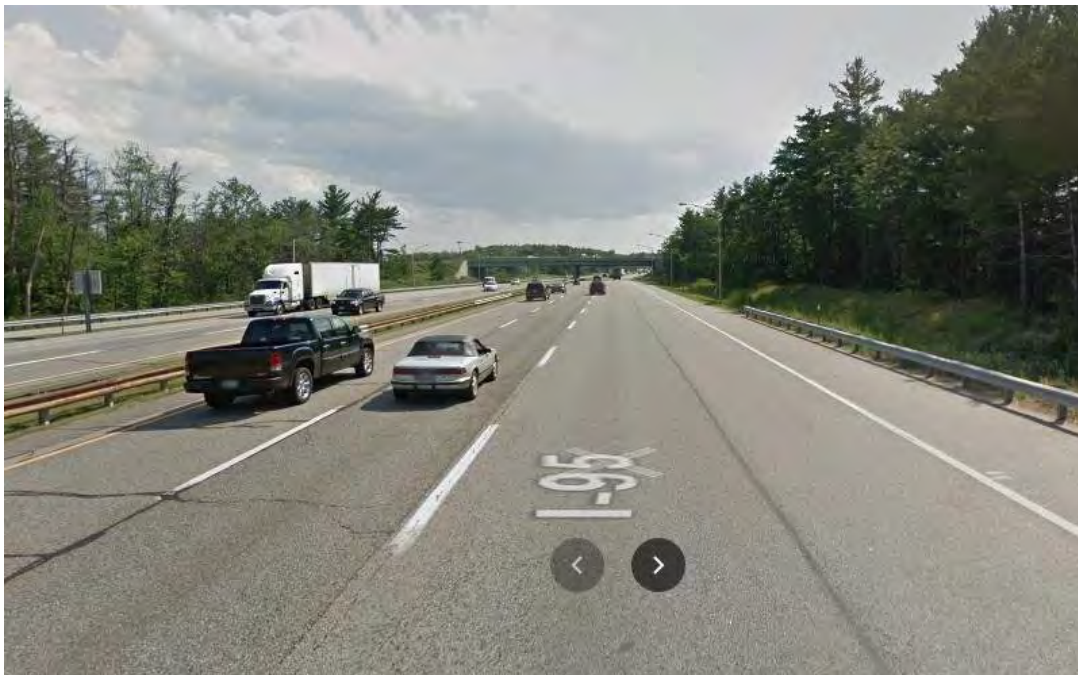
**Photo 2: Segment after Exit 32 SB On Ramp (2011)**

**Photo 2: Segment after Exit 32 SB On Ramp** captured by Google Maps<sup>2</sup> on July 2011 depicts the condition of this location at the time that it was most recently noted as an HCL.

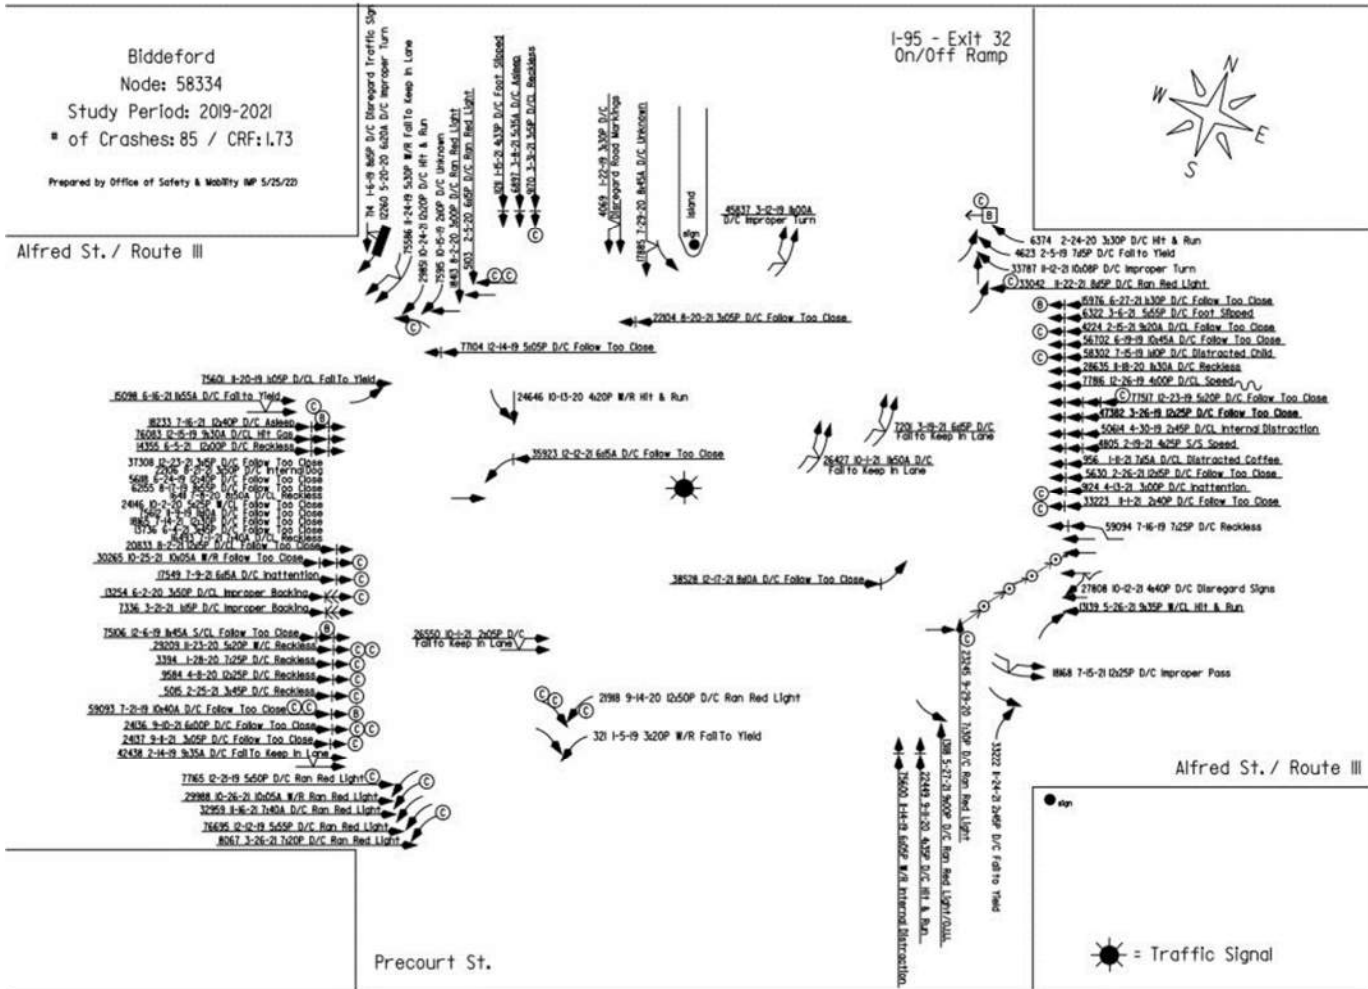
Figure 2: 2019-2021 Exit 32 Intersection Crash Diagram depicts the HCL location at the node of the Exit 32 Ramps intersection with Alfred Street. This location was identified as an HCL during 8 other time periods over the past 10 years.

As shown in Figure 2, there were 85 crashes resulting in a 32.9% injury rate during this analysis period.

- While there were many intersection movement crashes at this location, the majority occurred at the intersection approaches
  - Of the crashes that occurred at the intersection approaches, the vast majority were a result of vehicles following too close, followed by recklessness
- Many of the intersection movement crashes were a result of running red lights
- The vast majority of the crashes at this intersection occurred at or along the Alfred Street approaches
- June to August and December to February were the most common time spans for which crashes occurred
- One of these crashes involved a heavy vehicle
