# 2022 Systemwide Safety and Capacity Study

June 30, 2023

Maine Turnpike Authority  
2360 Congress Street  
Portland, ME 04102

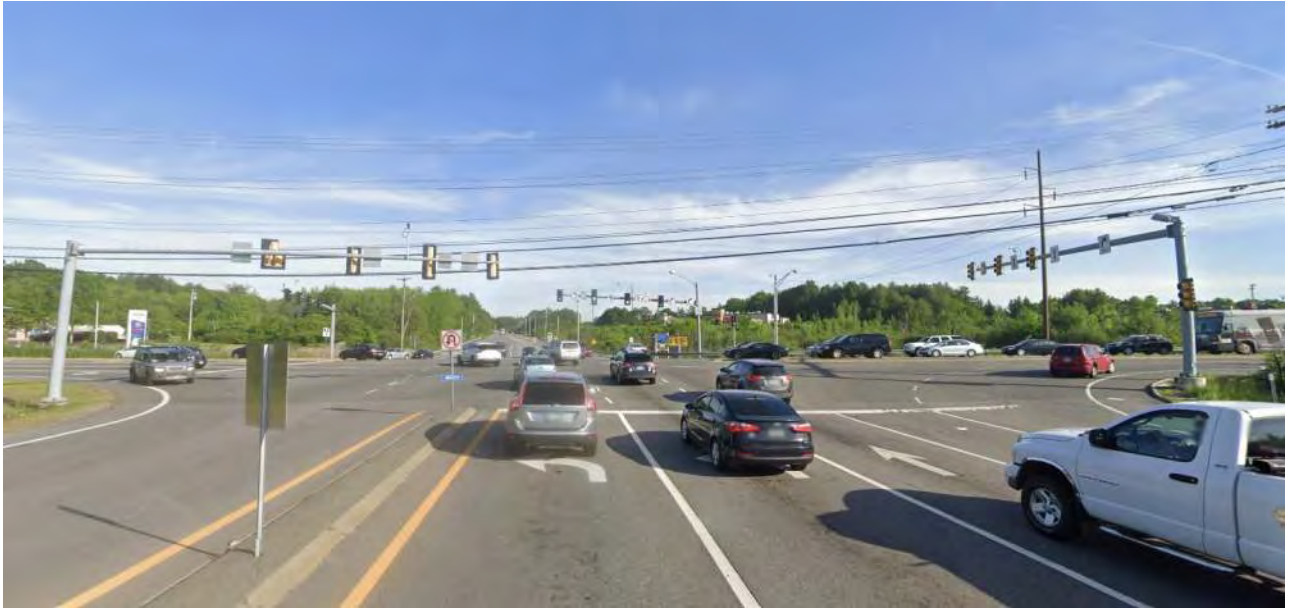
**Photo 1: Exit 32 Intersection** captured by Google Maps<sup>3</sup> in June of 2019 depicts the condition of this location at the time that it was most recently noted as an HCL. The photo represents the intersection from the view of the Exit 32 Ramps approach.

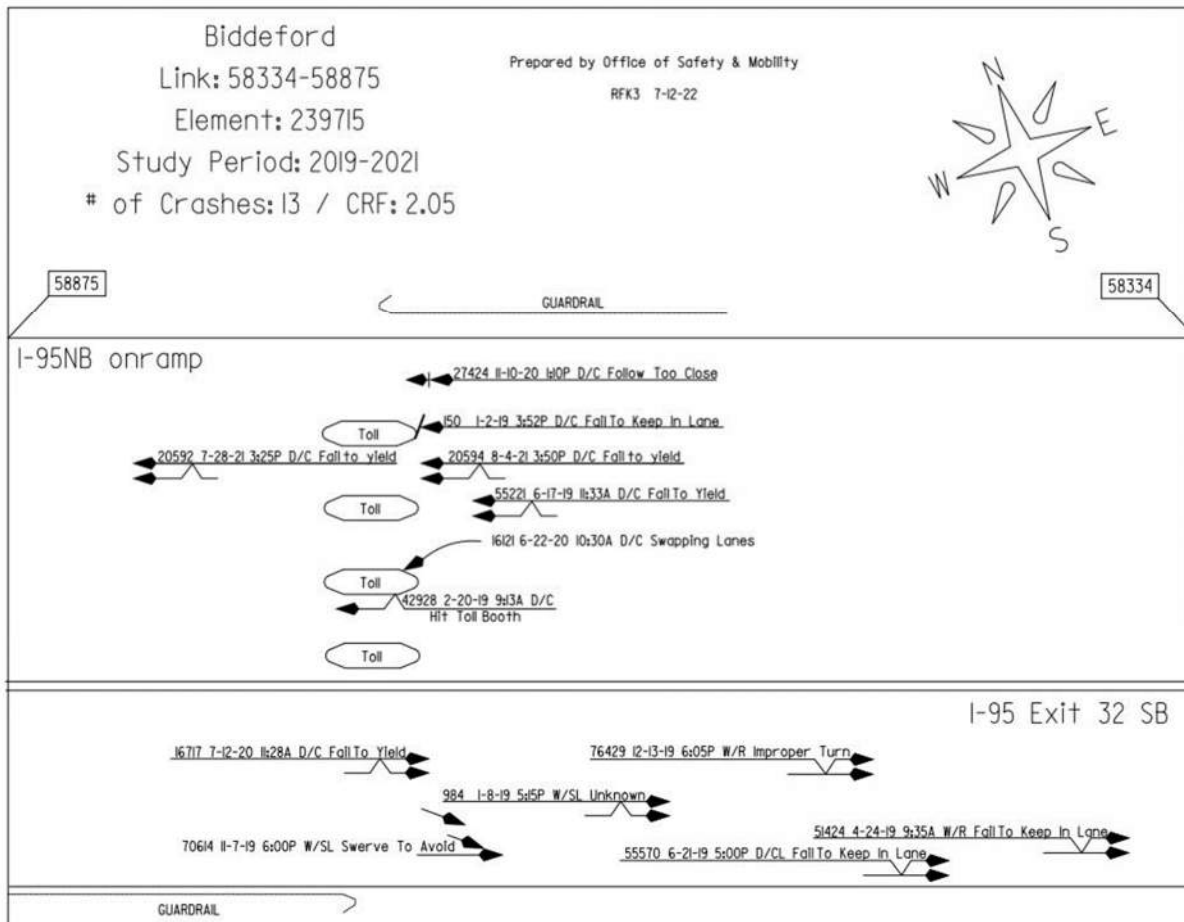
**Figure 3: 2019-2021 Exit 32 Plaza Ramps Crash Diagram** depicts the HCL at the Exit 32 Toll Plaza. This location was identified as an HCL during 9 other time periods over the past 10 years.

As shown in **Figure 3**, there were 13 crashes resulting in a 0% injury rate during this analysis period.

- The most common cause of crash at this location was failure to yield, followed by failure to keep in lane
- 8 of these 13 crashes were sideswipe crashes
- While there is not a strong correlation between time of year and crash frequency, the majority of the crashes occurred during typical AM and PM Peak commuting hours

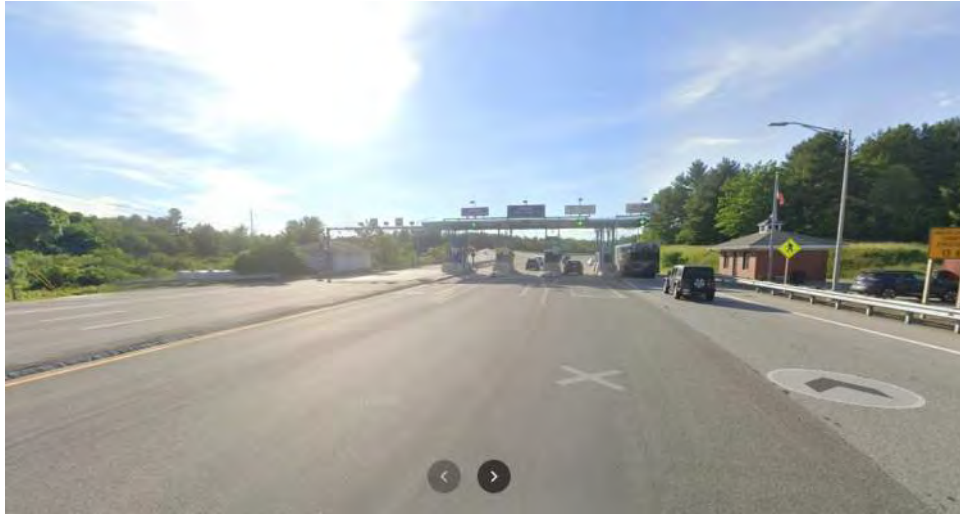
**Photo 2: Exit 32 Plaza Ramps**

**Photo 2: Exit 32 Plaza Ramps**, captured by Google Maps<sup>4</sup> in of June 2019, depicts the condition of this location at the time that it was most recently noted as an HCL.

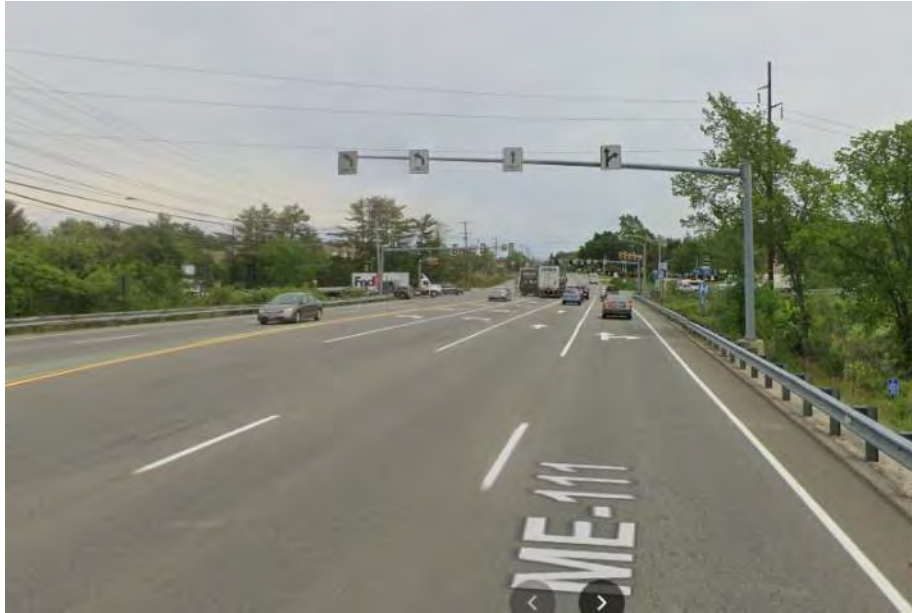
It can be observed from this table that there were 8 crashes at this location with a 12.5% injury rate during this time period.

**Photo 3: Alfred St Approach EB** captured by Google Streetview on June 2019 depicts the condition of this location at the time that it was most recently noted as an HCL.

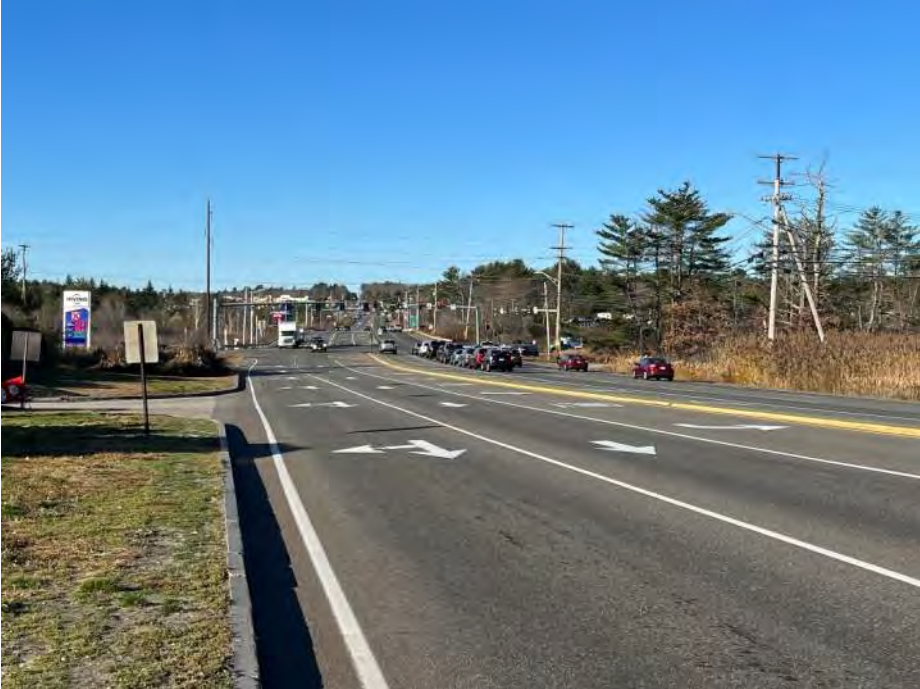
**Photo 4: Alfred Street WB Approach<sup>5</sup>**

It can be observed from this table that there were 5 crashes at this location with a 0% injury rate during this time period.

**Photo 4: Alfred Street WB Approach** captured by HNTB on November 8<sup>th</sup>, 2022, depicts the condition of this location at the time that it was most recently noted as an HCL.

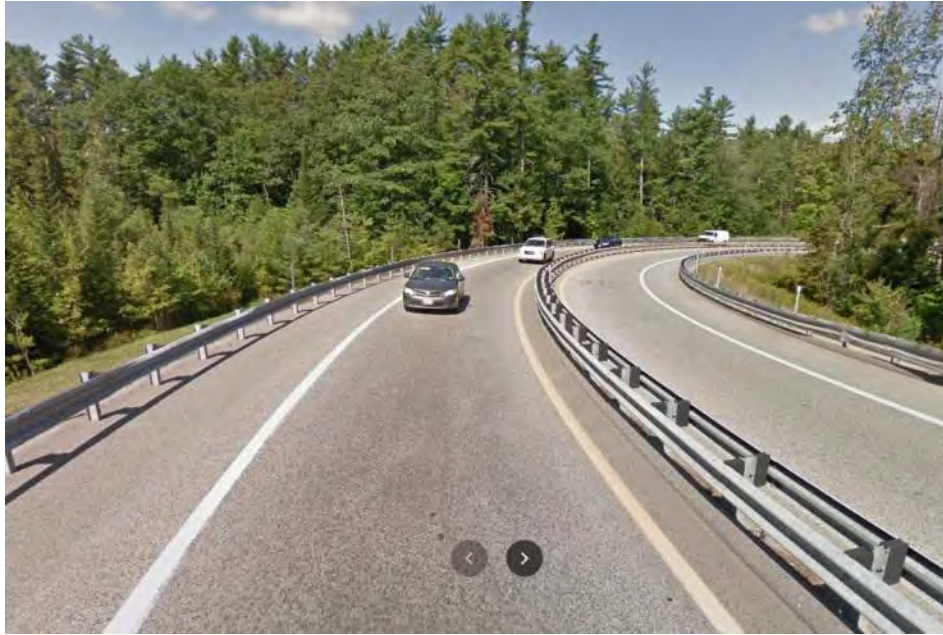
- 6 of the 8 crashes in this location resulted in vehicles departing from the roadway and colliding with guardrail spans
  - 4 of these 6 crashes were a result of unsafe speeds
  - All but one of these crashes occurred when the road was not dry
  - While it is not depicted in the crash diagram, this location is along the curve of the ramp
- The two crashes that did not result in vehicles departing from the roadway were a result of following too close
- 7 of the 8 crashes occurred between the months of October and February, the months in which winter conditions are most common
- There is not a strong correlation between time of day and crash frequency

**Photo 5: Exit 32 SB Off Ramp** captured by Google Maps<sup>6</sup> in September of 2017 depicts the condition of this location at the time that it was most recently noted as an HCL.

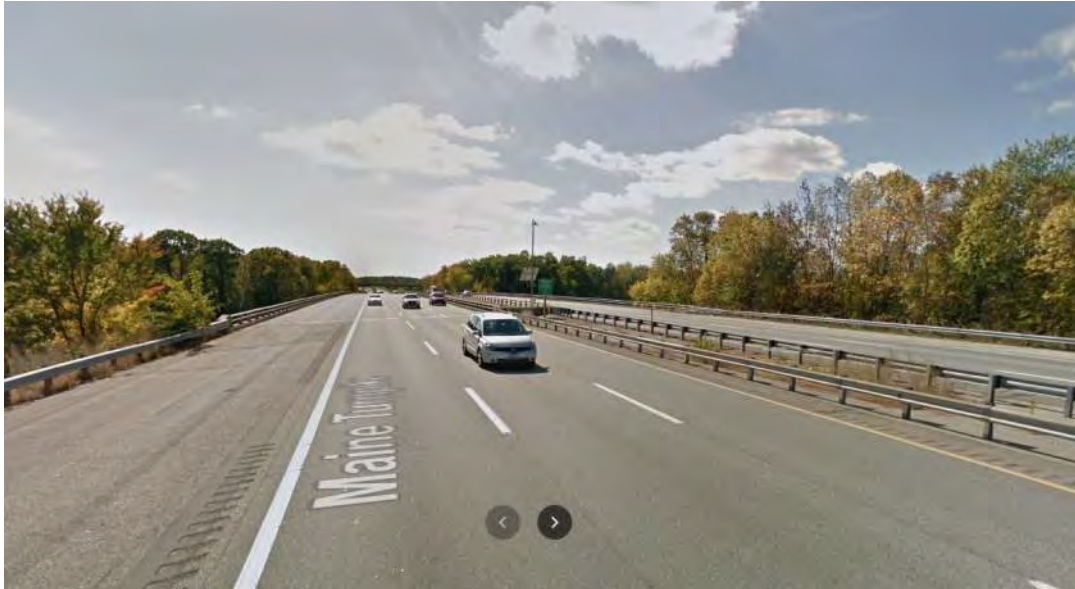
- 8 of the 16 crashes included in this crash diagram (50%) were a result of unsafe speed
  - None of these 8 crashes occurred on a dry roadway
  - 7 of these 8 crashes resulted in vehicles departing from the travel way and colliding with either bridge rail or guardrail
- 2 crashes at this location were due to collisions with large animals
- 3 of the 16 crashes included in this diagram occurred during the time period of increased summer traffic volumes
- 9 of the 16 crashes occurred during the evening hours between 5:00pm and 10:00pm

**Photo 1: Mainline over Saco River** captured from Google Maps<sup>2</sup> in October of 2015 depicts the condition of this location at the time that it was most recently noted as an HCL.

Many of the crashes in this location were a result of unsafe speeds, especially in cases that the roadway was wet or icy. Additionally, large animal collisions were present in this area. While this can be used to identify safety concerns during the analysis period, the most recent time span in which this location was identified as an HCL was 2012-2014. For this

reason, the recommendations for this HCL will focus around monitoring the area for any current safety concerns, particularly the post-construction conditions after the surrounding interchange updates are implemented.

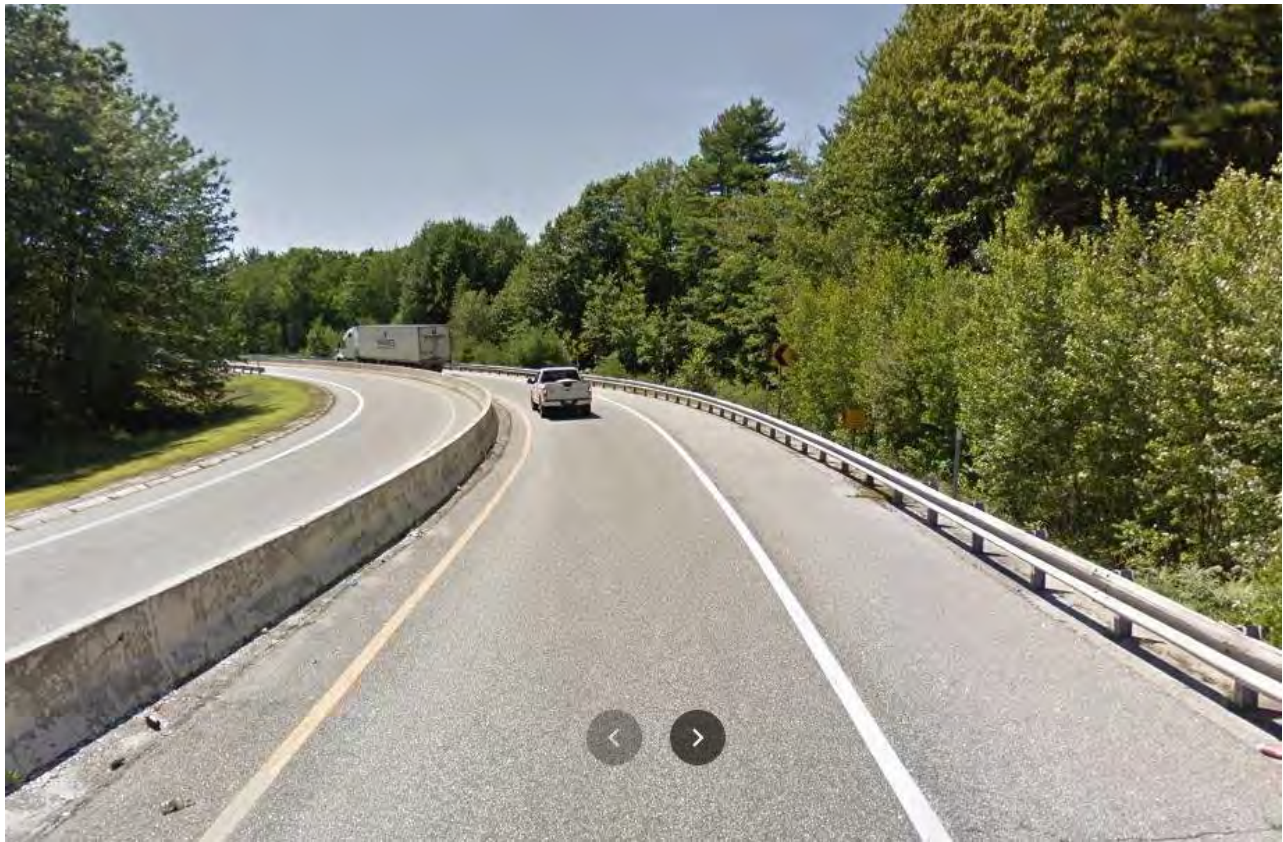
- The two most common causes of crashes at this location were unsafe speeds and inattention, each contributing to 3 crashes
- Following too closely contributed to 2 crashes at this location
- 6 of the crashes along the ramp resulted in vehicles departing from the travel way and colliding with guardrail
- 6 of the 9 crashes occurred between the months of October and February, the months in which winter conditions are most common in this area
- Crashes in this area are most common in the evening, with 6 of the 9 occurring between 5:30pm and midnight

**Photo 1: Exit 36 SB Off Ramp** captured by Google Maps<sup>3</sup> in July of 2018 depicts the condition of this location at the time that it was most recently noted as an HCL.

Since this location will soon be under construction to implement major reconfiguration and changes to both the ramp as well as surrounding areas, the recommendations for this HCL will center around monitoring post-construction conditions. This will be especially important as travel patterns change and vehicles distribute themselves between the Exit 35 and 36s interchanges, as well as begin to maneuver the collector distributor that will be present along the southbound corridor.

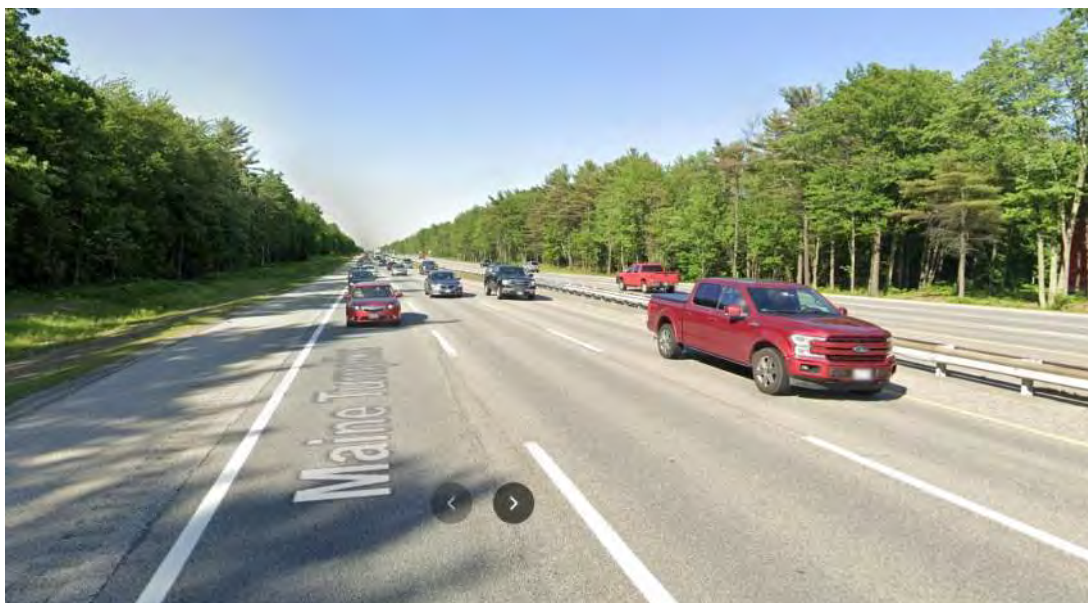
- The most common cause of crash in this location was following too close, which contribute to 7 crashes during this time period
  - This is a common crash type in locations of high volumes and congestion such as this mainline segment
- Collisions with animals was the next most frequent contributing factor in this location, contributing to 4 crashes, followed by speeding which was the cause of 3 crashes
- 7 of these crashes resulted in vehicles departing from the travel way, some of which resulted in collisions with guardrail
- 3 of these crashes involved heavy vehicles
- 12 of these 26 crashes occurred from May to October during the time of increased volumes through this area
- 11 of these crashes occurred during evening hours between 3:30pm and 9:00pm

**Photo 1: Just Prior to Exit 36 SB Off Ramp** captured by Google Maps<sup>2</sup> in June of 2019 depicts the condition of this location at the time that it was most recently noted as an HCL.

The southbound segment should continue to be monitored as construction around the Exit 36 interchange is implemented to examine any lingering or resultant safety concerns in the post-construction condition.

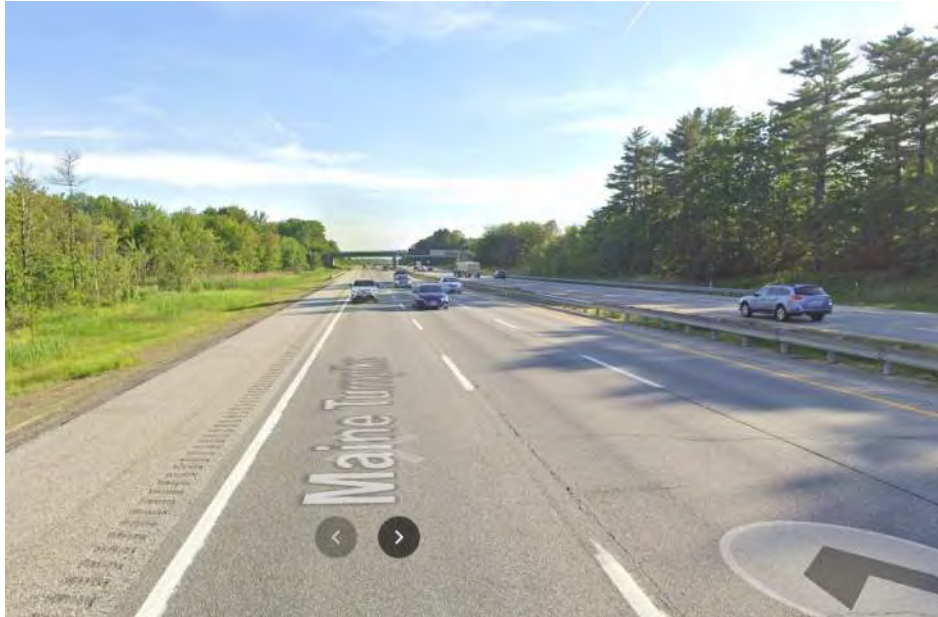
- The most common crash cause at this location during the analysis period was following too close, which contributed to 22 crashes
  - This is a common crash cause at locations such as these that have high traffic volumes, causing congestion
- Speed was the next most common contributing factor, causing 15 crashes at this location
  - Many of these occurred during times in which the pavement was not dry
- There were 10 crashes involving collisions with animals at this location
- 20 of these crashes resulted in vehicles departing from the roadway, some of which resulted in these vehicles colliding with guardrail
- 3 of these crashes involved heavy vehicles
- 38 of these 71 crashes (approximately 54%) occurred between the months of May and October when traffic volumes in this location are increased

**Photo 2: Just Prior to Exit 42 NB Off Ramp** captured by Google Maps<sup>3</sup> in June of 2019 depicts the condition of this location at the time that it was most recently noted as an HCL.

Vehicles following too close was the main crash cause at both of the HCLs examined as a part of this audit. This is a common crash type on congested roadways with high volumes such as this mainline segment. For this reason, future widening at this location should be evaluated, especially as volumes continue to grow in the future.

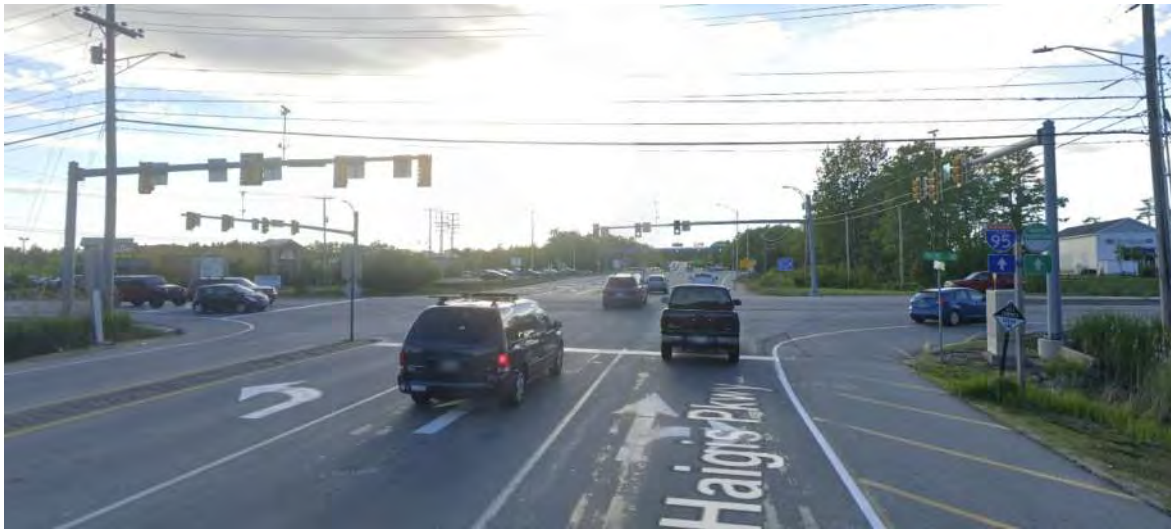
**Photo 1: Exit 42 Intersection** captured by Google Maps<sup>2</sup> in June of 2019 depicts the condition of this intersection at the time that it was most recently noted as an HCL.

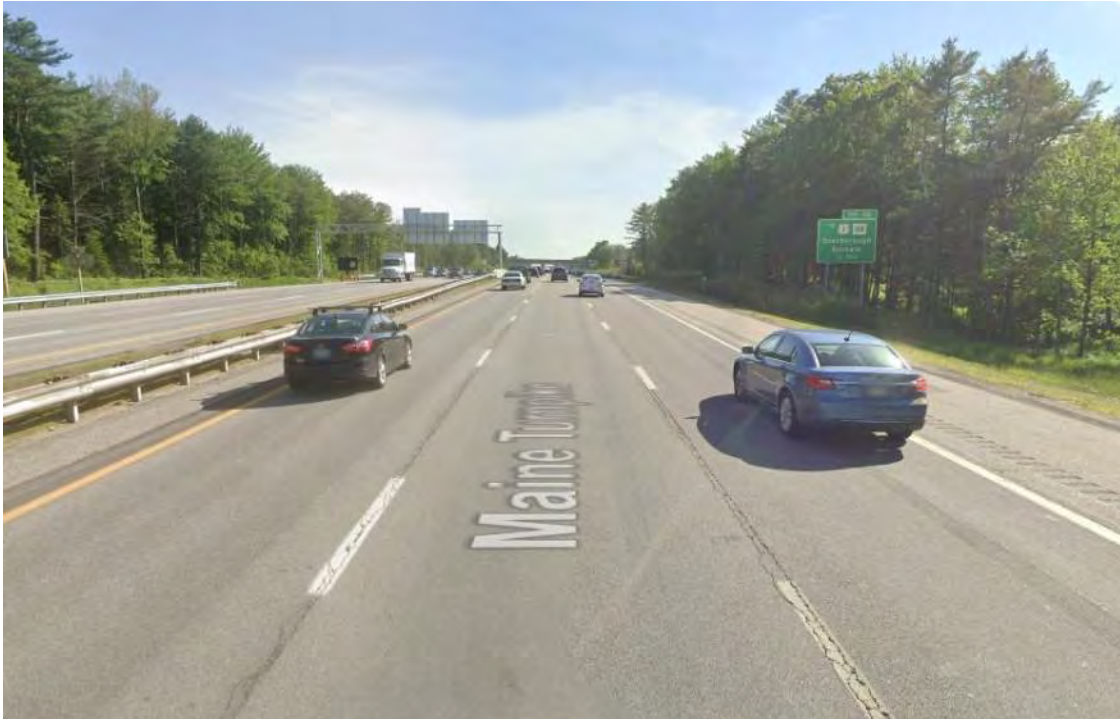
**Photo 1: Exit 42 SB Off Ramp Approach**

**Photo 1: Exit 42 SB Off Ramp Approach**, captured by Google Maps<sup>3</sup> in June of 2019, depicts the condition of this location at the time that it was most recently noted as an HCL.

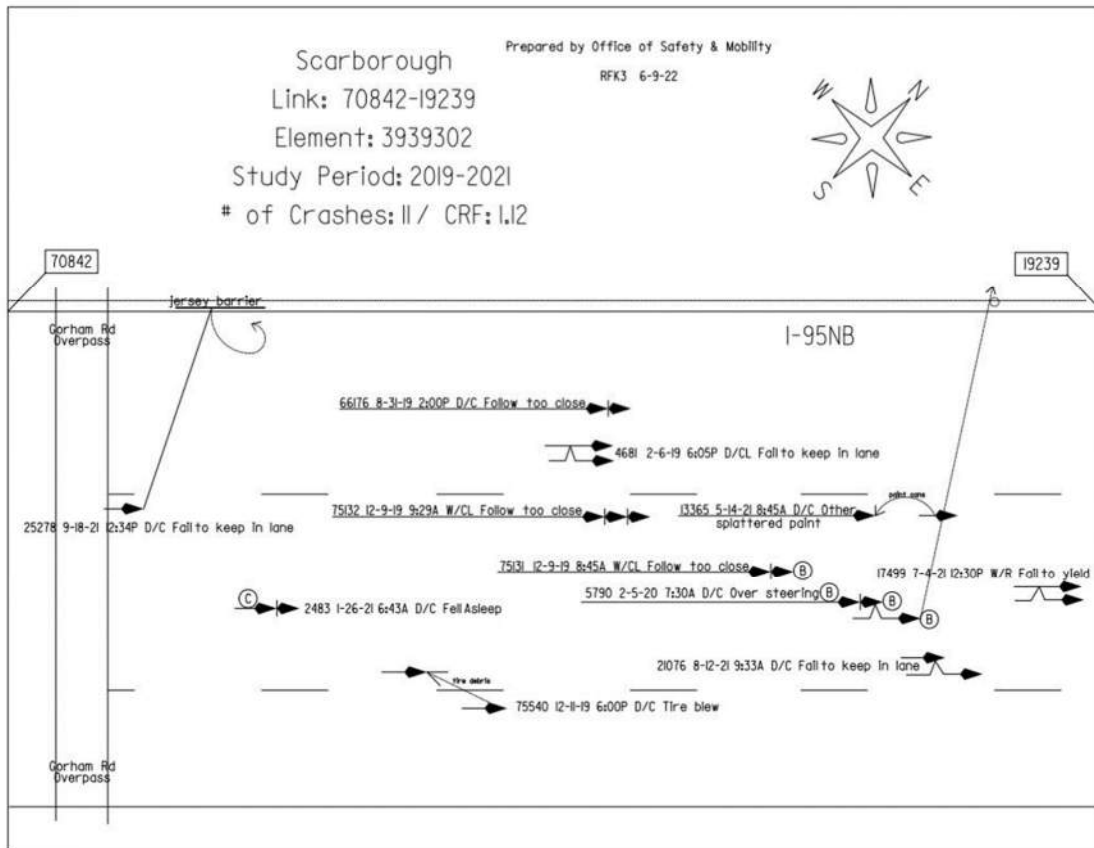
**Figure 3: 2019-2021 Exit 44 NB Off Ramp Approach Crash Diagram** depicts the HCL just south of the Exit 44 NB off ramp during the most recent period that it was identified as an HCL. This location was also classified as an HCL during the 2018-2020 and 2017-2019 time periods.

As shown in **Figure 3**, there were 11 crashes resulting in a 27.3% injury rate during this analysis period.

- Following too close and failure to keep in lane are the two most common contributing factors in this location, each causing 3 crashes
- 2 of the crashes in this location resulted in vehicles departing from the travel way, one of which result in a collision with jersey barrier
- 5 of the 11 crashes occurred during the winter months of December to February
- 5 of the 11 occurred during the typical AM Peak Hour period

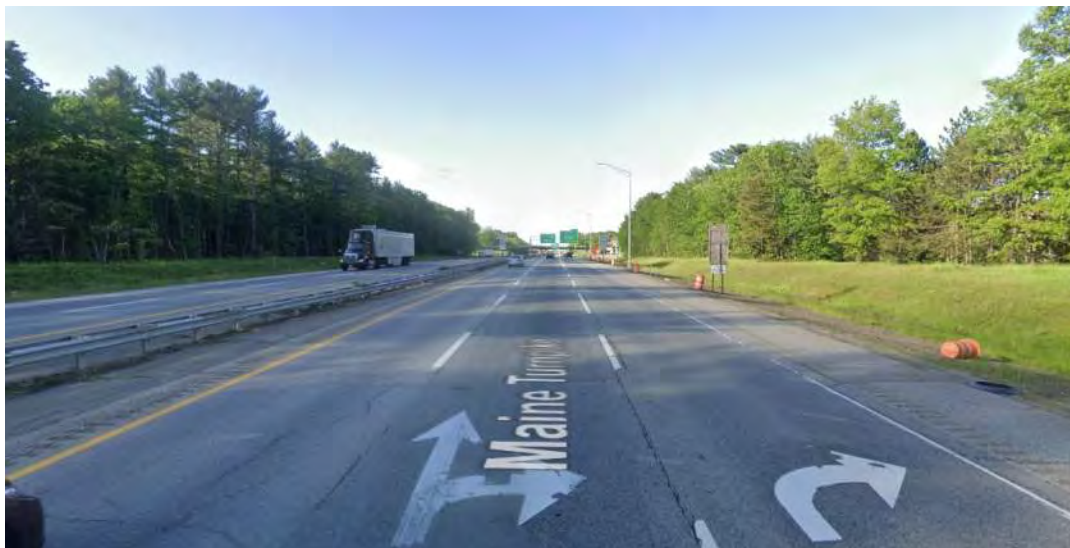
**Photo 2: Just South of the Exit 44 NB Off Ramp** captured by Google Maps<sup>4</sup> in June of 2019 depicts the condition of this location at the time that it was most recently noted as an HCL.

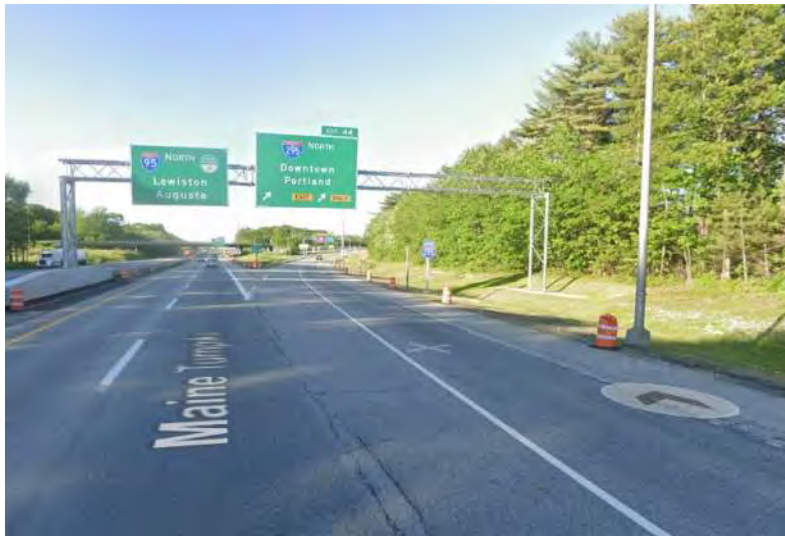
**Photo 3: Exit 44 NB Diverge**

**Photo 3: Exit 44 NB Diverge**, captured by Google Maps<sup>5</sup> in June of 2019, depicts the condition of this location at the time that it was most recently noted as an HCL.

Existing Road Audit	
Road alignment and Cross Section	Both segments included in this RSA are straight and flat, which do not pose any sight distance concerns. The diverge point at Exit 44 NB at the time that it was classified as an HCL was a choice lane.
Lighting	Lighting is present at both the northbound and southbound diverges.
General Sign Issues	Signage is present ahead of both diverges for information including exit information, lane use and advisory speed signs. These signs were updated as a part of the recent construction.
Marking and Delineation	Pavement markings delineating lanes were in good condition at the time that these locations were noted as HCLs. Striping has been updated as a part of the recent construction.
Barriers and Clear Zones	Guardrail and concrete barrier span the median along both segments in this location to separate the northbound and southbound travel directions. Guardrail also exists along portions of the outside of both segments as a safety measure.

Many of the recorded crashes at this location were congestion-related in this high volume area. Since the location has recently been under construction to widen the mainline and Exit 44 ramps to address congestion concerns through the area, the mitigation recommendations will focus around monitoring the area to ensure that the recent improvements are effective in clearing up congestion. Additionally, there were some crashes that involved standing water through the area, so this will also be recommended for monitoring to ensure that the new pavement is effective in draining water from the travel way.

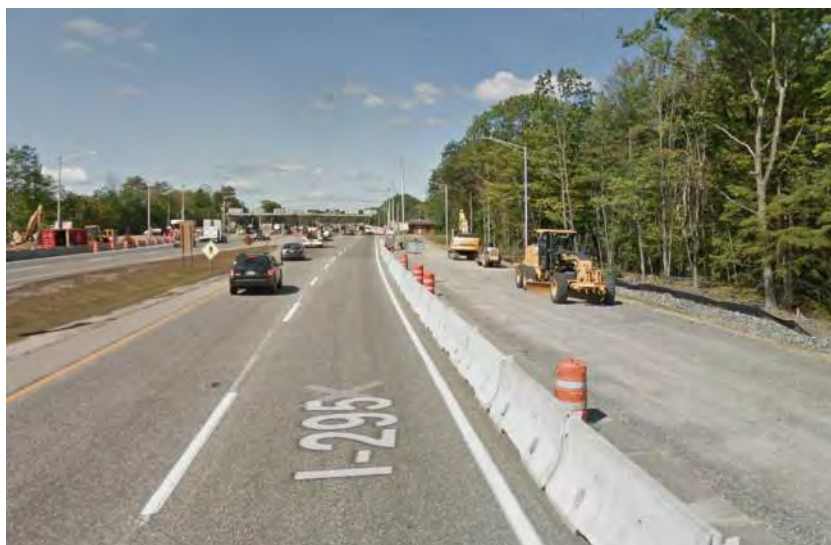
**Photo 1: I-295 WB Toll Plaza** captured by Google Maps<sup>2</sup> in September of 2017 depicts the condition of this location at the time that it was most recently noted as an HCL.

As can be seen from **Photo 1**, this area was under construction during the time in which it was most recently noted as an HCL. For this reason, the safety recommendations will center around monitoring the toll plaza location now that construction has concluded.

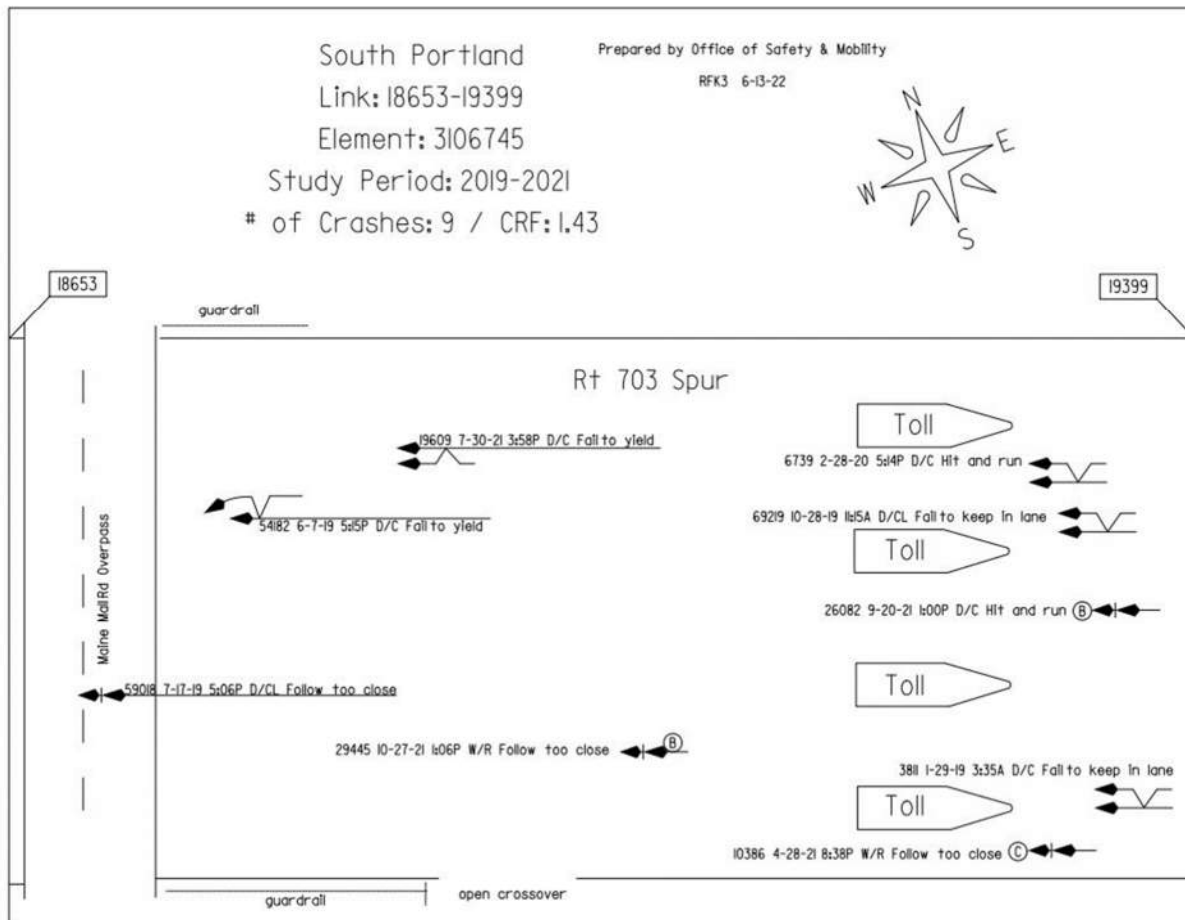
**Figure 1: 2019-2021 Exit 45 On Ramp Toll Plaza Crash Diagram** depicts the toll plaza segment for the most recent time period in which it was identified as an HCL. This location has been classified as an HCL for 4 other time periods over the last 10 years.

As shown in **Figure 1**, there were 9 crashes resulting in a 33.3% injury rate during this analysis period.

- The most common cause of crash at this location is following too close which was a contributing factor for 3 of these 9 crashes
- Failure to yield, failure to keep in lane and hit and runs were the other types of crashes at this location, each contributing to 2 crashes
- 6 of the 9 crashes at this location happened from May to October, the time period in which there is an increased volume at this interchange
- 4 of these recorded crashes happened during the typical PM Peak hours of around 4:00pm to 6:00pm
- 7 of these crashes occurred when the pavement was dry and the weather was either clear or cloudy, while the other 2 happened during rain when the pavement was wet

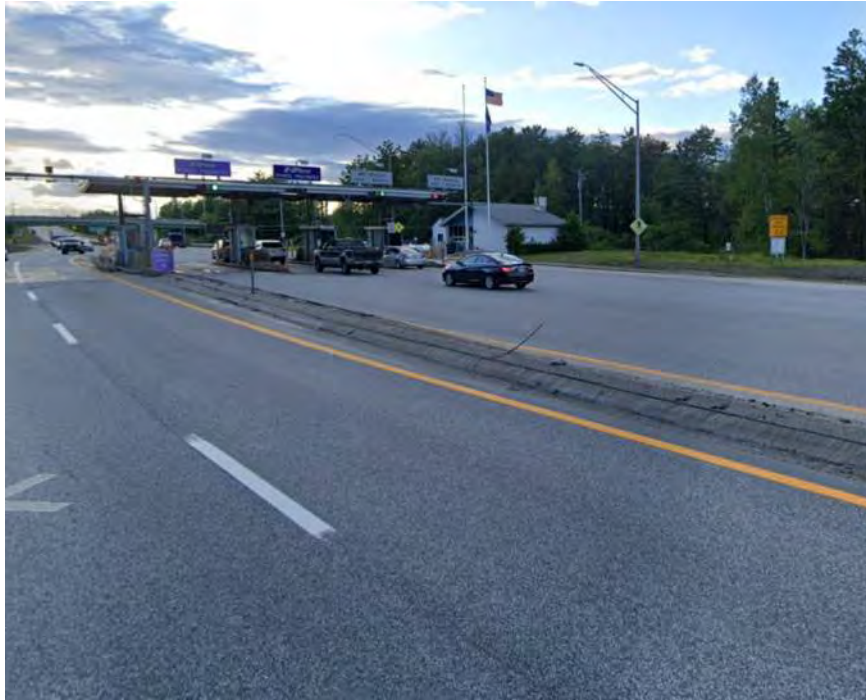
**Photo 1: Exit 45 On Ramp Toll Plaza (2021)**

**Photo 1: Exit 45 On Ramp Toll Plaza (2019)** captured by Google Maps<sup>2</sup> in June of 2019 depicts the condition of this location at the time that it was most recently noted as an HCL.

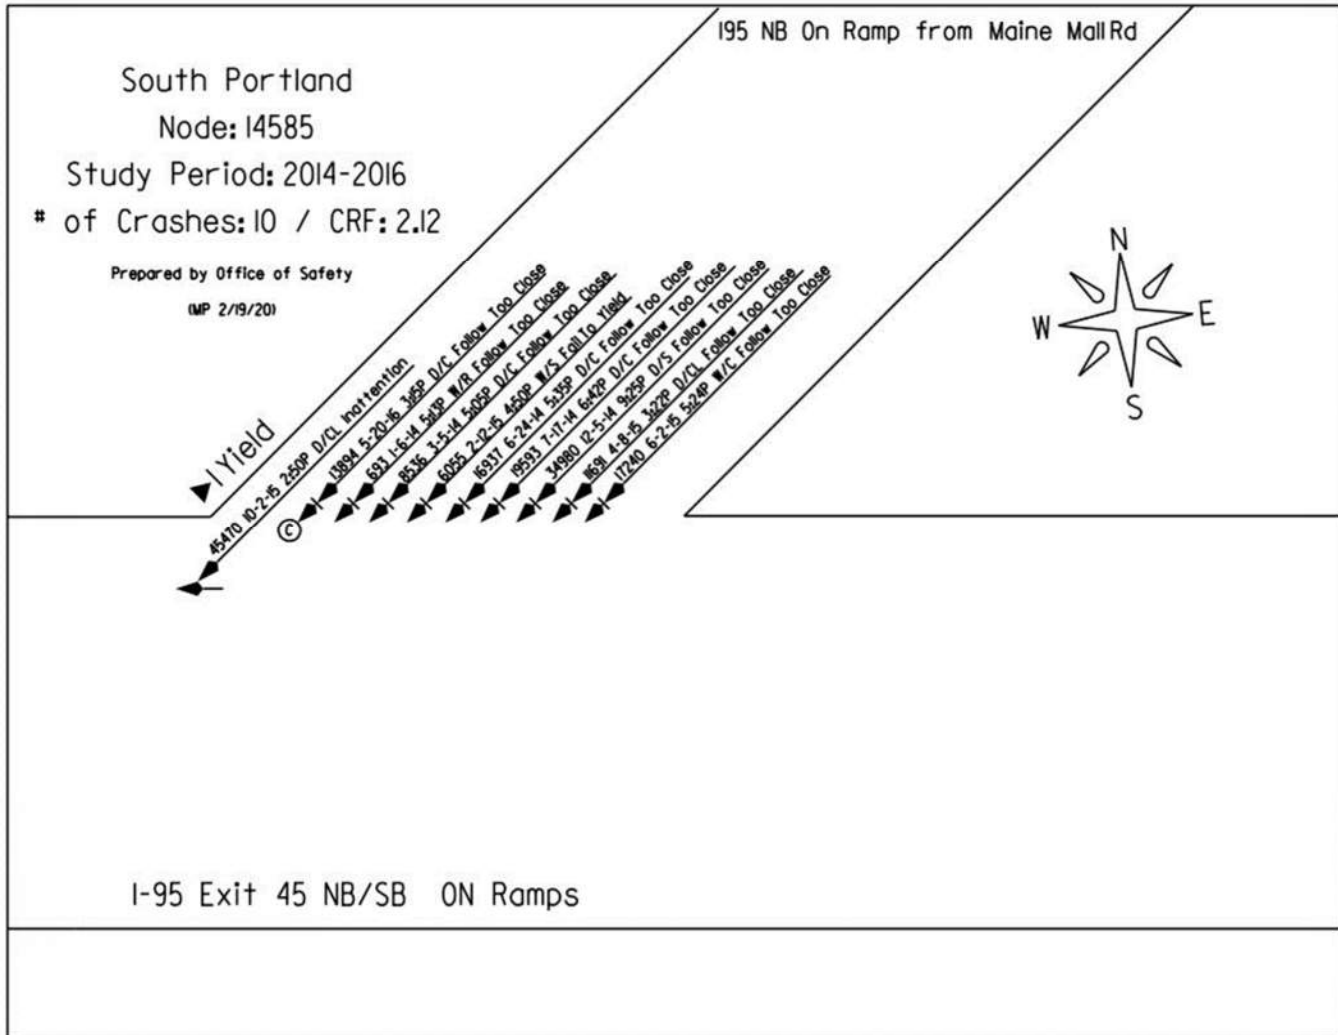
**Figure 2: 2014-2016 Route 703 Merge to Exit 45 On Ramps Crash Diagram** depicts the crash diagram for the merge point of the Maine Turnpike Approach and ramp from Maine Mall Road during the most recent period in which it was identified as an HCL. This location was identified as an HCL for 3 other time periods over the past 10 years.

As shown in **Figure 2**, there were 10 crashes resulting in a 10% injury rate during this analysis period.

- 1 of these crashes was a turning movement crash while the other 9 happened at the ramp from Maine Mall Road approach
- 8 of the 9 crashes at the approach were a result of vehicles following too close
- 5 of these crashes occurred between the months of May and October when there are increased volumes in this area

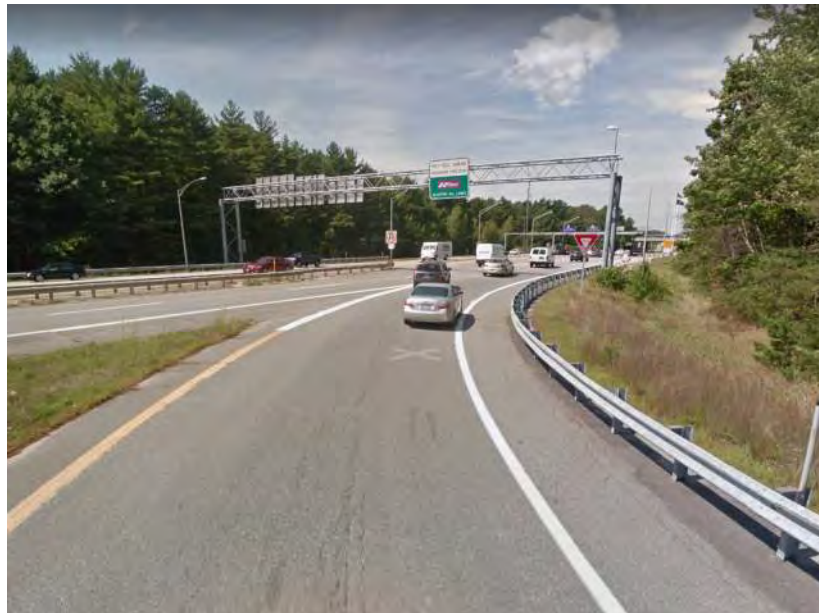
**Photo 2: Route 703 Merge with Exit 45 On Ramps (2016)** captured by Google Maps<sup>3</sup> in August of 2016 depicts the condition of this location at the time that it was most recently noted as an HCL.

Pavement	The pavement along the Maine Mall Road ramp was most recently given a pavement condition rating <sup>6</sup> of F, while the Maine Turnpike Approach pavement along the HCL segment was rated as C and D.

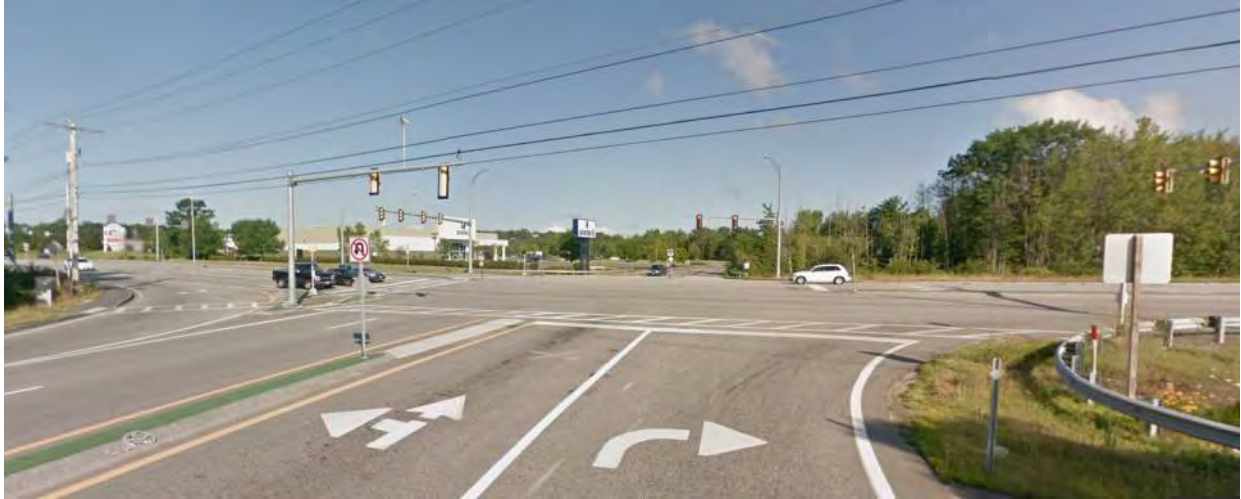
**Photo 1: Exit 45 Off Ramp Intersection (2011)** captured by Google Maps<sup>2</sup> in August of 2011 depicts the condition of this location at the time that it was most recently noted as an HCL.

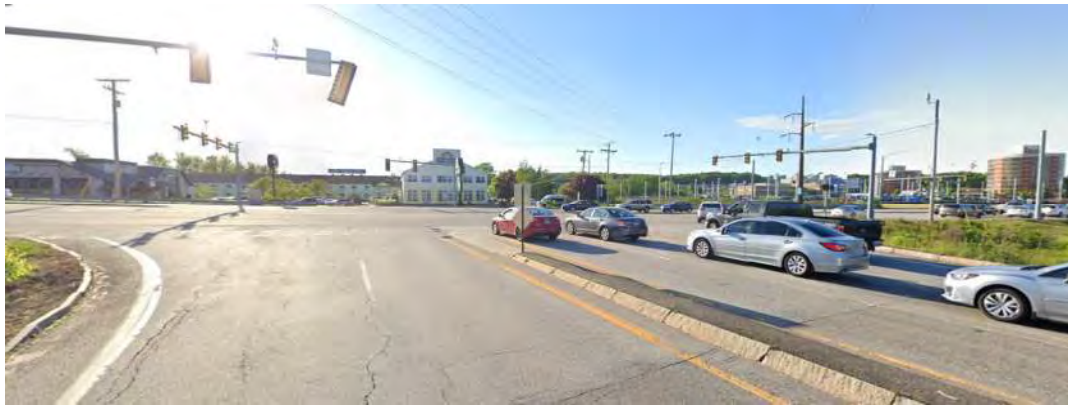
**Photo 3: Exit 45 On Ramps Intersection (2019)** captured by Google Maps<sup>3</sup> in June of 2019 depicts the condition of this location at the time that it was most recently noted as an HCL.

Following too closely was the most common cause of crash at the On Ramp intersection, which is a common crash type at areas that are nearing or at capacity. If this location continues to be an HCL post-construction, its signal timing, phasing and geometry (especially in regards to lane use) should be evaluated for traffic flow improvement.

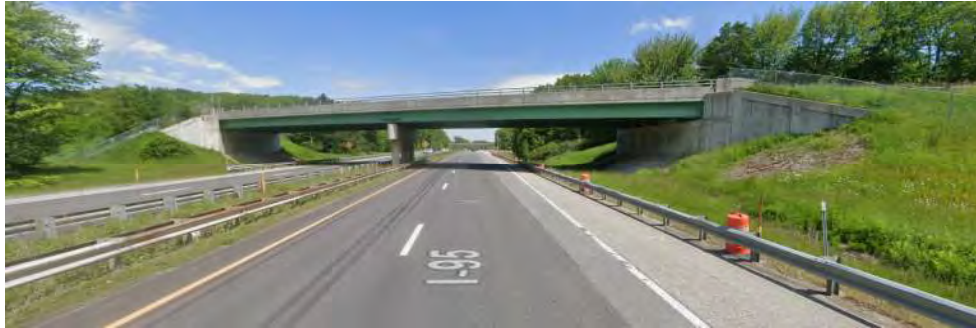
**Photo 1: I-95 NB South of Exit 47 Off Ramp (2019)** captured by Google Maps<sup>2</sup> in June of 2019 depicts the condition of this location at the time that it was most recently noted as an HCL.

Existing Road Audit <sup>3</sup>	
Road alignment and Cross Section	This segment is along slight horizontal and vertical curvature. However, the curves are not so abrupt as to create sight distance concerns.
Lighting	Lighting spans the beginning portion of this mainline segment and can also be found around the Exit 47 interchange.
General Sign Issues	Typical signage through this area is to notify drivers of the upcoming Exit 47 interchange. Under current conditions, this segment has temporary construction signage throughout.
Marking and Delineation	Temporary pavement markings are currently along the entirety of this segment to designate the temporary lane configuration.
Barriers and Clear Zones	While guardrail could be found spanning both sides of the roadway pre-construction, it is currently along the inside of the roadway to separate the northbound and southbound travel directions while construction barrels can be found along the outside of the travel way.

Over the past 10 years, this location has recently began being classified as an HCL. Many of the crashes at this location were consistent with locations that experience high volumes and congestion. Since this location is currently undergoing widening construction to address this congestion, the mitigation recommendations will focus around monitoring the location post-construction for any remaining and/or resultant safety concerns.

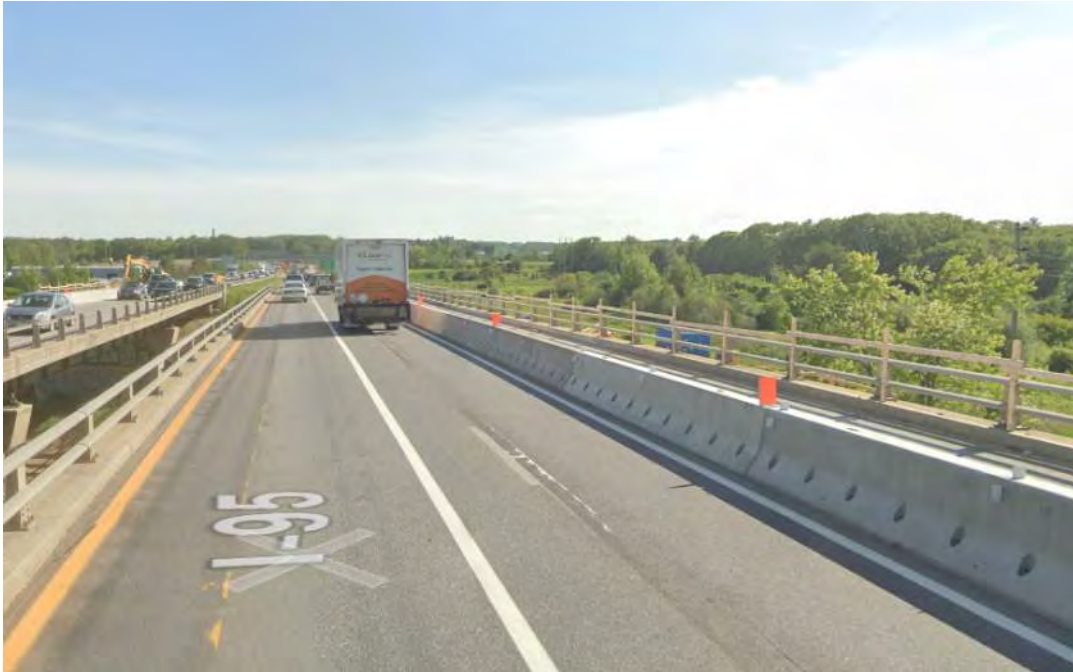
**Photo 1: I-95 SB Just North of Exit 47 Off Ramp (2019)** captured by Google Maps<sup>2</sup> in June of 2019 depicts the condition of this location at the time that it was most recently noted as an HCL.

Existing Road Audit	
Road alignment and Cross Section	This roadway segment is straight with some vertical curvature at the bridge over the railroad crossing. This is not steep enough of a curve to create sight distance concerns.
Lighting	Some temporary lighting currently spans this area as a part of the construction setup. Permanent lighting exists around the Exit 47 interchange.
General Sign Issues	Signage for the Exit 47 interchange can be found along this mainline segment.
Marking and Delineation	As can be seen in <b>Photo 1</b> , this location has recently been under temporary configuration and is adequately striped as such. Markings designate lane separation throughout the segment.
Barriers and Clear Zones	Guardrail, concrete barrier and bridge rail can be found along the median through the entirety of this segment to separate the northbound and southbound travel directions. Under the temporary construction conditions, concrete barrier is currently along the outside of the roadway.

Over the past 10 years, this location has recently began being classified as an HCL. Many of the crashes at this location were consistent with locations that experience high volumes and congestion. Since this location is currently undergoing widening construction to address this congestion, the mitigation recommendations will focus around monitoring the location post-construction for any remaining and/or resultant safety concerns.

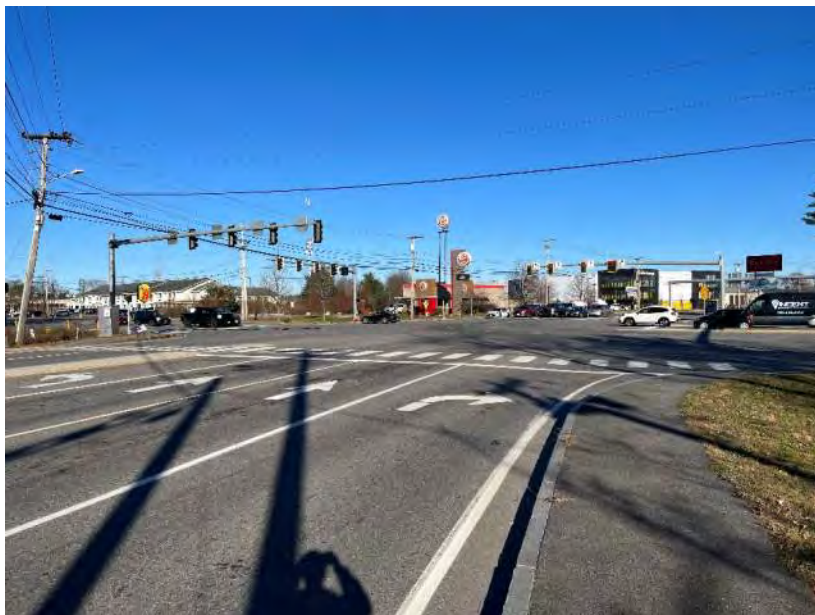
**Photo 1: Exit 48 Intersection (2022)** captured by HNTB in November of 2022 depicts the condition of this location at the time that it was most recently noted as an HCL.

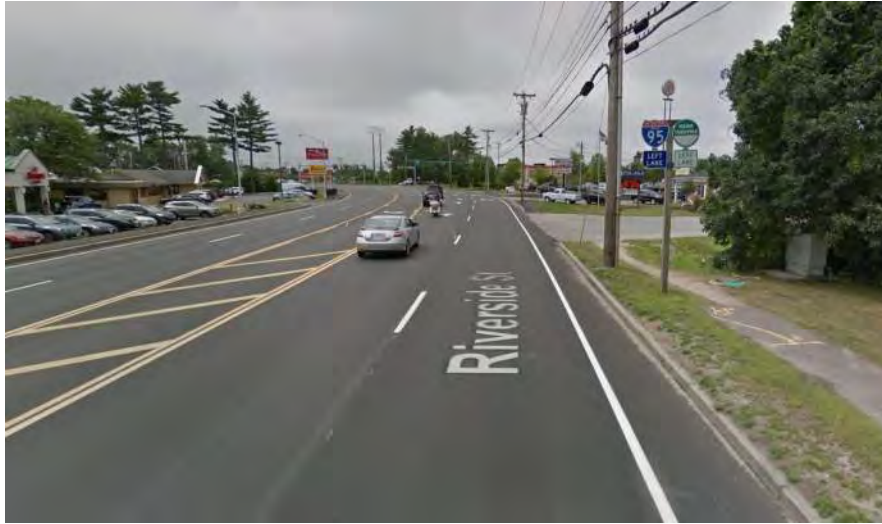
**Photo 2: Riverside Street Southbound Approach (2018)** captured by Google Maps<sup>3</sup> in July of 2018 depicts the condition of this location at the time that it was most recently noted as an HCL.
