# 2022 Systemwide Safety and Capacity Study

June 30, 2023

Maine Turnpike Authority  
2360 Congress Street  
Portland, ME 04102

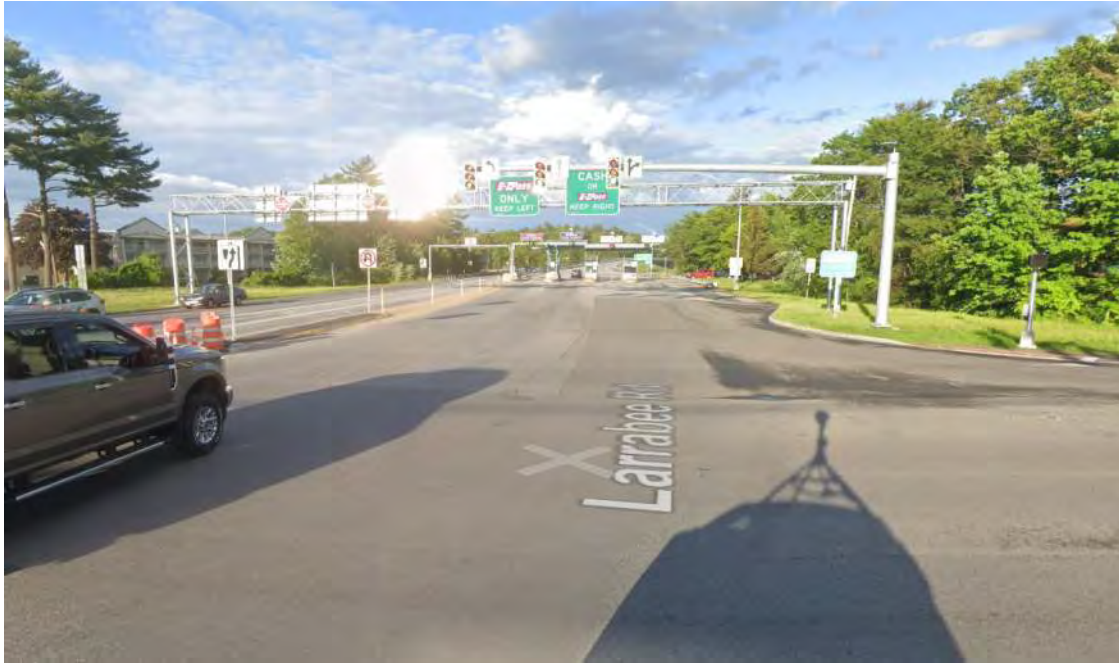
**Photo 3: Exit 48 Toll Plaza Approach (2019)** captured by Google Maps<sup>4</sup> in June of 2019 depicts the condition of this location at the time that it was most recently noted as an HCL.

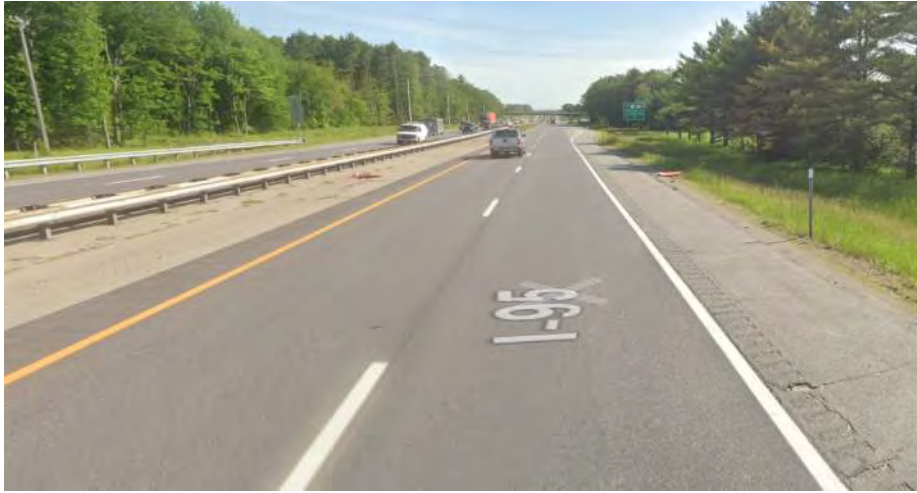
**Photo 1: Exit 48 Southbound Approach (2019)** captured by Google Maps<sup>2</sup> in June of 2019 depicts the condition of this location at the time that it was most recently noted as an HCL.

Existing Road Audit	
Road alignment and Cross Section	This segment of roadway is straight and flat, allowing for good sight distance.
Lighting	Lighting can be found along this segment near the Exit 48 interchange.
General Sign Issues	This segment includes signage for the Exit 48 interchange.
Marking and Delineation	Adequate markings exist along this mainline segment to separate travel lanes and shoulders.
Barriers and Clear Zones	Guardrail and concrete barrier separate the northbound and southbound travel directions of I-95 along this segment. Guardrail is also present at some locations along the outside of the travel way through the segment.
Bridges and Culverts	Bridge 1486 carries Warren Ave over this mainline segment and has components which have been given condition ratings <sup>3</sup> of good and very good.
Pavement	The pavement along this segment has been given a pavement condition rating <sup>4</sup> of A.

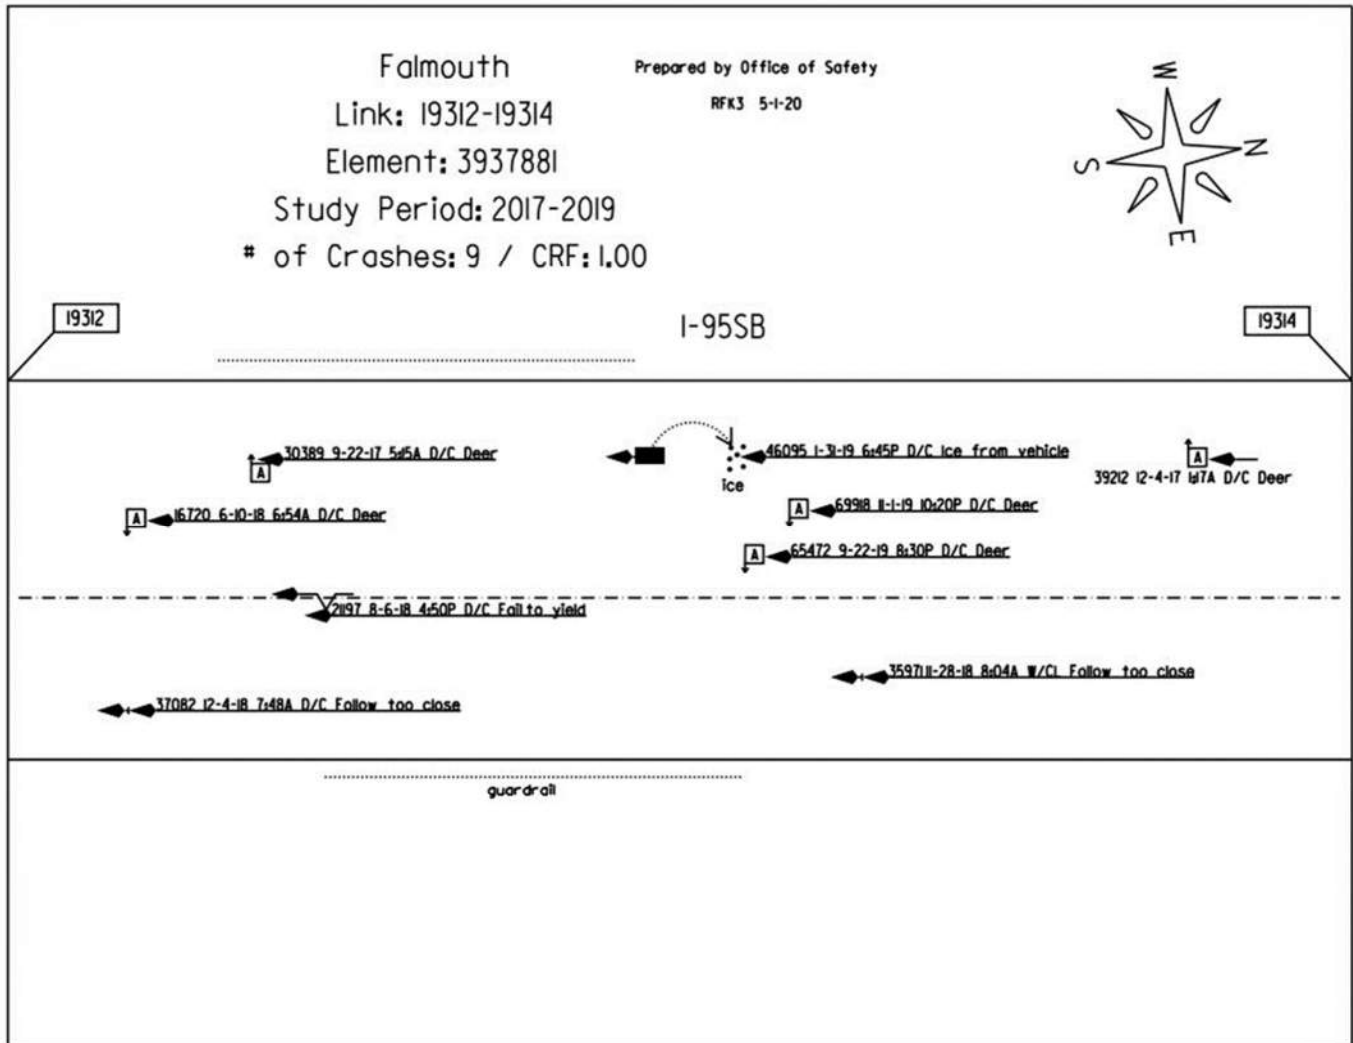
**Figure 2: 2017-2019 Mile Marker 52-53 Southbound Crash Diagram**

As shown in **Figure 2**, there were 9 crashes resulting in a 0% injury rate during this analysis period.

- Collisions with deer was the most common type of crash at this location with 5 crashes
- 2 of the crashes at this location were a result of vehicles following too close
- 5 of the 9 crashes at this location occurred between the winter months of November to January
- All but 1 of these crashes occurred when the roadway was dry and the weather was either clear or cloudy
- There is not a strong correlation between time of day and crash frequency at this location

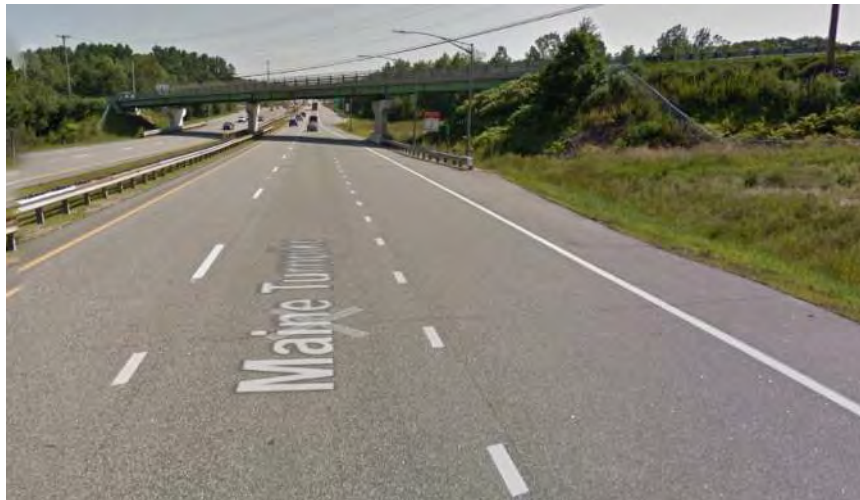
**Photo 1: Just South of Exit 53 Southbound On Ramp**

Existing Road Audit	
Road alignment and Cross Section	This roadway segment is straight and flat, creating good sight distance conditions.
Lighting	Lighting can be found at the northerly end of this segment near the Exit 53 interchange and the Blackstrap Road overpass.
General Sign Issues	There is signing along this segment for the Exit 52 interchange.
Marking and Delineation	This segment has adequate pavement markings to separate travel lanes as well as shoulders.
Barriers and Clear Zones	Guardrail spans the entirety of the inside of the roadway along this segment to separate the northbound and southbound travel directions. Lengths of guardrail can also be found along the outside of the roadway to protect against hazards including bridge abutments and steep side slopes.
Bridges and Culverts	Bridge 0283 carries Blackstrap Road over this mainline segment and has components which have been given condition ratings <sup>3</sup> of satisfactory and good.  Bridge 1489 is the southerly endpoint of this segment and carries I-95 SB over the Presumpscot River. This bridge has been given condition ratings of satisfactory and good.

Pavement	The pavement along this segment has been given a pavement condition rating <sup>4</sup> of B.
Heavy Vehicles	This segment tends to average around 5% to 8% heavy vehicles.

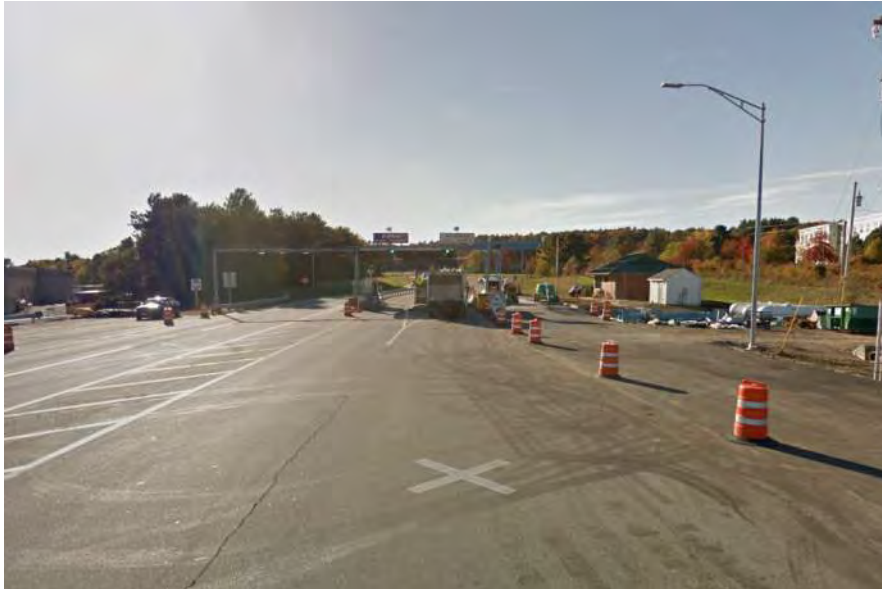
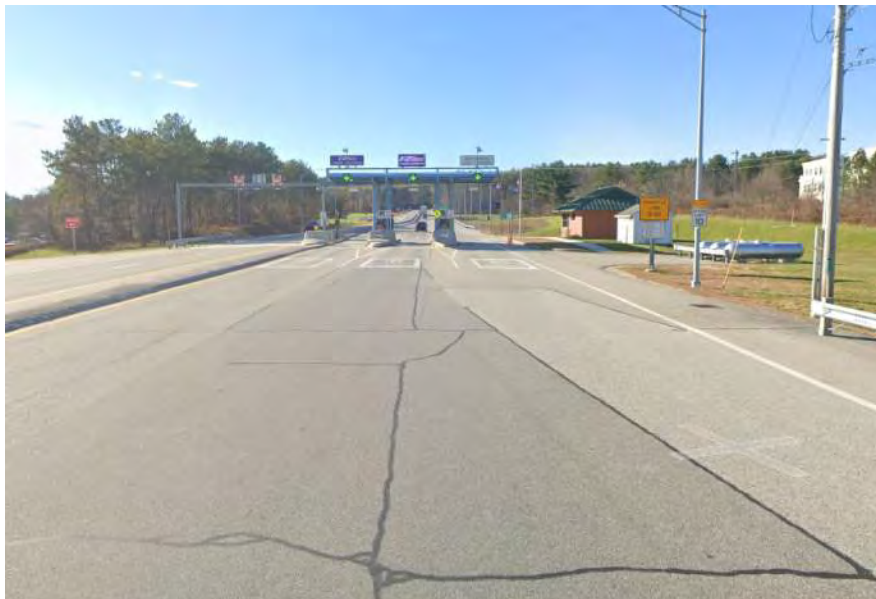
**Photo 1: Exit 53 Toll Plaza (2016)**

- 3 of these crashes occurred on the on ramp side of the segment while the other 3 were on the off ramp side
- The most common cause of crash at this location was improper lane change, which contributed to 3 crashes
  - All 3 of these crashes occurred within the weave segment of the off ramp
- The next most common cause is following too close which contributed to 2 crashes
- 1 of these crashes involved a heavy vehicle
- 5 of these 9 crashes occurred between the months of December to February
- The two most common times of crash at this location were the noontime and PM peak hours, with 4 crashes occurring between 12:30pm and 2:00pm, and 4 crashes occurring from approximately 4:00pm – 5:30pm

Existing Road Audit <sup>2</sup>	
Road alignment and Cross Section	This roadway segment is straight and flat, with the toll plaza being the only obstruction to sight distance.
Lighting	Lighting is present throughout this segment.
General Sign Issues	Signage is present through this segment to designate things such as toll plaza collection types by lane and lane designation upon approach the adjacent intersection.

Marking and Delineation	There are adequate pavement markings through this location which help to separate lanes and guide vehicles through the toll plaza.
Barriers and Clear Zones	Guardrail and asphalt medians separate the travel directions through this segment. Some guardrail spans can be found on the outside of the roadway through the segment.
Bridges and Culverts	No bridges or culverts exist along this segment.
Pavement	The pavement along this segment has been given a pavement condition rating <sup>3</sup> of C.
Heavy Vehicles	The percentage of heavy vehicles at this location tends to 0% - 3%

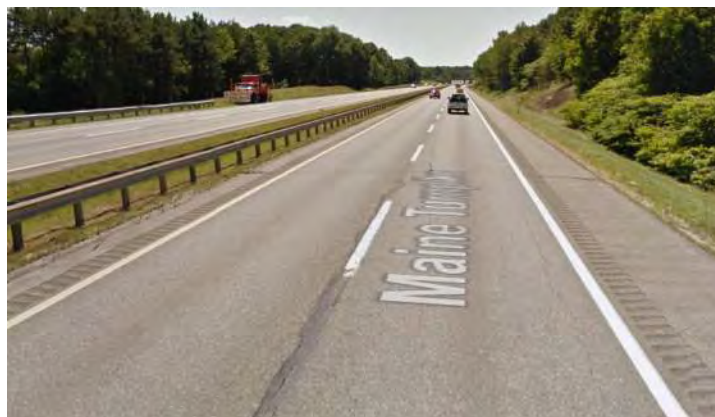
**Photo 1: I-95 SB Between Mountain and Leighton Road (2011)**

It can be observed from this table that there were 10 crashes at this location with a 25% injury rate during this time period.

Pavement	The pavement along this segment has been given a pavement condition rating of C.
Heavy Vehicles	This mainline segment has percentages of heavy vehicles that tend to average around 5% to 8%.

The majority of crashes in this location were the result of going off the road, however, this area has not been identified as an HCL since 2013. For this reason, recommendations will focus around continuing to monitor the location for any future safety concerns.

- No recommendations at this time – continue monitoring as part of future studies.

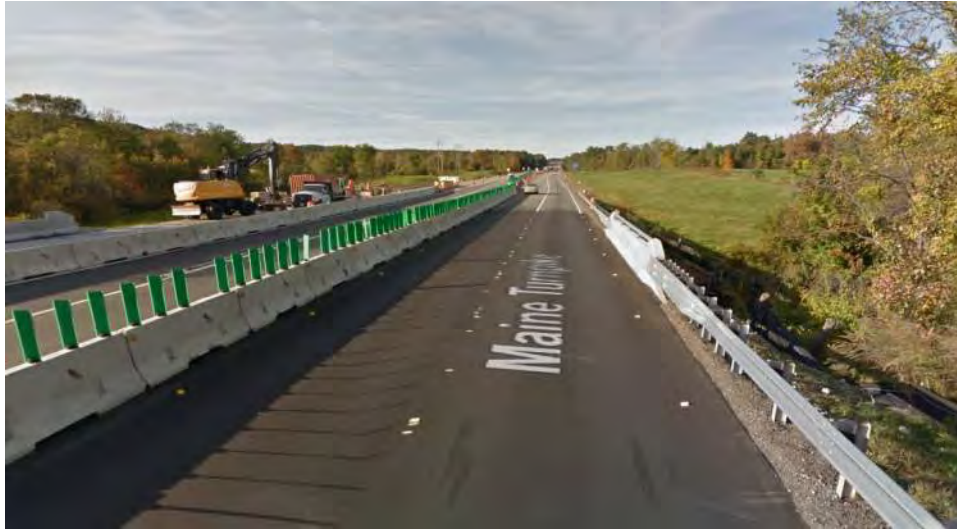
**Photo 1: NB Just North of Hurricane Road (2015)**

It can be observed from this table that there were 13 crashes at this location with a 10.4% injury rate during this time period.

Existing Road Audit	
Road alignment and Cross Section	The northbound segment of this location is straight and flat. The southbound segment has some horizontal curvature, but does not create sight distance concerns.
Lighting	The southbound segment has lighting along the northern portion of it.
General Sign Issues	Signage exists along the segments to denote mile marker locations.
Marking and Delineation	Adequate markings exist along the entirety of the segments to separate travel lanes as well as shoulders.
Barriers and Clear Zones	Guardrail is along the median of the roadway for the entire length of both segments to separate the northbound and southbound travel directions. Guardrail is along the majority of the outside of both segments.
Bridges and Culverts	Along the northbound segment, bridge 0280 carries Hurricane Road over I-95 and bridge 0284 carries I-95 NB over the Piscataqua River. At the northern segment, bridge 0285 carries Blackstrap Road over I-95. The condition ratings <sup>4</sup> that components of each of these bridges has been given can be found below: <ul style="list-style-type: none"> <li>• 0280: Good and Satisfactory</li> </ul>

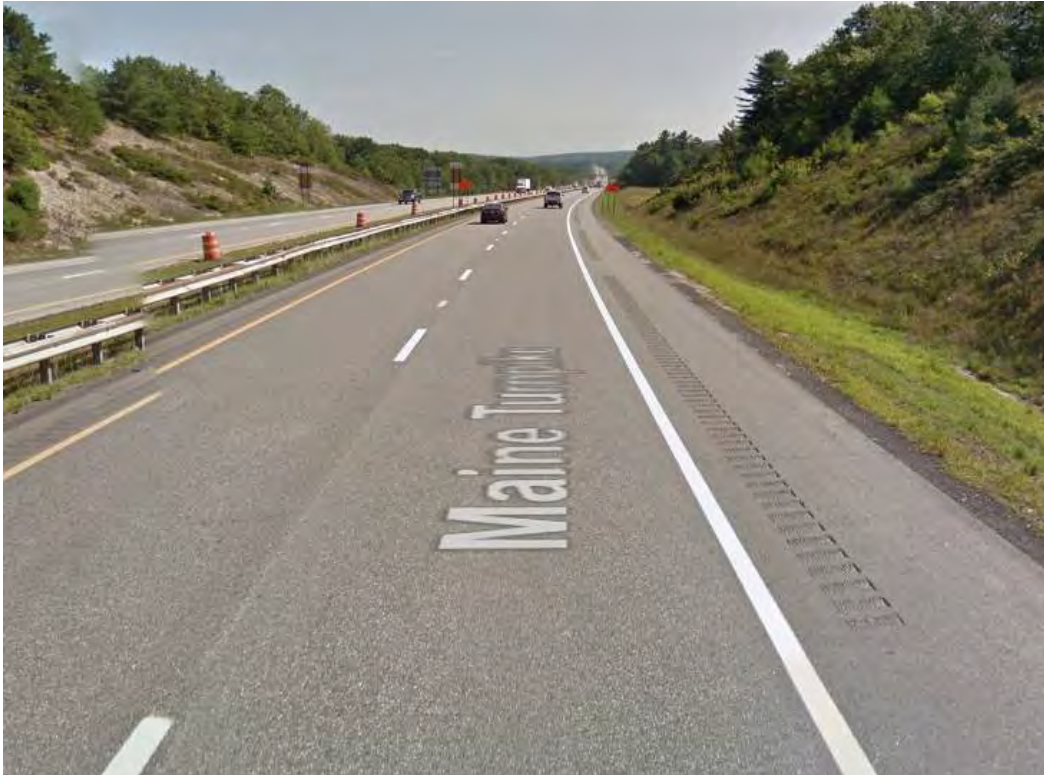
**Photo 2: SB South of Upper Blackstrap Road (2018)**

- The leading cause of crash in this location is speed, which contributed to 11 crashes
- Collisions with animals was the next most common type of crash, with 6 total crashes
- 2 Of the crashes at this location involved heavy vehicles
- 16 of the crashes at this location resulted in vehicles departing from the travel way
  - 13 of these 16 roadway departures resulted in vehicles colliding with guardrail
- 11 of the crashes at this location occurred between the summer months of June to August
- There is not a strong correlation between time of day and crash frequency at this location

<ul style="list-style-type: none"> <li>• 0284: Very Good and Satisfactory</li> <li>• 0285: Good and Satisfactory</li> </ul>
Pavement	Both segments have pavement which was given pavement condition ratings <sup>5</sup> of B.
Heavy Vehicles	The percentages of heavy vehicles through this area ranges from 4% to 13%, depending on direction and time of day.

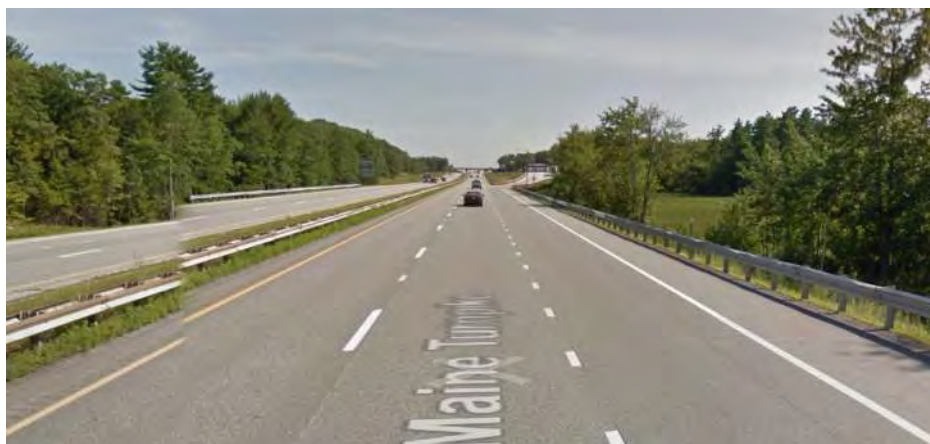
**Photo 1: North of SB Service Plaza**

- The most common cause of crash at this location was speed, which contributed to 3 crashes
- The next most common cause was following too close which contributed to 2 crashes
- 4 of the crashes at this location resulted in vehicles departing from the roadway
  - 1 of these 4 resulted in collision with guardrail
- 4 of the 9 crashes at this location occurred between February and April
- The majority of crashes at this location occurred in the morning, with 5 crashes happening between approximately 5:30am and 9:00am

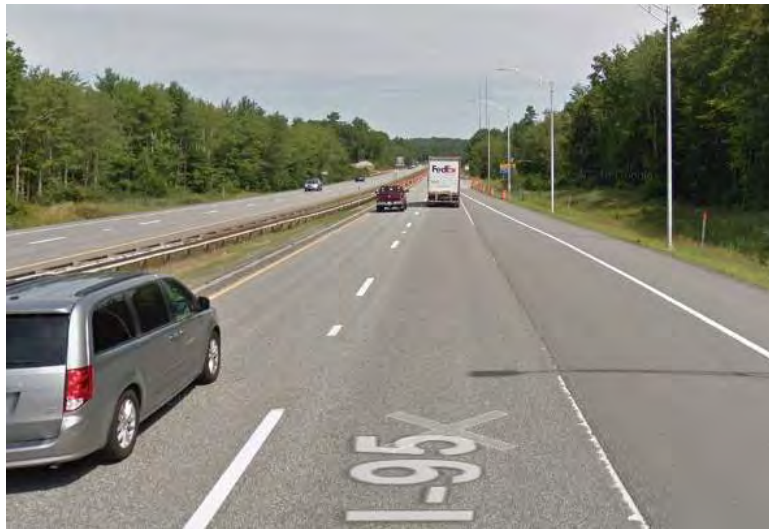
**Photo 2: NB North of Gray Service Plaza (2018)**

- The two most common causes of crash at this location are collisions with animals and failure to keep in lane, each while contributed to 2 crashes
  - One of the failure to keep in lane crashes occurred in construction conditions when the left lane was closed
- 2 of the crashes at this location resulted in vehicles departing from the travel way and colliding with guardrail
- There does not appear to be a strong correlation between time of year and crash frequency
- Many of the crashes at this location occurred during the early morning, with 4 crashes being recorded between 2:00am and 7:00am

Existing Road Audit	
Road alignment and Cross Section	Both segments at this location are straight and flat which does not create sight distance concerns.
Lighting	Lighting can be found along the northbound segment at this location.
General Sign Issues	Signage along the SB segment with information for the Cumberland Service Plaza.
Marking and Delineation	Adequate markings exist along the entirety of the segments to separate travel lanes as well as shoulders.
Barriers and Clear Zones	Guardrail is along the median of the roadway for the entire length of both segments to separate the northbound and southbound travel directions. Guardrail is along portions of the outside of both segments.
Bridges and Culverts	No bridges or culverts exist along the segments included in this RSA.
Pavement	Both HCL segments at this location have pavement that have been given pavement condition ratings <sup>4</sup> of B.

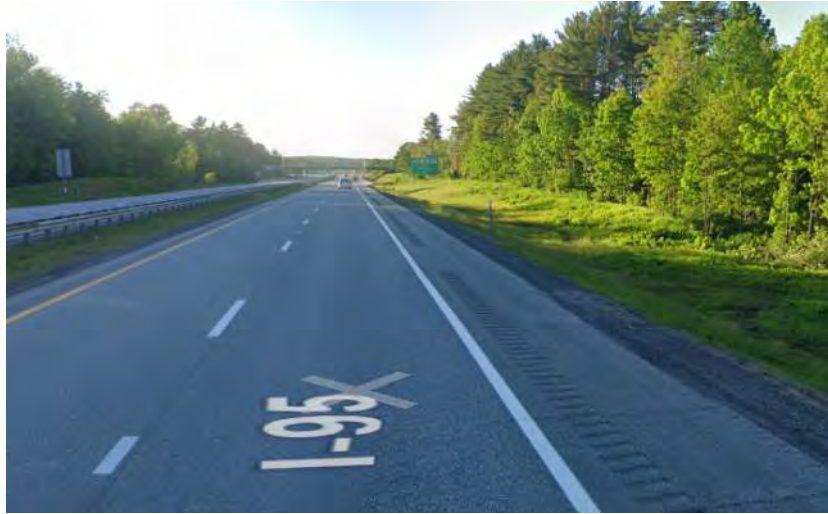
**Photo 1: South of Exit 63 Off Ramp (2019)**

- The most common crash type at this location was following too close, which cause 4 crashes
- 3 crashes at this location were caused by collisions with animals
- 4 of these 10 crashes resulted in vehicles departing from the roadway
- 1 of these crashes was a work zone crashes
- 3 of these crashes occurred during the month of June, while 4 occurred between the months of October and December
- 6 of these crashes occurred during typical PM peak hours of approximately 4:30pm to 6:30pm

Existing Road Audit	
Road alignment and Cross Section	Both segments at this location are straight and flat which does not create sight distance concerns.
Lighting	Lighting can be found along both segments near the Exit 63 interchange.
General Sign Issues	Signing exists along both segments. Signing along the NB segment is to notify drivers of the Exit 63 interchange.
Marking and Delineation	Adequate markings exist along the entirety of the segments to separate travel lanes as well as shoulders.
Barriers and Clear Zones	Guardrail is along the median of the roadway for the entire length of both segments to separate the northbound and southbound travel directions.
Bridges and Culverts	Bridge 0288 carries Center Road over both segments at this location and has components which have been given condition ratings <sup>4</sup> of fair and good.
Pavement	The pavement along the NB segment has been given a pavement condition rating <sup>5</sup> of B, while the SB segment has been given a pavement condition rating of C.

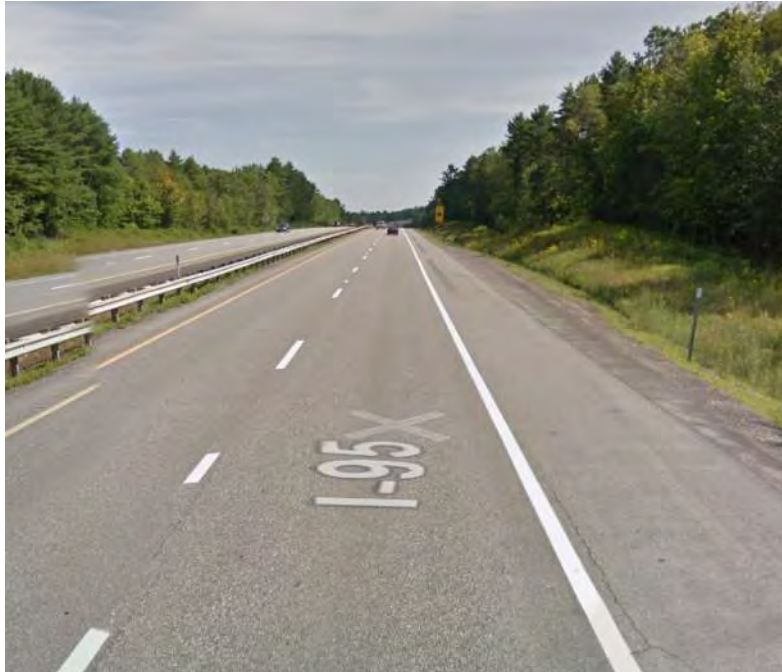
**Photo 2: SB South of Exit 63 On Ramp (2018)**

- The most common cause of crash at this location was failure to yield, which contributed to 4 crashes
- 2 of these crashes were collisions with large animals
- 6 of these 9 vehicles were sideswipe-type crashes
- 1 of these crashes involved a heavy vehicle
- 1 of these crashes resulted in a vehicle departing from the travel way
- 4 of these crashes occurred in the months of November and December
- 4 of the crashes occurred between 12:00pm and 2:00pm

Failure to stay in lane crashes are also common at this location. The area should be continued to be monitored for this concern.

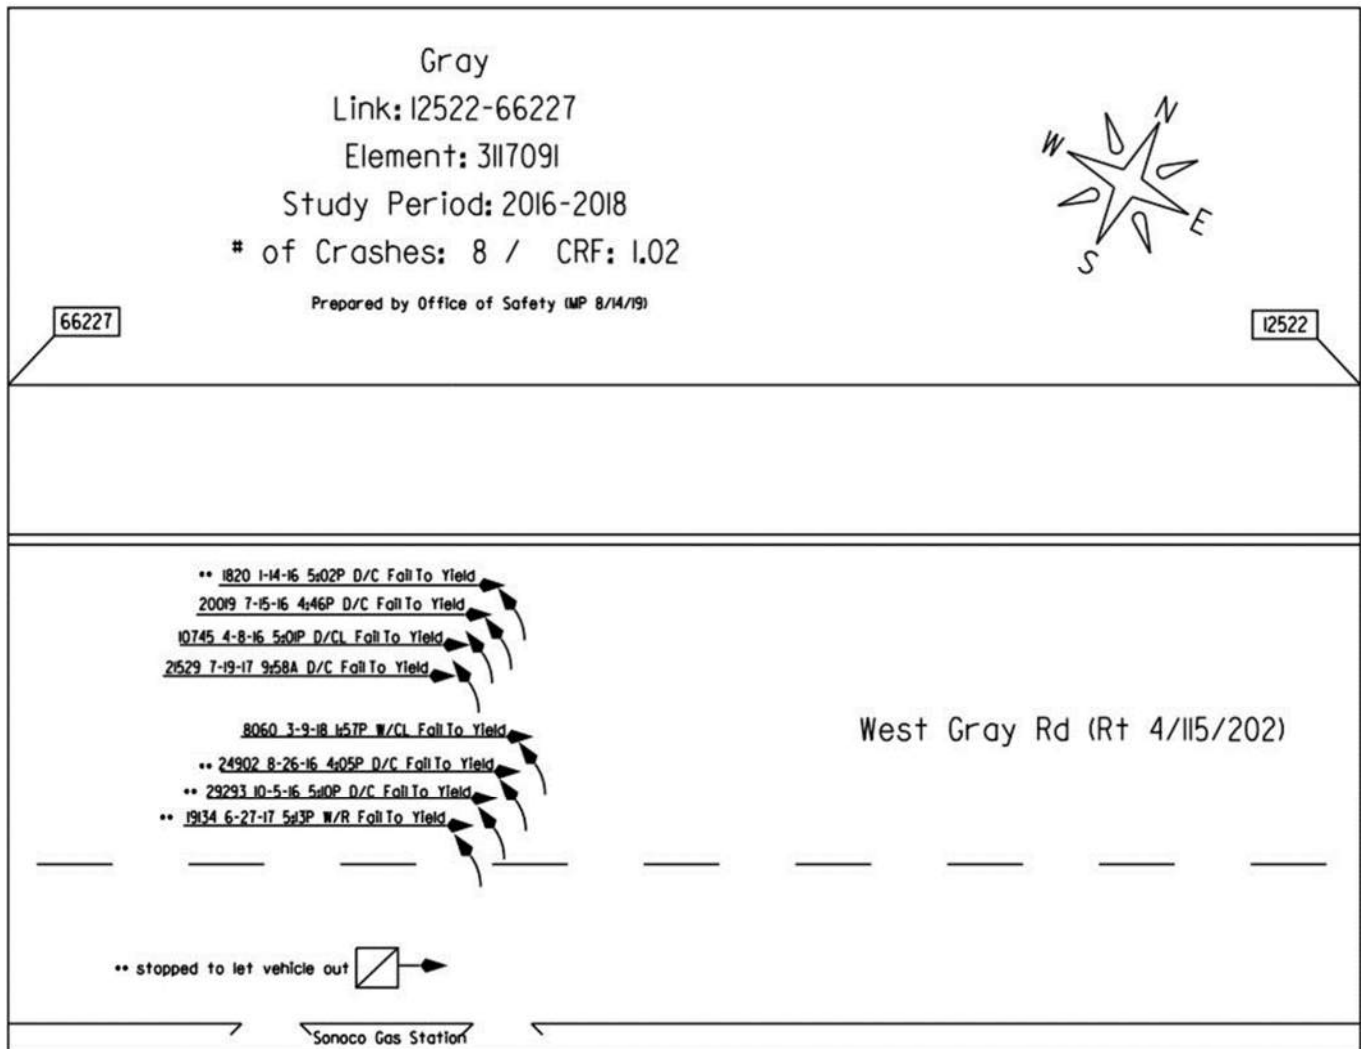
**Figure 2: 2016-2018 WB NB Ramps Intersection Approach Crash Diagram**

As shown in **Figure 2**, there were 8 crashes resulting in a 0% injury rate during this analysis period.

- All of the recorded crashes at this location were between vehicles traveling EB and vehicles attempting to take a left turning movement out of the Sonoco Gas Station
  - 4 of these occurred as vehicles were stopped to let the vehicles out
- 4 of the crashes at this location occurred during the months of June through August
- 6 of the crashes occurred during the PM Peak hours of 4:00pm to 5:30pm

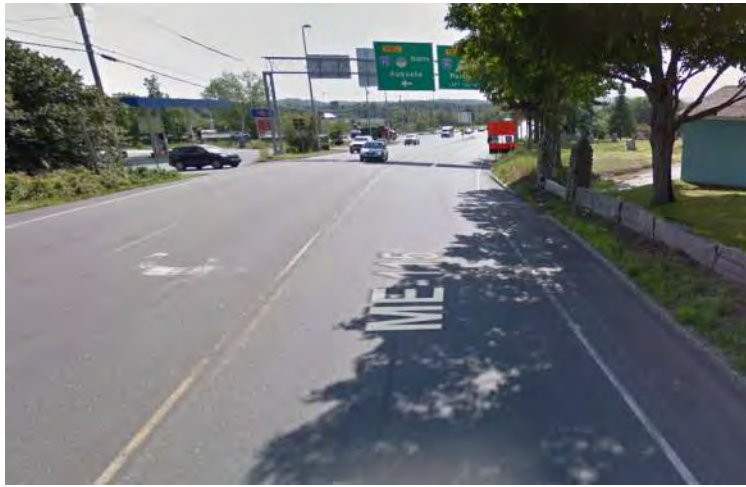
**Photo 1: NB Ramps Intersection WB Approach (2018)**

Existing Road Audit	
Road alignment and Cross Section	The W. Gray Road approach to the NB Ramps intersection is a flat segment of roadway with some curvature to it.  The SB Ramps intersection location is flat, and all approaches are straight at the intersection and do not approach the intersection at any skew.
Lighting	There is lighting at both intersections.
General Sign Issues	There is signage at the SB ramps intersection which includes information including lane usage, route guidance and movement restrictions.
Marking and Delineation	Markings at the NB Ramp approach segment designate lane use and separate travel lanes and directions. At the intersections, markings separate lanes at each approach and designate turning lane use.
Barriers and Clear Zones	Guardrail exists along the NB approach of the SB ramps intersection which then wraps to the southern corners of the intersection. Asphalt medians can also be found at each approach to separate travel directions.

Rear-end collisions at the Exit 63 SB intersection and movements at the Sunoco Gas Station are the most prominent crash patterns at these intersections. Recommendations will focus around evaluating the intersection signal timing and phasing to determine whether this could be a potential cause of the safety concerns.

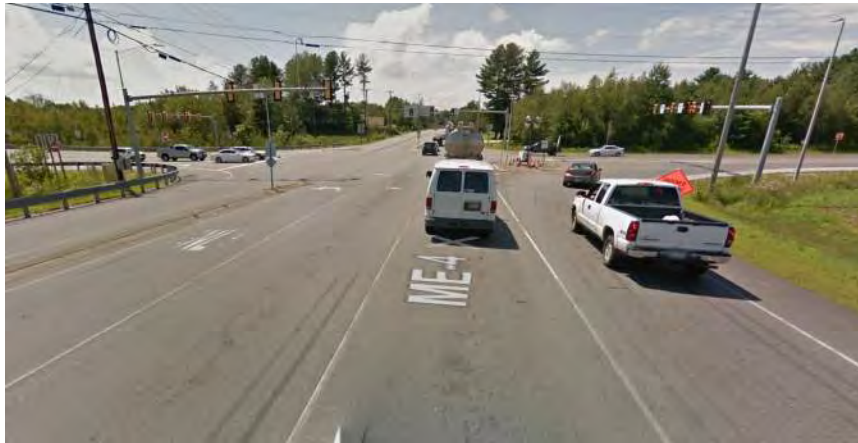
**Photo 2: SB Ramps Intersection (2018)**

- The leading cause of crash at this location is following too close, which contributed to 16 of the 35 crashes at this location
- The next most common crash cause was failure to yield, which contributed to 8 crashes
- 10 of these 35 crashes were turning movement crashes
  - The most common crash causes at turning movement crashes were running red lights and failure to keep in lane
- The Wildlife Parkway SB Approach and the W. Gray Road WB Approach were the most common locations of crash at this intersection
- There is not a strong correlation between time of year and crash frequency at this location
- Many of the crashes at this location occurred during typical AM Peak hours of travel

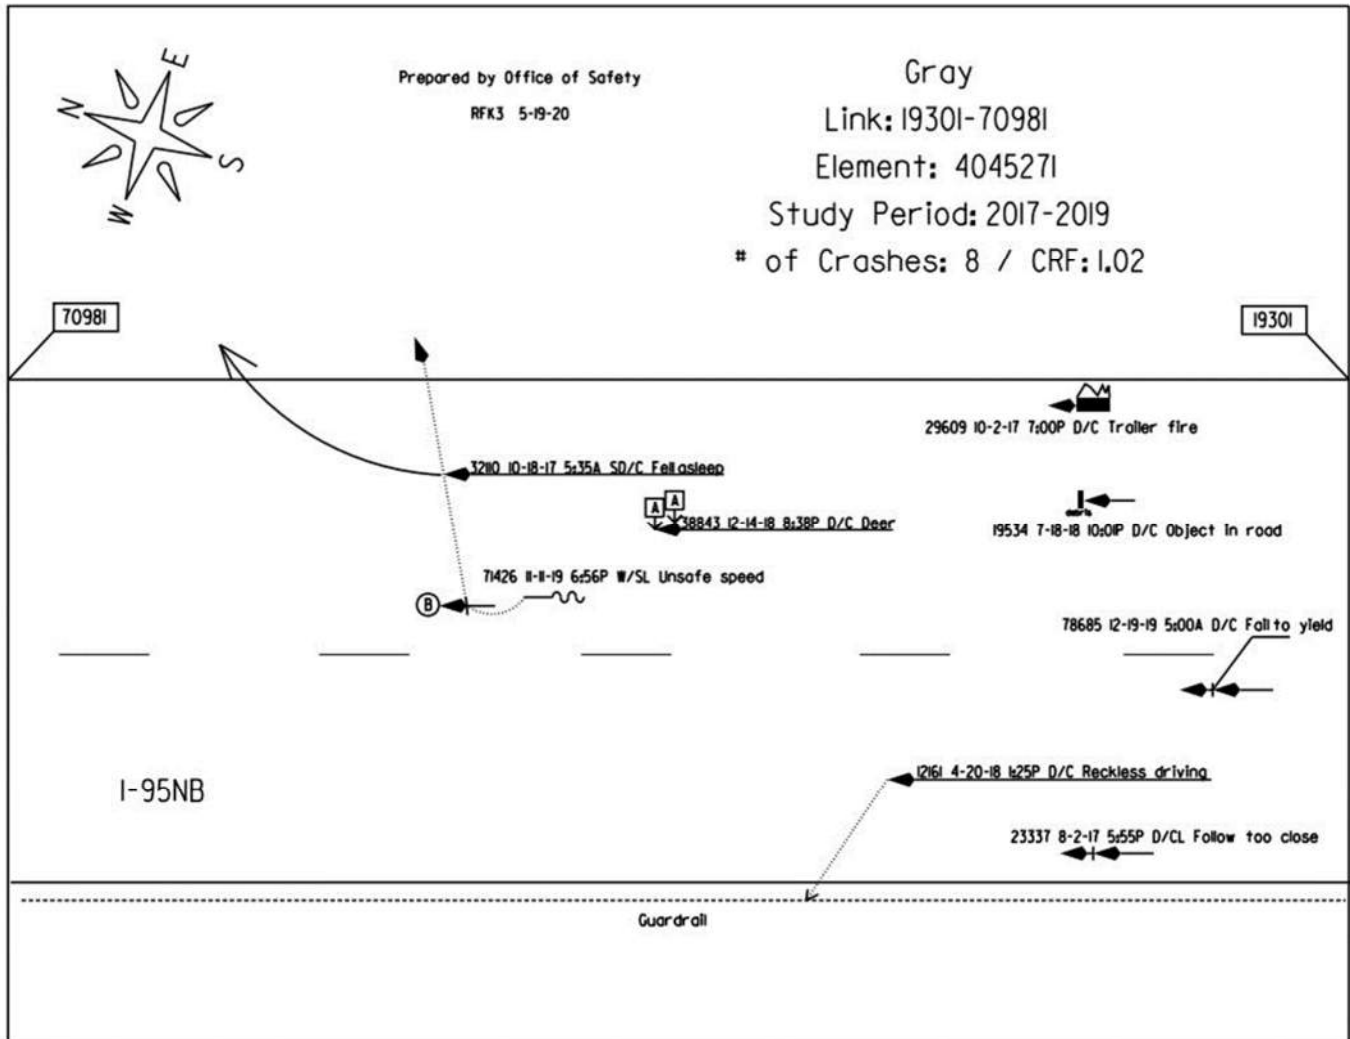
**Figure 2: 2017-2019 Immediately North of Exit 63 NB On Ramp Crash Diagram**

As shown in **Figure 2**, there were 8 crashes resulting in a 12.5% injury rate during this analysis period.

- There are no crash types that repeated along this segment during this time period
- There was 1 crash which involved a heavy vehicle
- 3 of the crashes in this location resulted in vehicles departing from the travel way
  - 1 of these 3 resulted in a vehicle colliding with guardrail
- 5 of these 8 crashes occurred during the months from October through December
- The majority of the crashes at this location occurred during evening hours

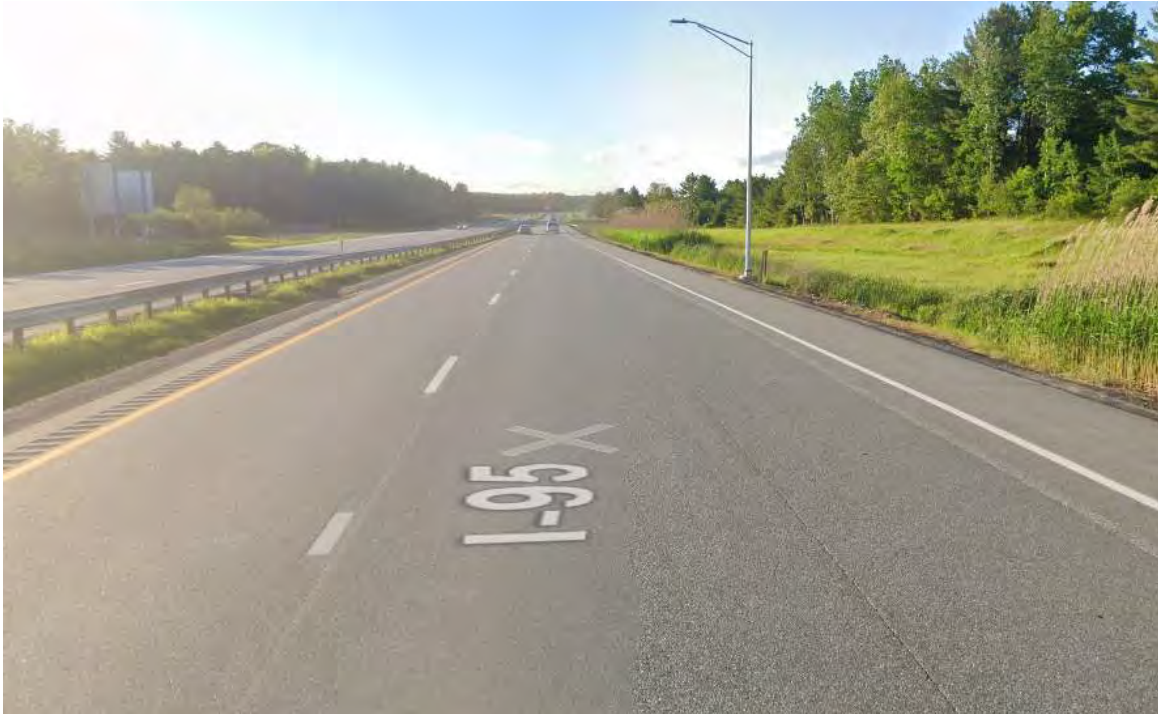
**Photo 1: Just North of Exit 63 NB On Ramp (2019)**

Existing Road Audit	
Road alignment and Cross Section	Both segments at this location are straight and flat which does not create sight distance concerns.
Lighting	Lighting exists along the southern segment near the Exit 63 interchange.
General Sign Issues	Signing exists through this location which includes animal warning signs.
Marking and Delineation	This location is adequately marked to separate lanes as well as shoulders.
Barriers and Clear Zones	Guardrail is along the inside of the roadway to separate the northbound and southbound travel directions. There is also a guardrail run along the outside of the northern segment.
Bridges and Culverts	Bridge 0289 carries W. Gray Road over I-95 at the southern end of these segments and has components which have been given condition ratings <sup>4</sup> of satisfactory and good.
Pavement	The pavement through this area has been given a pavement condition rating <sup>5</sup> of B.

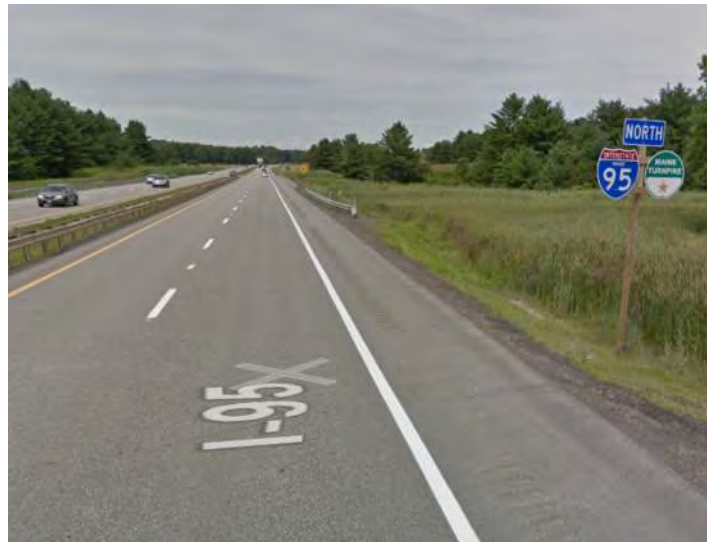
**Photo 2: I-95 NB (2018)**

- The most common cause of crash at this location was unsafe speed, which contributed to 4 crashes
- The next most common crash type was collisions with large animals which contributed to 3 crashes
- 8 of these 13 crashes resulted in vehicles departing from the travel way
  - 6 of these 8 crashes resulted in vehicles colliding with guardrail
- There is not a strong correlation between time of year nor time of day and crash frequency at this location

Unsafe speeds, especially during inclement weather, is one of the leading causes of crash at this location. Because of this, the area should be included in a speed study evaluation to determine whether decreased posted speed limits during weather events should be implemented.

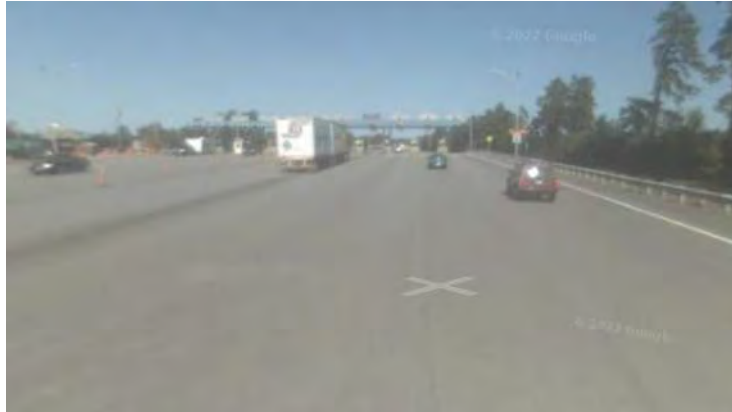
**Photo 2: New Gloucester Toll Plaza NB (2008)**

- The most common cause of crash at this location was inattention which contributed to 3 of the 9 crashes
- The next most common causes were falling asleep, unsafe backing and failure to yield, all which contributed to 2 crashes each
- 2 of these crashes resulted in vehicles departing from the travel way
  - 1 of these 2 resulted in vehicles colliding with guardrail
- There are not strong correlations between time of day nor time of year and crash frequency at this location

**Photo 1: New Gloucester Toll Plaza NB (2008)** captured by Google Maps<sup>2</sup> in October of 2008 depicts the condition of this location at the time most nearly to which it was most recently noted as an HCL.

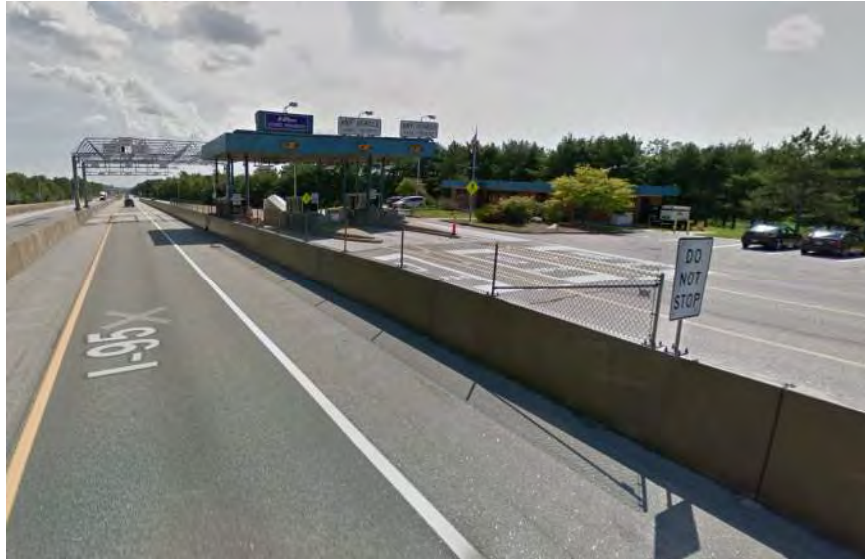
- The leading crash cause at this location was unsafe speed which contributed to 3 crashes
- Animal collisions was the next most common type of crash with 2 crashes
- 1 of these crashes involved heavy vehicles
- 4 of these crashes resulted in vehicles departing from the travel way
- 7 of these 13 crashes occurred during the months of November and December
- 5 of these crashes occurred from approximately 5:00pm to 6:00pm

**Photo 2: NB Toll Plaza (2018)** captured by Google Maps<sup>3</sup> in July of 2018 depicts the condition of this location at the time that it was most recently noted as an HCL.

Another leading crash cause at these locations are maneuvers at the toll booth. The surrounding area should be evaluated for implementation of safety measures to bring added attention to the toll booth, such as rumble strips.

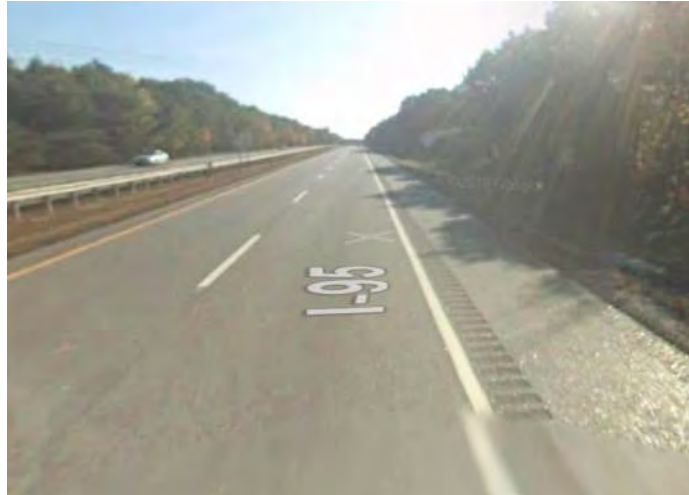
- 5 of these crashes were caused by unsafe speed
- 2 of these crashes involved collisions with animals
- 6 of these crashes resulted in vehicles departing from the roadway and colliding with objects including median guardrail or trees
- 1 of these crashes involved a heavy vehicle
- There is not a strong correlation between time of year and crash frequency at this location
- Many crashes at this location occurred during early morning hours, with 5 crashes occurring between 1:00am and 6:00am

**Photo 3: North of SB Toll Plaza (2008)** captured by Google Maps in October of 2008 depicts the condition of this location at the time most nearly to which it was most recently noted as an HCL.

Unsafe speeds, especially during inclement weather, is one of the leading causes of crash at this location. Because of this, the area should be included in a speed study evaluation to determine whether decreased posted speed limits during weather events should be implemented.

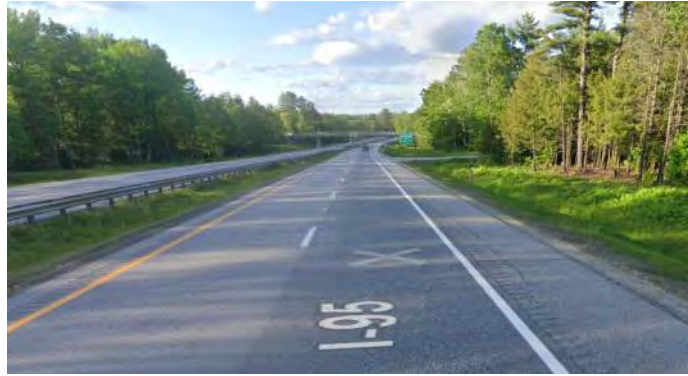
- There were 10 animal collisions at this location, as well as 1 additional crash which was due to avoiding a deer
- The next most common cause of crash at this location was speed, which contributed to 4 crashes
- There was 1 crash at this location that involved a heavy vehicle
- 6 of these crashes caused vehicles to depart from the travel way and collide with objects such as signs or guardrail

**Photo 1: I-95 NB Near Poland Springs Bridge (2019)** captured by Google Maps<sup>2</sup> in June of 2019 depicts the condition of this location at the time that it was most recently noted as an HCL.

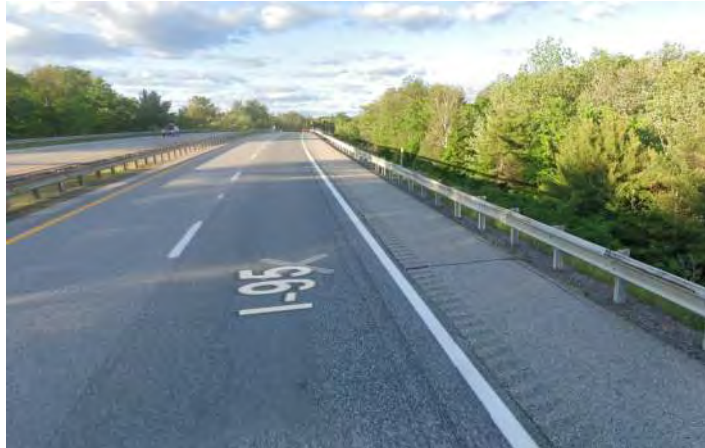
- The leading crash causes at this location were speed, falling asleep and collisions with animals which each contributed to 3 crashes
- 8 of these 12 crashes resulted in vehicles departing the travel way and colliding with guardrail
- 6 of these crashes occurred between the months of June through August
- There is not a strong correlation between time of day and crash frequency at this location

**Photo 2: I-95 NB Just South of Exit 75 (2019)** captured by Google Maps<sup>3</sup> in June of 2019 depicts the condition of this location at the time that it was most recently noted as an HCL.

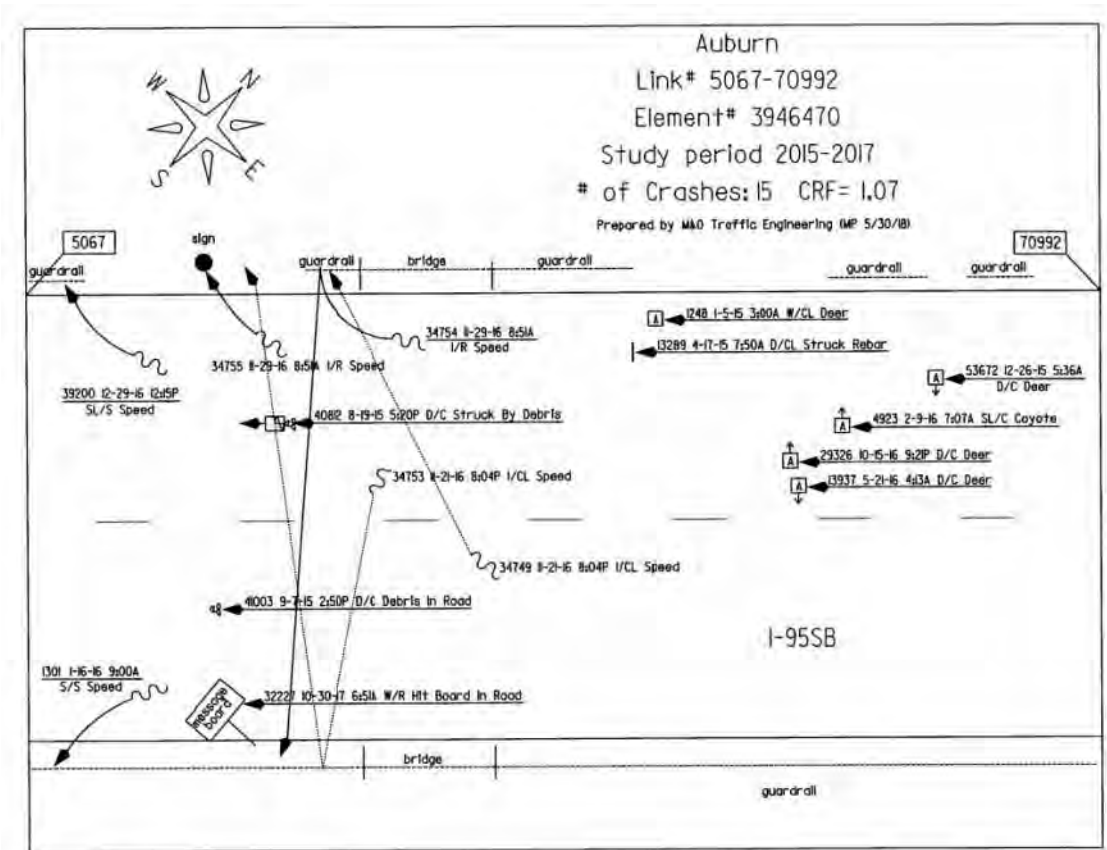
**Figure 2: 2015-2017 Exit 75 SB Off Ramp Approach Crash Diagram** depicts the crash diagram for the most recent time period in which this location was identified as an HCL. This location was classified as an HCL during one other time period over the past 10 years.

As shown in **Figure 2**, there were 15 crashes resulting in a 0% injury rate during this analysis period.

- There were 5 animal collision crashes at this location during the time period
- 5 of the crashes at this location were due to speeding
- 4 crashes occurred as a result of vehicles striking various inanimate objects in the roadway
- 6 of the 15 crashes resulted in vehicles departing from the travel way
  - 5 of these 6 resulted in collisions with objects including guardrail, bridge rail and signs
- There is not a strong correlation between time of year and crash frequency at this location

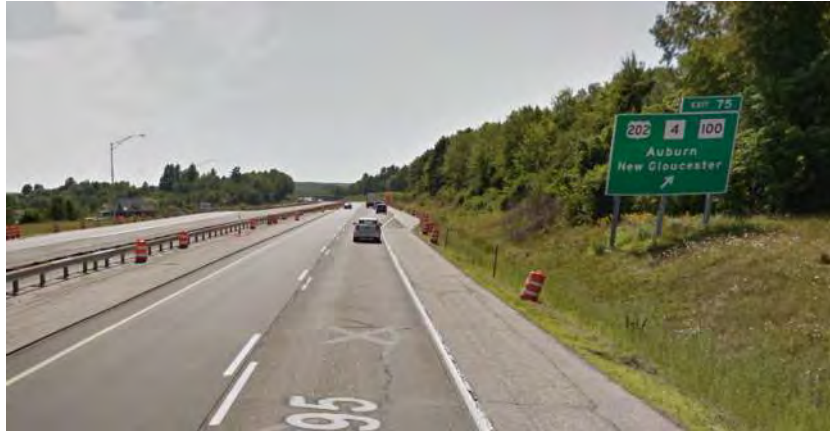
**Photo 1: I-95 SB North of Exit 75 Interchange (2018)** captured by Google Maps in July of 2018 depicts the condition of this location most nearly to the time that it was most recently noted as an HCL.

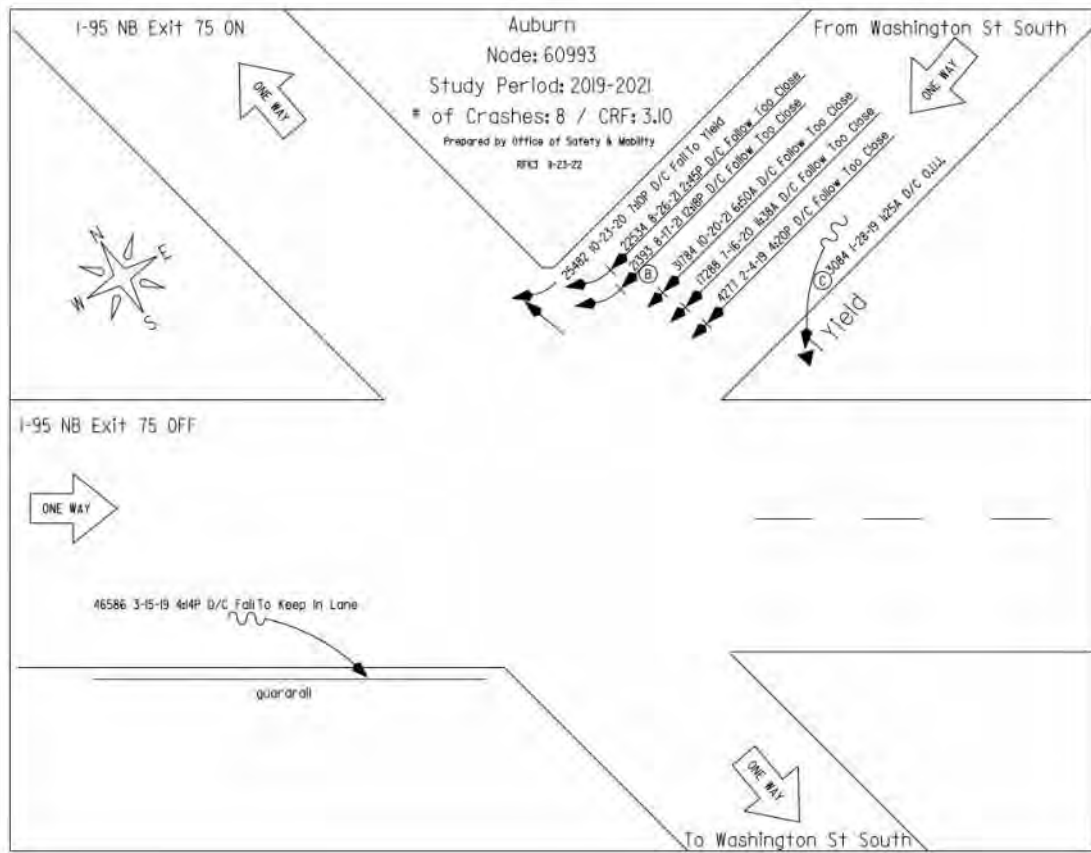
**Figure 2: 2019-2021 Exit 75 Intersection Weave Crash Diagram** depicts the crash diagram at this location during the most recent time period in which it was identified as an HCL. This location was classified as an HCL during 1 other time period over the prior 10 years.

As shown in **Figure 2**, there were 8 crashes resulting in a 25% injury rate during this analysis period.

- All but 1 of these crashes involved vehicles traveling along the Washington Street SB slip ramp
- 5 of these 8 crashes were a result of following too close
- 2 of these crashes were single vehicle crashes which resulted in the vehicles departing from the travel way and colliding with either guardrail or signage
- 5 of these crashes occurred between the months of July and October
- There is not a strong correlation between the time of day and crash frequency at this location
