# 2022 Systemwide Safety and Capacity Study

June 30, 2023

Maine Turnpike Authority  
2360 Congress Street  
Portland, ME 04102

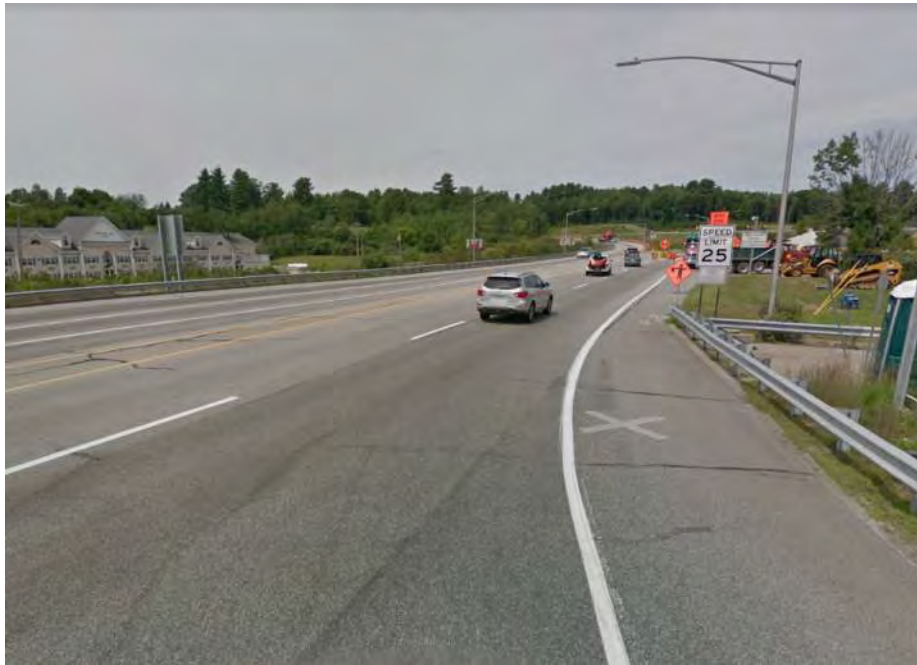
**Photo 1: Exit 75 Ramps Weave (2018)** captured by Google Maps<sup>3</sup> in July of 2018 depicts the condition of this location at the time most nearly to when was most recently noted as an HCL. The view of the photo is from the perspective of vehicles approaching the weave from the Washington Street SB slip ramp.

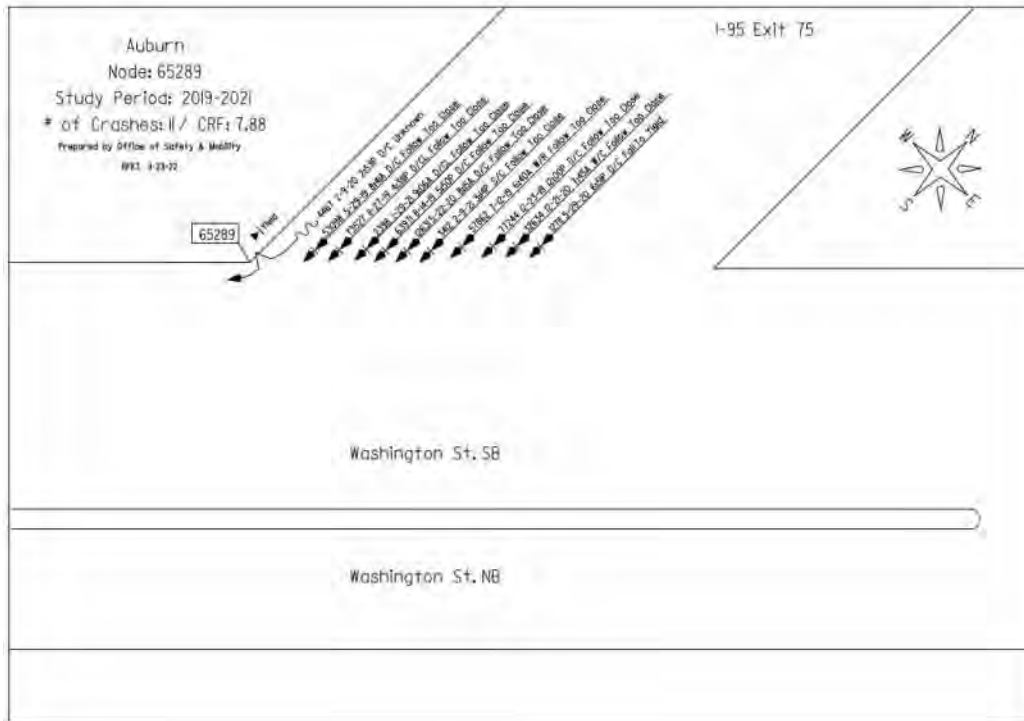
**Figure 3: 2019-2021 SB Off Ramps Slip Ramp Crash Diagram** depicts the diagram during which this location was most recently identified as an HCL. This location was also classified as an HCL during 7 other time periods over the prior 10 years.

As shown in **Figure 3**, there were 11 crashes resulting in a 0% injury rate during this analysis period.

- All of these crashes occurred along the slip ramp
- 9 of these 11 crashes were a result of following too close along the ramp
- 1 of these crashes was a single vehicle crash
  - This crash resulted in the vehicle departing the roadway
- There is not a strong correlation between time of day nor time of year and crash frequency at this location

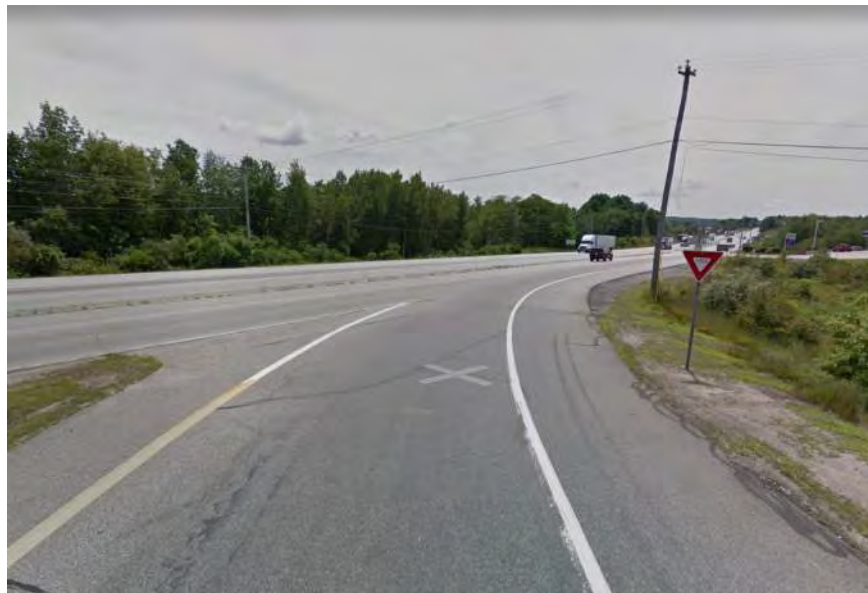
**Photo 2: Exit 75 Off Ramps Slip Ramp Merge (2018)** captured by Google Maps<sup>4</sup> in July of 2018 depicts the condition of this location most nearly to time that it was most recently noted as an HCL. This photo views the location from the view of the slip ramp.

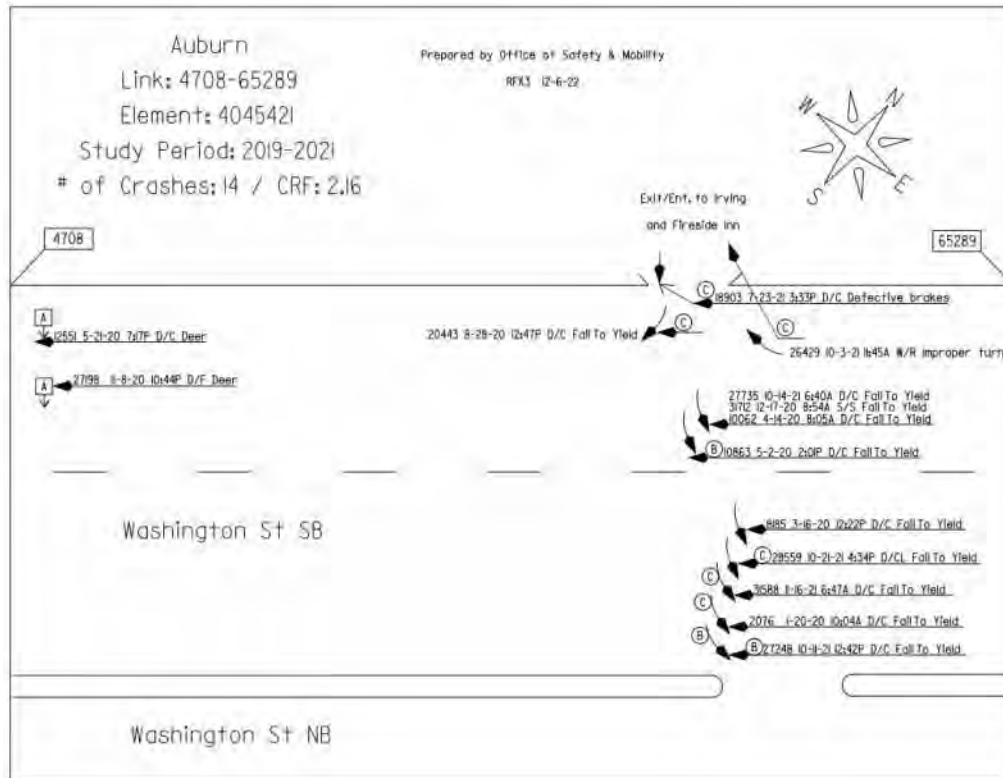
**Figure 4: 2019-2021 Washington Street After Slip Ramp Crash Diagram** depicts the crash diagram during the last time period in which the location was identified as an HCL. This segment was classified as an HCL during 5 other time periods over the past 10 years.

As shown in **Figure 4**, there were 14 crashes resulting in a 57.1% injury rate during this analysis period.

- 9 of these 14 crashes were turning movement crashes between vehicles traveling along Washington Street SB and vehicles attempting to turn left out of the Irving/Fireside Inn Entrance (these were all a result of failure to yield)
  - There was an additional similar type of crash with the only difference being the vehicle exiting the business drive was attempting to turn right
- There were 2 collisions with large animals at this location
- One of the crashes at this location resulted in a vehicle departing from the travel way
- 6 of these 14 crashes occurred in the months October and November
- There is not a strong correlation between time of day and crash frequency at this location

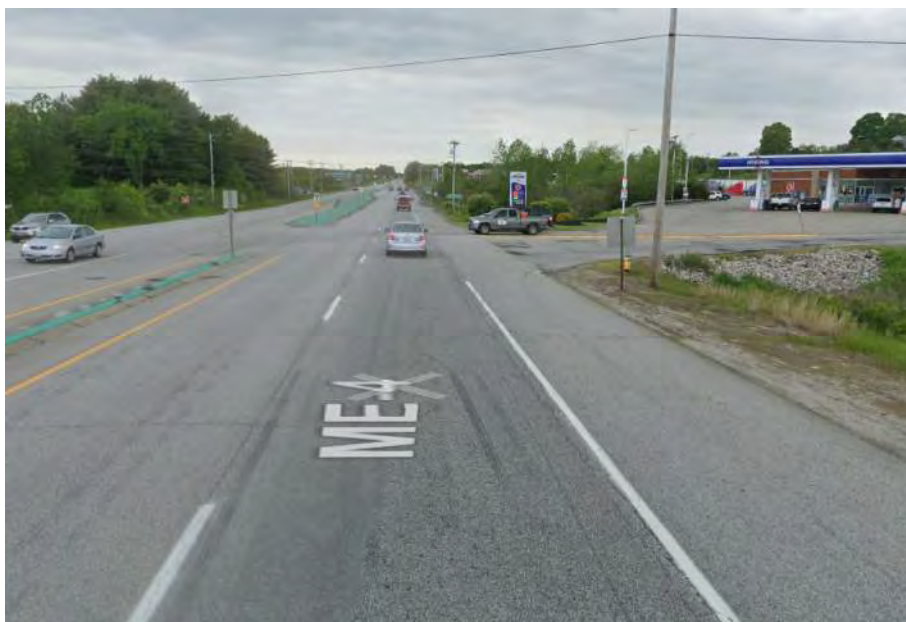
**Photo 3: Washington Street at Irving Drive (2019)** captured by Google Maps<sup>5</sup> in June of 2019 depicts the condition of this location at the time that it was most recently noted as an HCL.

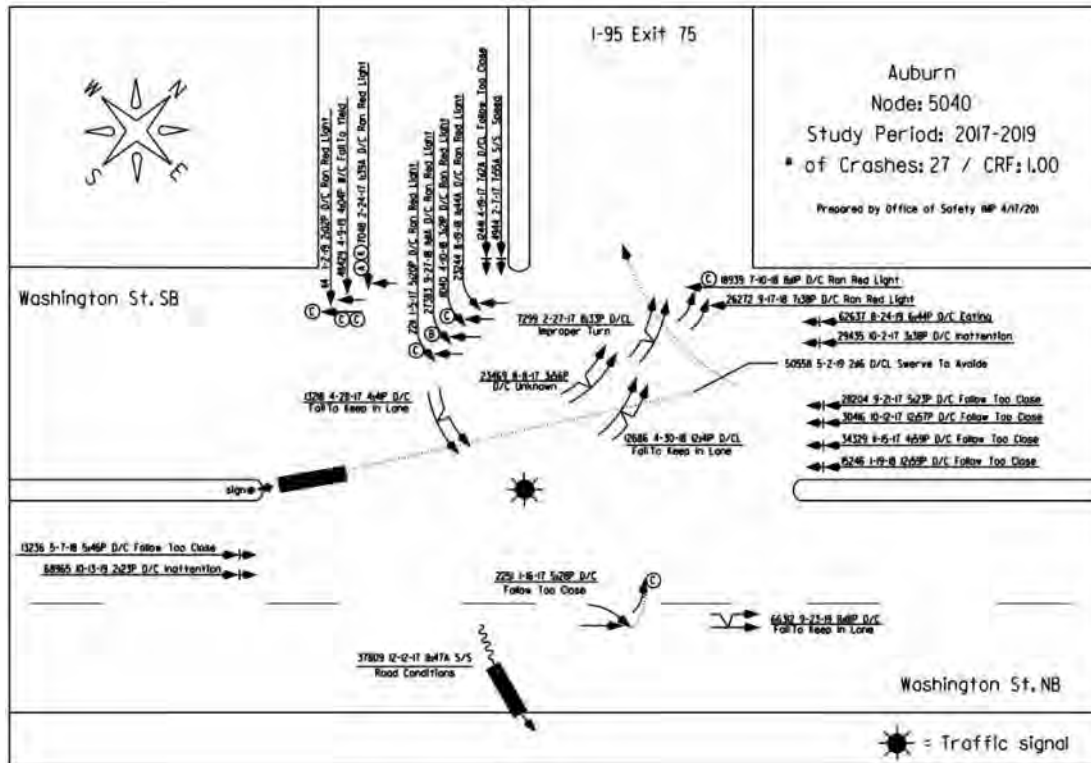
**Figure 5: 2017-2019 Exit 75 Intersection Crash Diagram** depicts the crash diagram for the intersection during the most recent time period in which it was identified as an HCL. This intersection was also classified as an HCL during 3 other time periods over the past 10 years.

As shown in **Figure 5**, there were 27 crashes resulting in a 25.9% injury rate during this analysis period.

- The most common cause of crash at this location was running red lights which contributed to 8 crashes
- The next most frequent cause was following too close which caused 7 crashes
- 11 of these crashes involved turning movements
  - 5 of these 11 involved vehicles originating from the ramps approach to the intersection
- Heavy vehicles were involved in 2 of these crashes
- There was 1 fatality at this location which was caused by a crash resultant from running a red light between a vehicle from the ramp approach and a vehicle from the Washington Street SB approach
- There is not a strong correlation between time of year and crash frequency at this location
- 12 of these crashes occurred between the times of approximately 3:30pm and 8:00pm

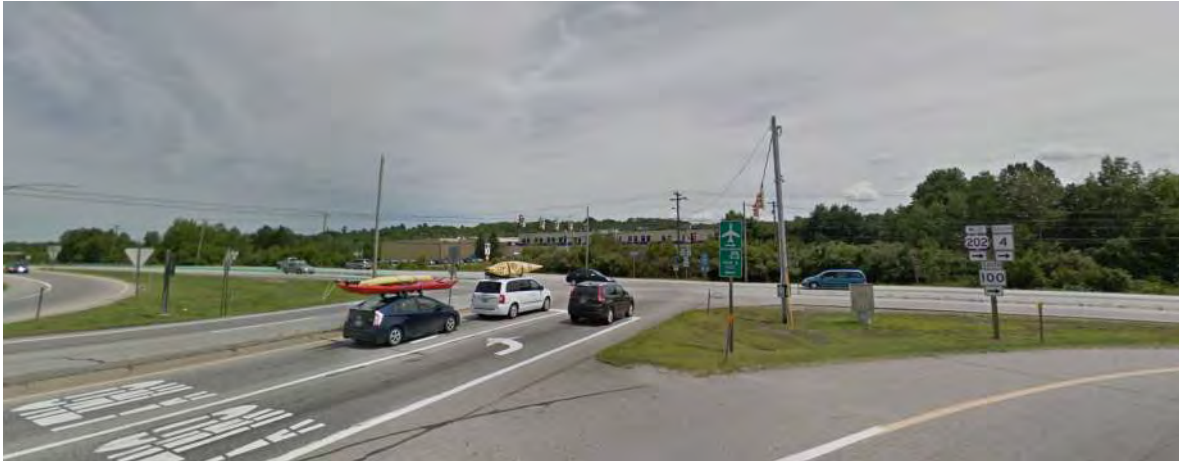
**Photo 4: Exit 75 Intersection (2018)** captured by Google Maps<sup>6</sup> in July of 2018 depicts the condition of this location at the time that it was most recently noted as an HCL.

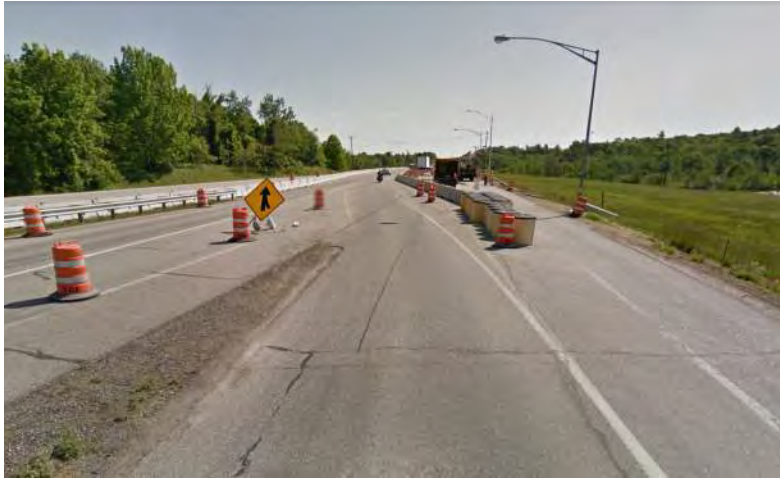
- All but 1 of these crashes occurred along the on ramp portion of the merge
  - The 1 other crash was due to failure to yield between a vehicle originating from the ramp and another from the mainline
- 5 of these crashes were a result of vehicles following too close
- 2 of the crashes were due to inattention
- 5 of these crashes occurred between the months of April and July
- 4 of these crashes occurred between 8:00am and 9:00am

**Photo 1: Exit 75 on Ramp Merge (2012)** captured by Google Maps<sup>2</sup> in May of 2012 depicts the condition of this location at the time that it was most recently noted as an HCL. **Photo 2: Exit 75 on Ramp Merge (2022)** depicts the current condition of the merge point.

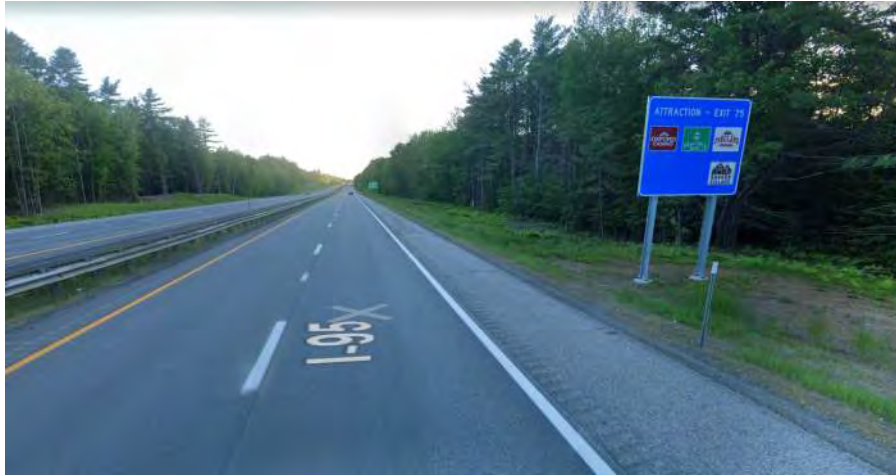
It can be observed from this table that there were 17 crashes at this location with a 0% injury rate during this time period.

**Photo 2: I-95 SB (2019)** captured by Google Maps<sup>3</sup> in June of 2019 depicts the condition of this location at the time that it was most recently noted as an HCL.

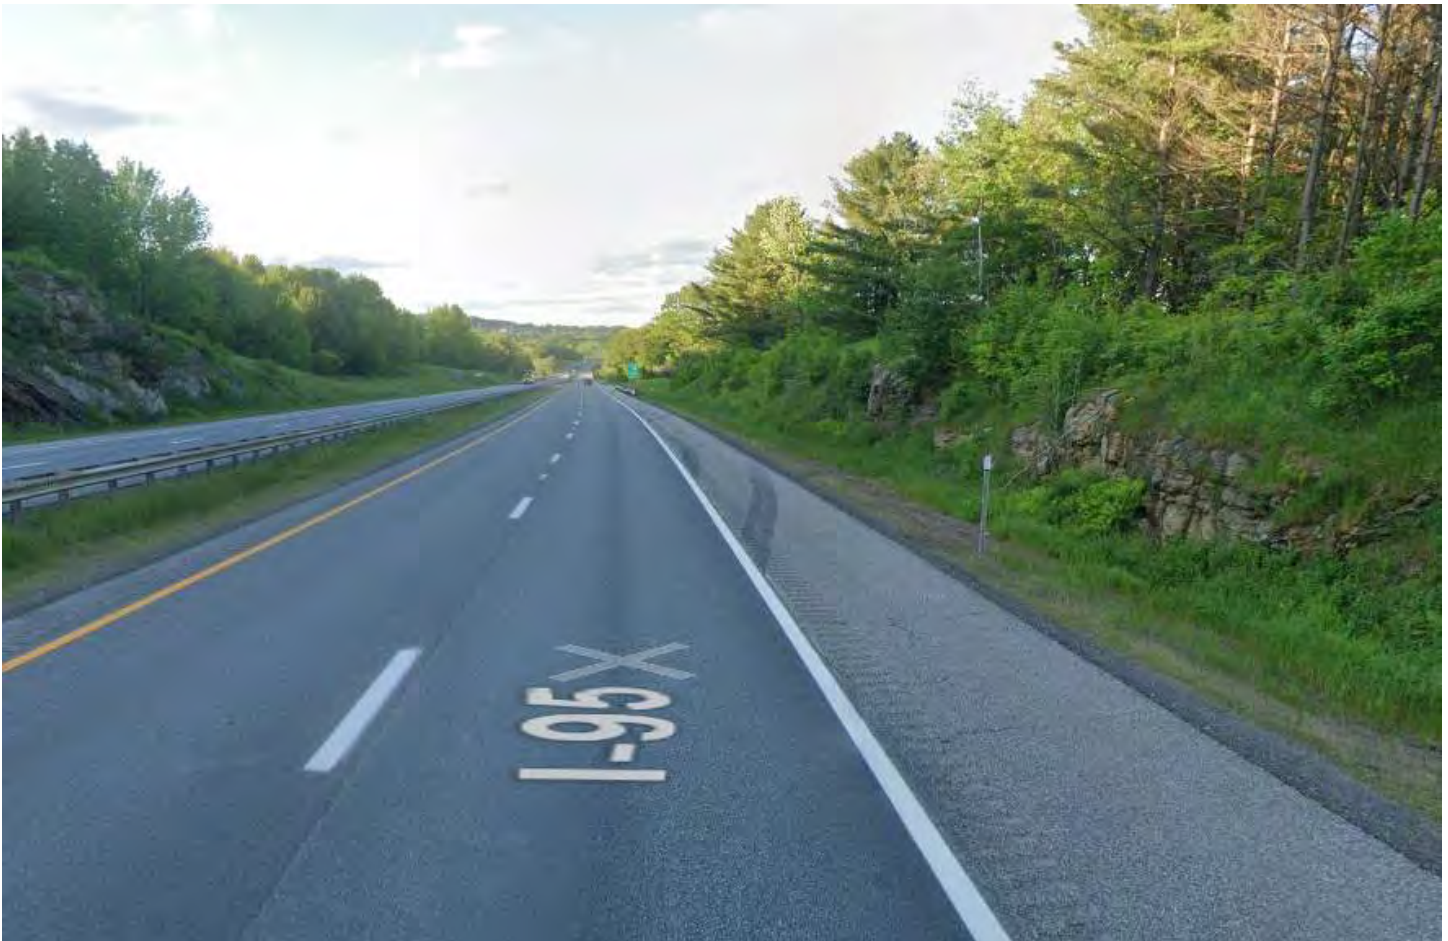
**Photo 1: I-95 NB (2019)** captured by Google Maps<sup>2</sup> in June of 2019 depicts the condition of this location at the time that it was most recently noted as an HCL.

Existing Road Audit	
Road alignment and Cross Section	This mainline segment is flat and has a curve that is not abrupt enough to create sight distance concerns.
Lighting	There is no lighting along this segment.
General Sign Issues	Signage along this segment notifies drivers of the upcoming Exit 80 interchange.
Marking and Delineation	This location is adequately marked to separate lanes as well as shoulders.
Barriers and Clear Zones	Guardrail is along the inside of the roadway to separate the northbound and southbound travel directions. There are also lengths of guardrail along the outside of the roadway along portions of the segment.
Bridges and Culverts	Bridge 0086 carries I-95 over the Androscoggin River at the northerly end of this segment and has components which have been given condition ratings <sup>3</sup> of good.

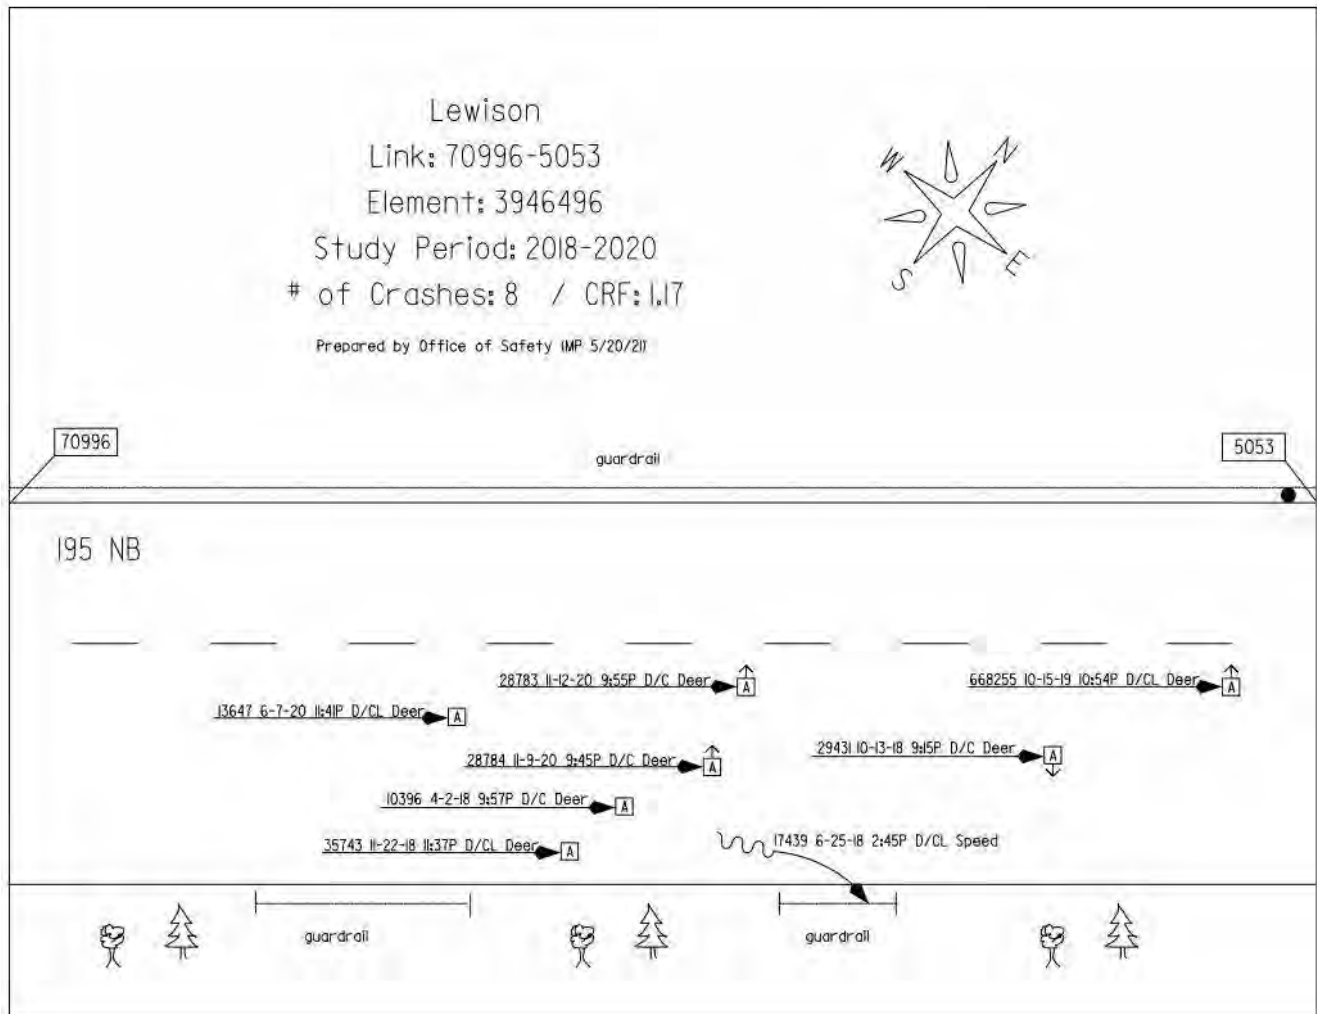
**Figure 2: 2018-2020 I-95 NB Crash Diagram** depicts the HCL for this location during the most recent time span in which it was identified as an HCL. This location was identified as an HCL during 3 other time periods over the past 10 years.

As shown in **Figure 2**, there were 8 crashes resulting in a 0% injury rate during this analysis period.

- All but one of the crashes at this location were collisions with deer
- The only other crash at this location was due to speed and resulted in the vehicle departing the roadway and colliding with guardrail
- 5 of these 8 crashes occurred during the months of October and November
- All of the crashes at this location occurred in the afternoon or evening, with 6 crashes occurring between 9:30pm and midnight

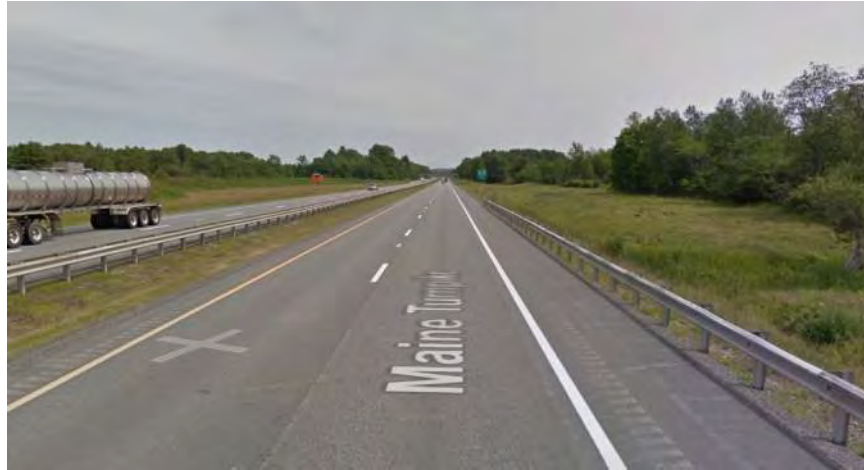
**Photo 1: I-95 NB Near Grove Street (2018)** captured by Google Maps<sup>2</sup> in August of 2018 depicts the condition of this location at the time that it was most recently noted as an HCL.

Existing Road Audit	
Road alignment and Cross Section	This mainline segment is flat and straight which does not create sight distance concerns.
Lighting	There is no lighting along this segment.
General Sign Issues	Signage along this segment notifies drivers of the upcoming Exit 86 interchange.
Marking and Delineation	This location is adequately marked to separate lanes as well as shoulders.
Barriers and Clear Zones	Median barrier exists along the entirety of the segment to separate the northbound and southbound travel directions.
Bridges and Culverts	Bridge 0102 carries Old Webster Road over I-95 and has components which have been given condition ratings <sup>3</sup> of satisfactory and good.  Bridge 0034 carries Grove Street over I-95 and has components which have been given condition ratings of good.
Pavement	The pavement along this segment has been given a pavement condition rating <sup>4</sup> of B.

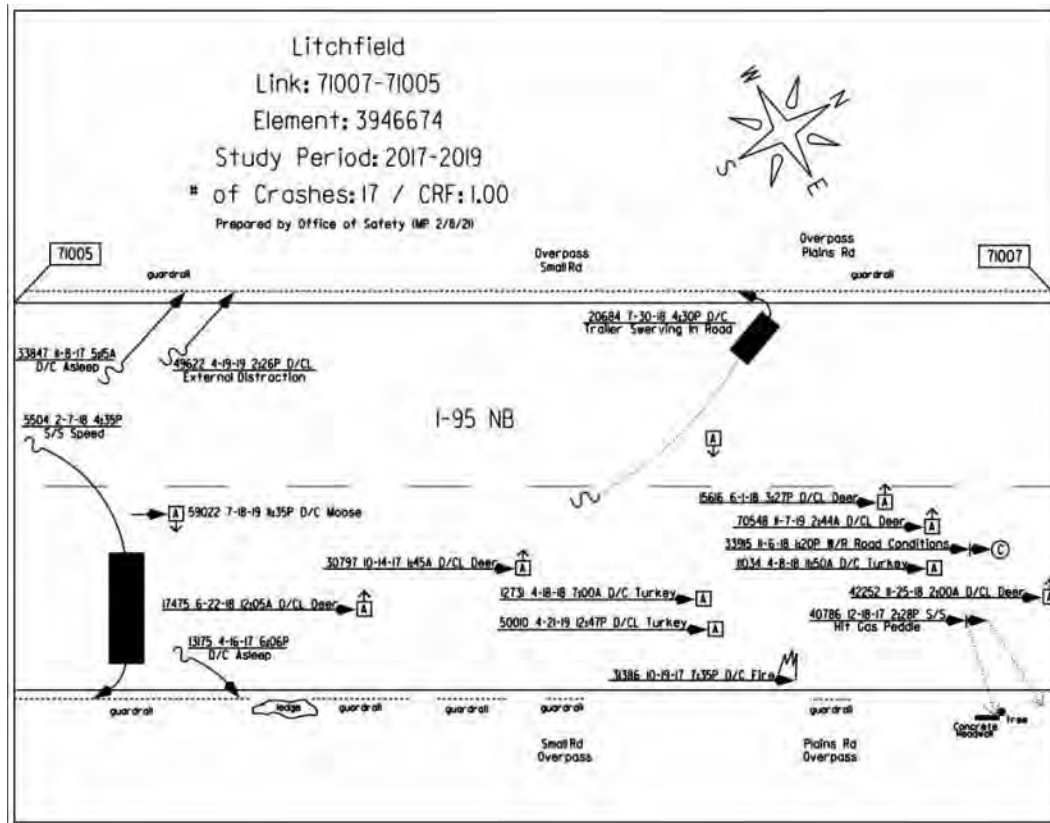
**Figure 2: 2017-2019 NB Segment Near Small Road Crash Diagram** depicts the crash diagram at this location during the time period in which it was most recently classified as an HCL. This location was identified as an HCL during 1 other time period over the past 10 years.

As shown in **Figure 2**, there were 17 crashes resulting in a 5.9% injury rate during this analysis period.

- The most common type of crash at this location was collisions with animals which attributed to 9 crashes at this location
- The next most common cause of crash was vehicle operators falling asleep which caused 2 crashes
- One of the crashes at this location was due to road conditions
- 2 of these crashes involved heavy vehicles
- 6 of these crashes resulted in vehicles departing from the travel way and colliding with objects such as guardrail, concrete headwalls or trees
- April and November were the most common months of crash at this location with 4 crashes occurring within each
- There is not a strong correlation between time of day and crash frequency at this location

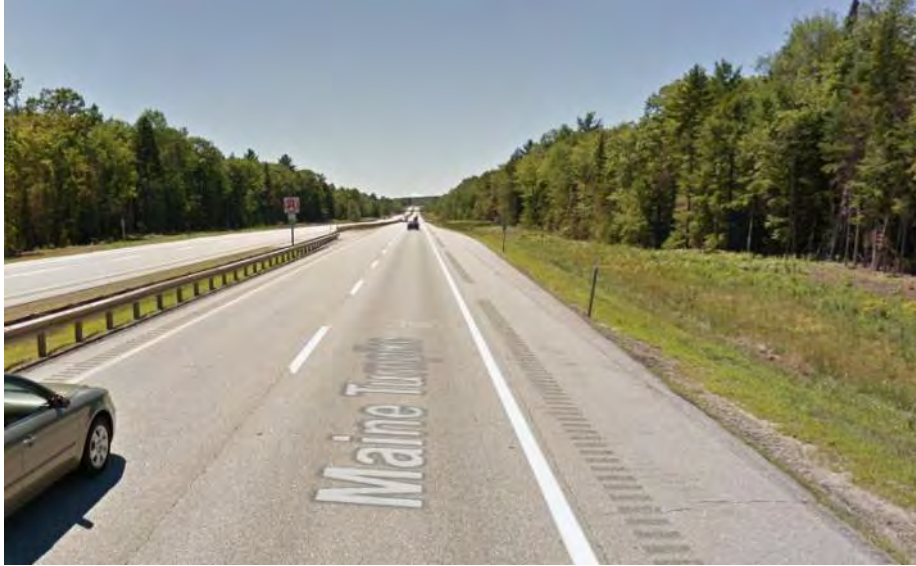
**Photo 2: I-95 NB Near Small Road (2018)** captured by Google Maps<sup>2</sup> in August of 2018 depicts the condition of this location at the time that it was most recently noted as an HCL.

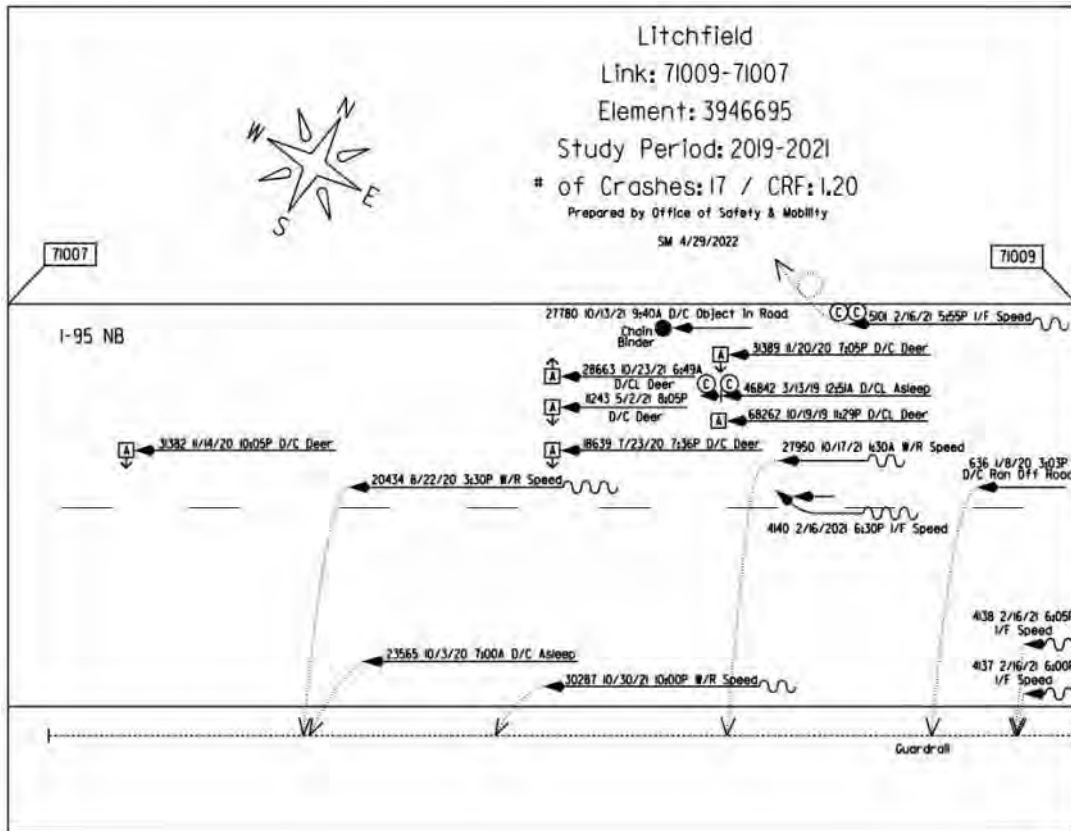
**Figure 3: 2019-2021 I-95 NB Near Stevenstown Road Crash Diagram** depicts the crash diagram for the most recent time period in which this location was identified as an HCL. This is the only time in the past 10 years that this segment was classified as an HCL.

As shown in **Figure 3**, there were 17 crashes resulting in a 11.8% injury rate during this analysis period.

- The most common cause of crash at this location was speeding which contributed to 7 crashes
- There were 6 collisions with animals at this location
- 8 of these crashes resulted in vehicles departing from the travel way
  - 7 of these 8 resulted in a collision with guardrail
- 13 of these 17 crashes occurred between the months of October and February
- 10 of these crashes occurred in the late evening, from approximately 6:00pm through midnight

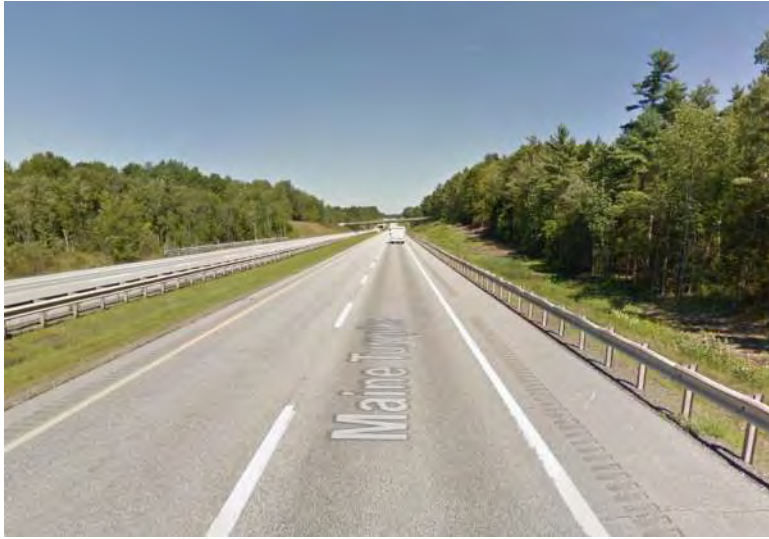
**Photo 3: NB Segment Near Stevenstown Road** captured by Google Maps<sup>3</sup> in August of 2018 depicts the condition of this location at the time that it was most recently noted as an HCL.

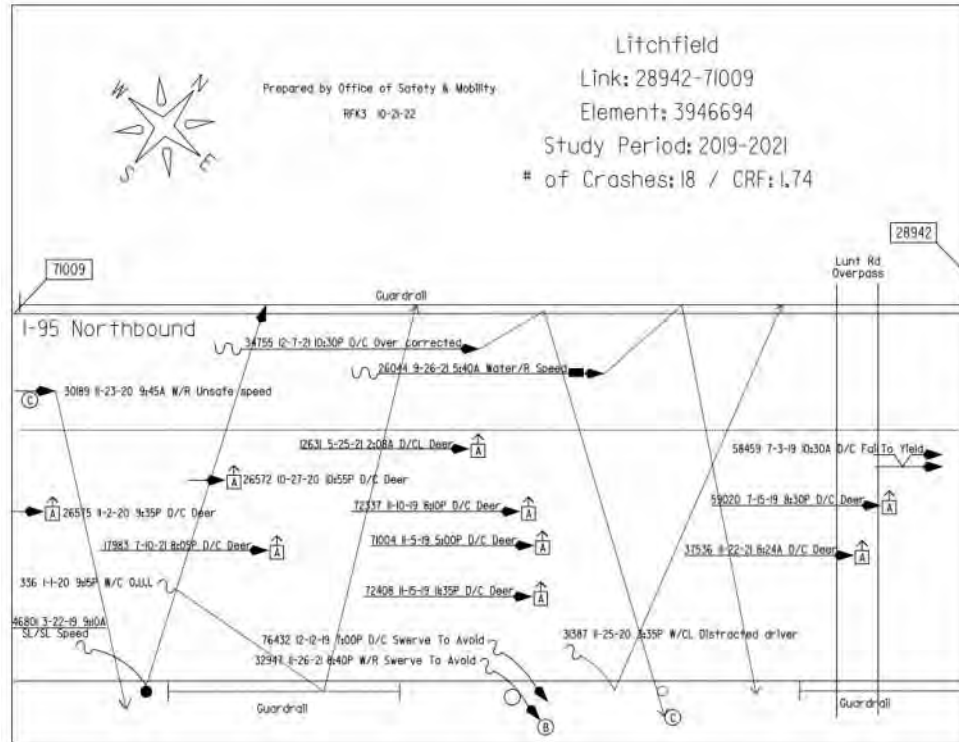
**Figure 4: 2019-2021 I-95 NB Over Lunts Hill Road Crash Diagram** depicts this mainline segment during the most recent time period in which it was identified as an HCL. This segment was identified as an HCL during two other time periods in the past 10 years.

As shown in **Figure 4**, there were 18 crashes resulting in a 16.7% injury rate during this analysis period.

- Of these 18 crashes were collisions with large animals
- The next most common cause of crash at this location was speeding which contributed to 3 crashes
  - One of these speed related crashes also involved water in the travel way
  - 1 of these crashes involved a heavy vehicle
- 8 of these crashes resulted in vehicles departing from the roadway
  - 5 of these 8 crashes resulted in collision with guardrail
- 12 of these crashes occurred between the months of October and January
- The majority of these crashes occurred during the evening hours, with 11 happening between 5:00pm and midnight

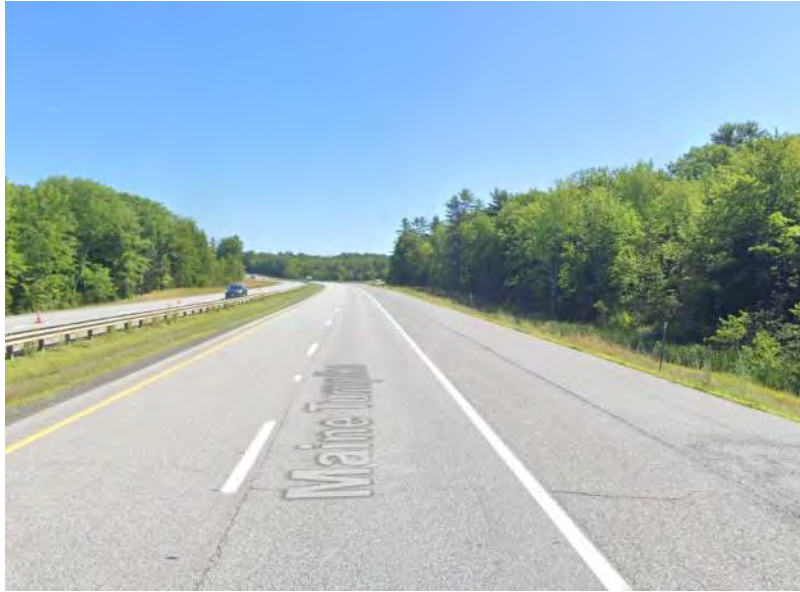
**Photo 4: I-95 NB Near Lunts Hill Road**

**Photo 4: Near Lunts Hill Road** captured by Google Maps in July of 2022 depicts the condition of this location most nearly to the time that it was most recently noted as an HCL.

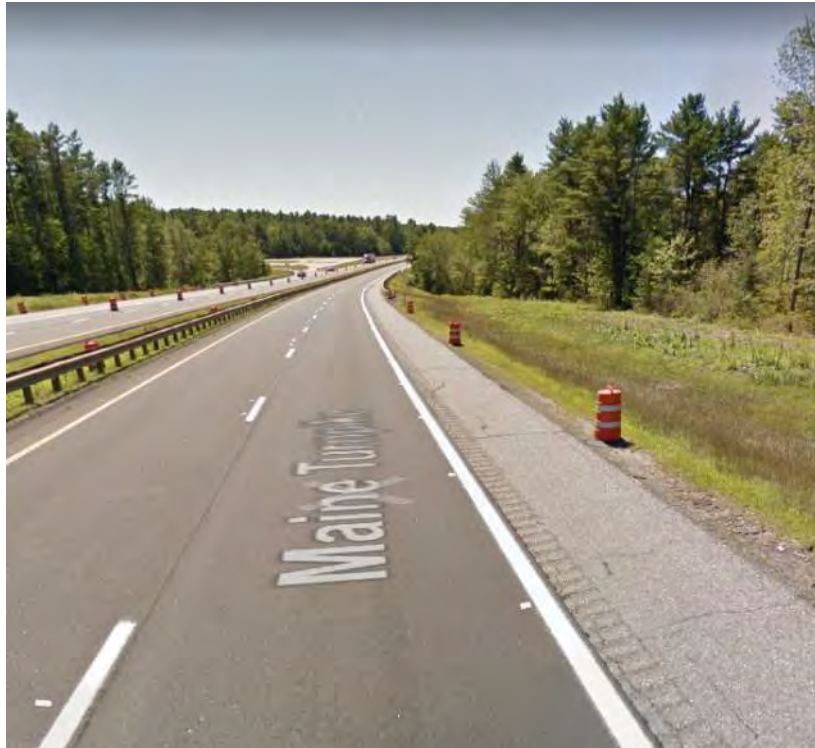
It can be observed from this table that there were 7 crashes at this location with a 42.9% injury rate during this time period.

**Photo 5: SB Segment Near Stevenstown Road** captured by Google MAPS in August of 2018 depicts the condition of this location most nearly to the time that it was most recently noted as an HCL.

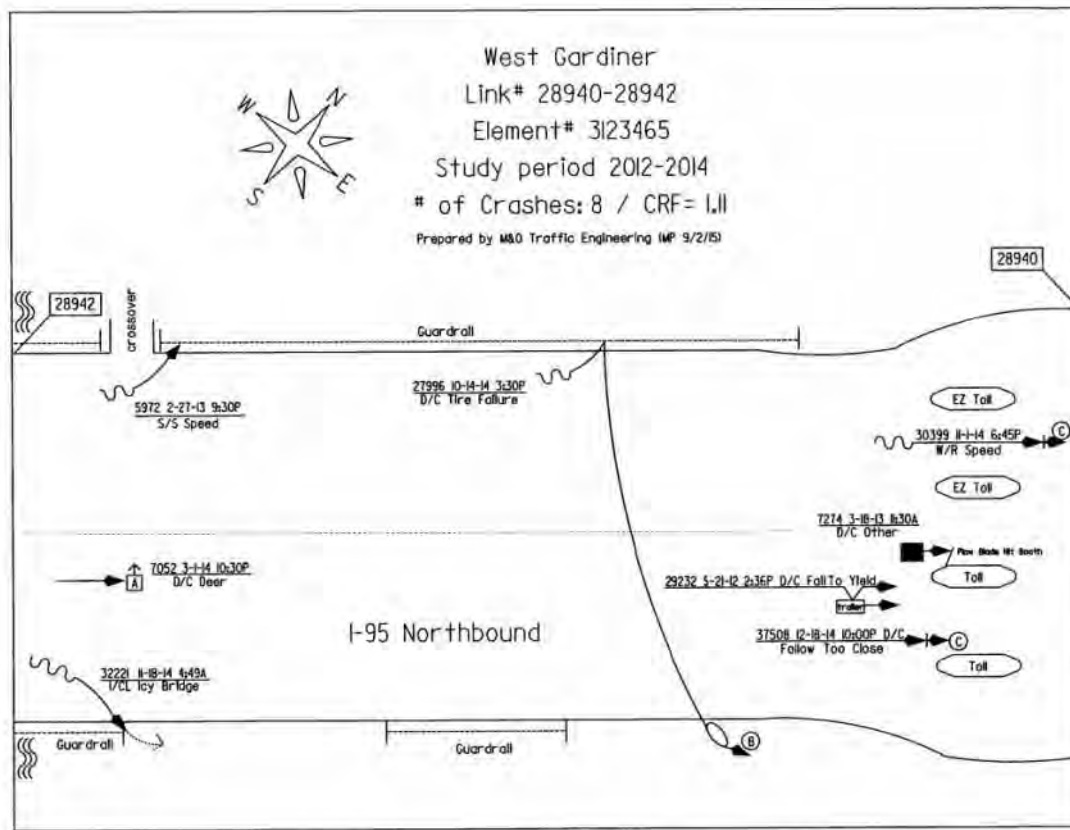
**Figure 2: 2012-2014 NB Toll Plaza Crash Diagram** depicts the crash diagram for the most recent time period in which this location was identified as an HCL. This is the only time over the past 10 years that the location has been classified as an HCL.

As shown in **Figure 2**, there were 8 crashes resulting in a 37.5% injury rate during this analysis period.

- The leading cause of crash at this location was speeding which contributed to 2 crashes
- There was 1 animal collision at this location
- 1 crash was due to the bridge being icy
- There was 1 heavy vehicle involved in these crashes
- 4 of the crashes at this location resulted in vehicles departing from the travel way and colliding with guardrail
- 4 of these crashes occurred between October and February
- Most of these crashes occurred during the evening hours

The toll plaza has not been an HCL since 2014. There are no recommendations at this time.

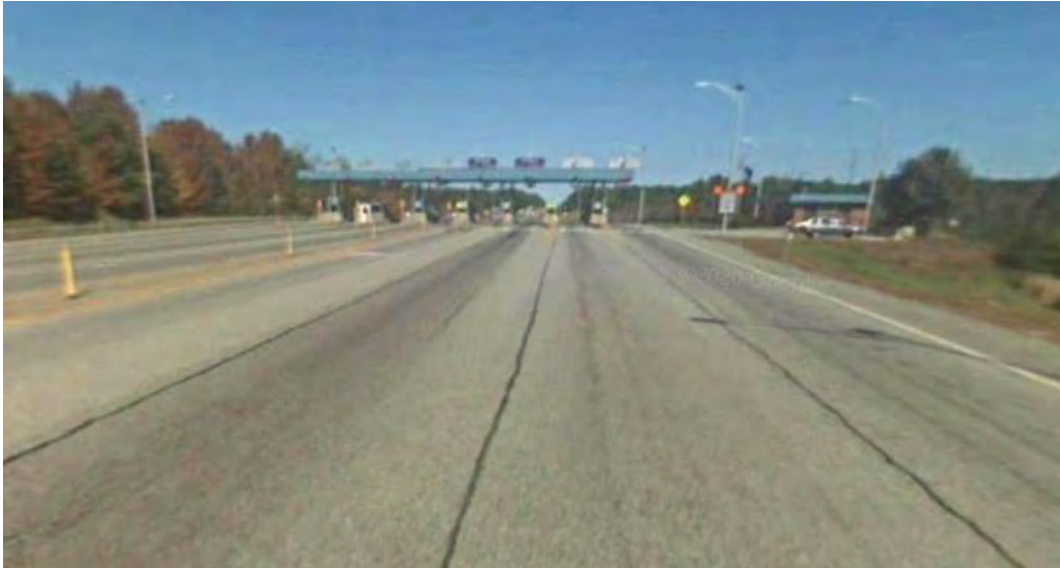
**Photo 1: NB Toll Plaza (2008)** captured by Google Maps in October of 2008 depicts the condition of this location most nearly to the time that it was most recently noted as an HCL.

Existing Road Audit	
Road alignment and Cross Section	This segment of roadway is straight and flat, with the toll plaza posing the only sight distance concerns
Lighting	Lighting is present around the toll plaza.
General Sign Issues	Signing exists at the toll plaza for purposes including designating speed limits and noting collection type by lane.
Marking and Delineation	This location is adequately marked to separate lanes as well as shoulders. Markings at the toll plazas aid in guiding vehicles through their lanes.
Barriers and Clear Zones	Median barrier exists along the entirety of the segment to separate the northbound and southbound travel directions. This consists of guardrail which transitions to concrete barrier near the toll plaza. There are also some lengths of guardrail along the outside of the roadway at some locations within the segment.
Bridges and Culverts	Bridge 0547 carries I-95 NB over Cobbosseecontee Stream and has components which have been given condition ratings <sup>2</sup> of satisfactory and good.

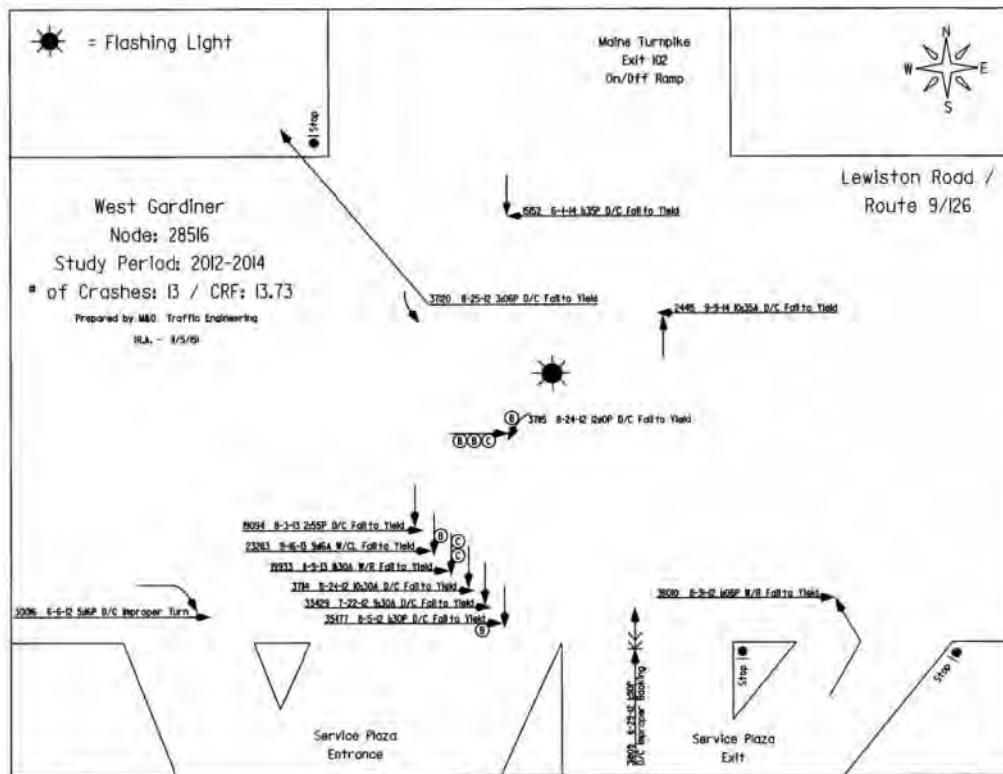
**Figure 2: 2012-2014 Exit 102 Intersection Crash Diagram** depicts the crash diagram for this location during the most recent time in which it was classified as an HCL. This location qualified as an HCL during two time periods prior to this in the past 10 years.

As shown in **Figure 2**, there were 13 crashes resulting in a 30.8% injury rate during this analysis period.

- All but 2 of the recorded crashes at this location were caused by failure to yield
- The majority of crashes at this location involved vehicles traveling along Lewiston Road EB, many of which were collisions between them and vehicle traveling SB from the Exit 102 Ramps
- 1 of these crashes resulted in a vehicle departing the travel way
- 12 of these crashes occurred between the months of June and September
- There is not a strong correlation between time of day and crash frequency at this location

A new roundabout was constructed the year after the HCL was reported in 2014. No further HCL's or significant crash patterns have been reported to date with the construction of the new roundabout. No recommendations at this time.

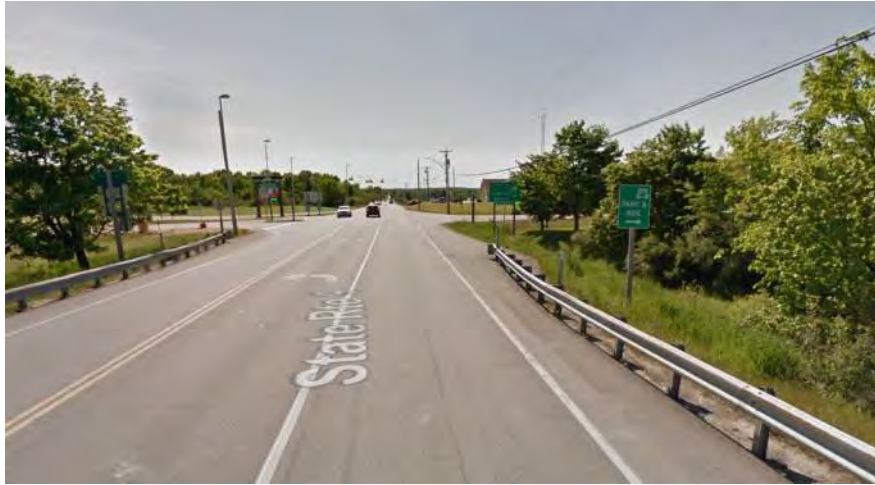
**Photo 1: Exit 102 Intersection (2012)** captured by Google Maps<sup>3</sup> in June of 2012 depicts the condition of this location at the time that it was most recently noted as an HCL. This photo is from the viewpoint of a vehicle traveling along Lewiston Road WB.

Existing Road Audit	
Road alignment and Cross Section	This intersection currently exists as a roundabout.
Lighting	There is lighting throughout the roundabout.
General Sign Issues	Signing at the approaches and at the roundabout include advisory speeds, yield, one way and route information signs.
Marking and Delineation	The roundabout is adequately marked with pavement markings to aid vehicles in navigating through the intersection.
Barriers and Clear Zones	Medians at each approach separate travel directions.
Bridges and Culverts	No bridges or culverts exist at this intersection.
Pavement	The pavement at the roundabout approaches have been most recently given the following pavement condition ratings: <ul style="list-style-type: none"> <li>• Ramps SB Approach: C</li> <li>• Lewiston Road EB Approach: B</li> <li>• Lewiston Road WB Approach: B</li> </ul>
Heavy Vehicles	The ramps at this intersection tend to have a percentage of heavy vehicles around 2% to 6%.

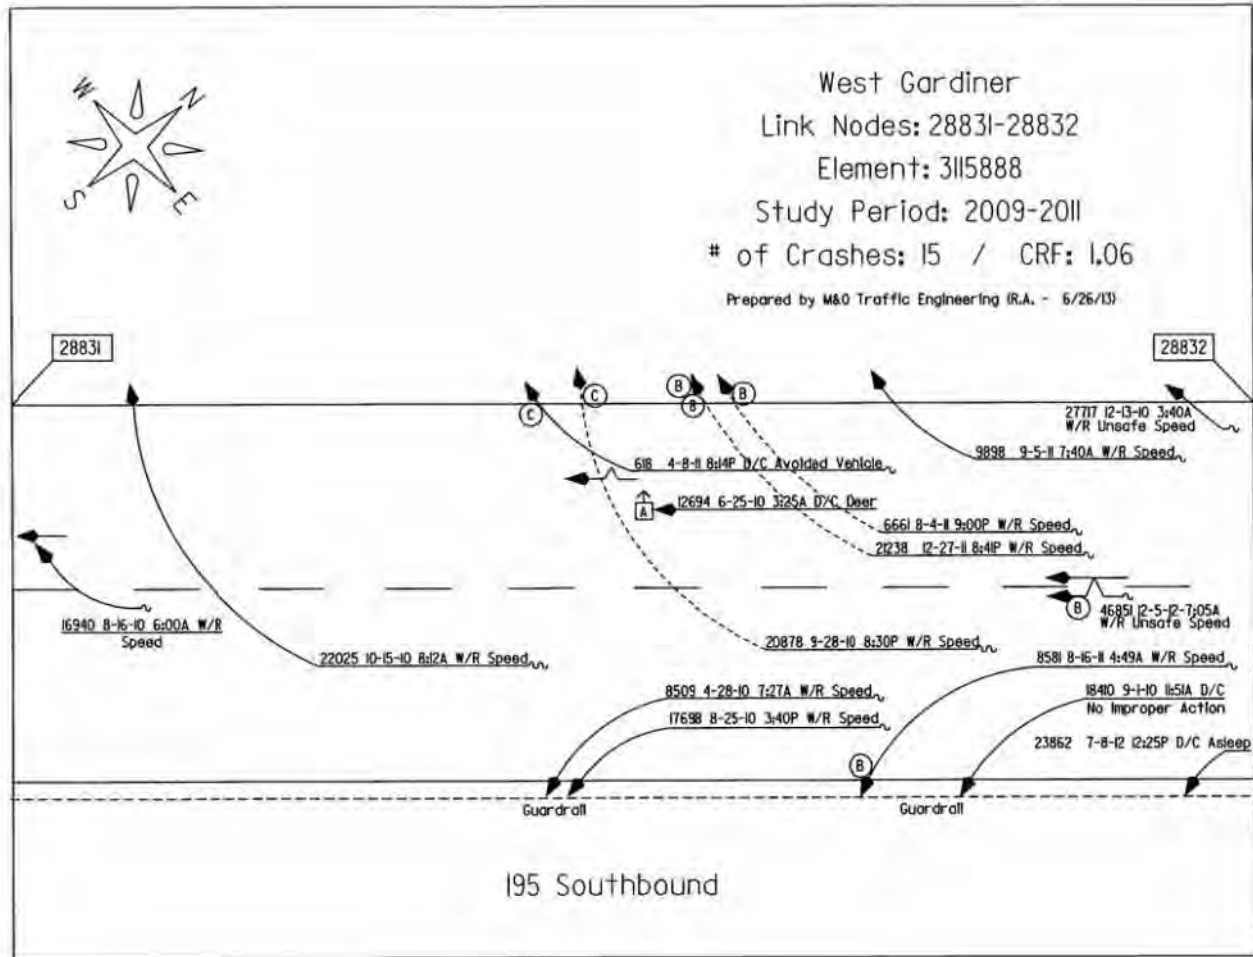
Figure 2: 2009-2011 I-95 SB Crash Diagram depicts the most recent available crash diagram for this location. 2012 was the only time period in the past 10 years in which this location was identified as an HCL.

As shown in Figure 2, there were 15 crashes resulting in a 40% injury rate during this analysis period.

- 11 of these 15 crashes were due to speeding
- There was 1 animal collision recorded at this location
- 12 of these crashes resulted in vehicles departing from the travel way
  - 5 of these 12 resulted in vehicles colliding with guardrail
- 8 of these crashes occurred between the months of August and October
- Many of these crashes occurred during early morning hours, with 7 crashes occurring between midnight and 9:00am

Speeding dominated the crash patterns for this area with a significant portion either leaving the travel lane or hitting the adjacent guardrail. The most recent recorded HCL was 10 years ago (in 2012) and there have been no reported HCL or significant crash patterns reported since. No recommendations at this time.

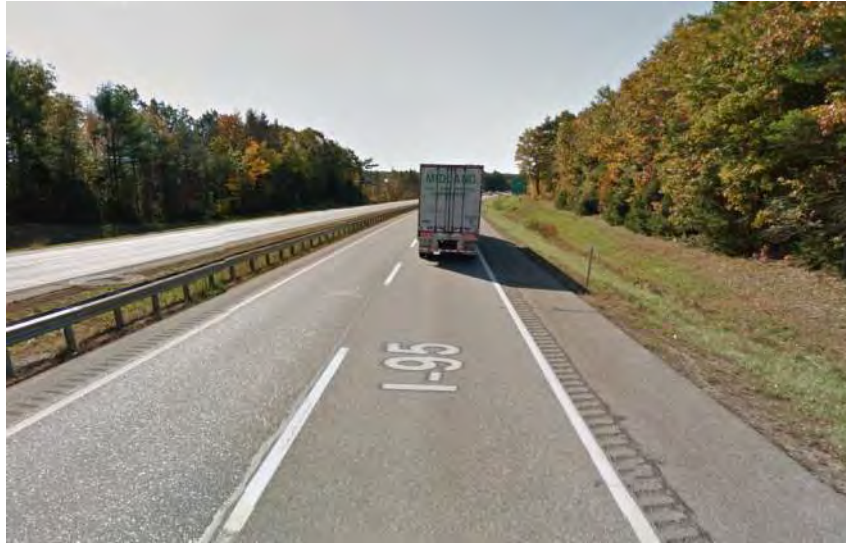
**Photo 1: I-95 SB (2011)** captured by Google Maps<sup>2</sup> in October of 2011 depicts the condition of this location at the time that it was most recently noted as an HCL.

Existing Road Audit	
Road alignment and Cross Section	This section of I-95 SB is flat but is along a horizontal curve.
Lighting	There is no lighting along this segment.
General Sign Issues	There is signage along this segment for the upcoming Exit 102 Interchange.
Marking and Delineation	This location is adequately marked to separate lanes as well as shoulders.
Barriers and Clear Zones	Median barrier exists along the entirety of the segment to separate the northbound and southbound travel directions. There are also some lengths of guardrail along the outside of the roadway at some locations within the segment.
Bridges and Culverts	Bridge 0550 carries High Street over I-95 at the southerly end of this segment and has components which have most recently been given condition ratings <sup>3</sup> of satisfactory and good.
Pavement	The pavement along this segment has most recently been given a pavement condition rating <sup>4</sup> of C.
