# 2022 Systemwide Safety and Capacity Study

June 30, 2023

Maine Turnpike Authority  
2360 Congress Street  
Portland, ME 04102

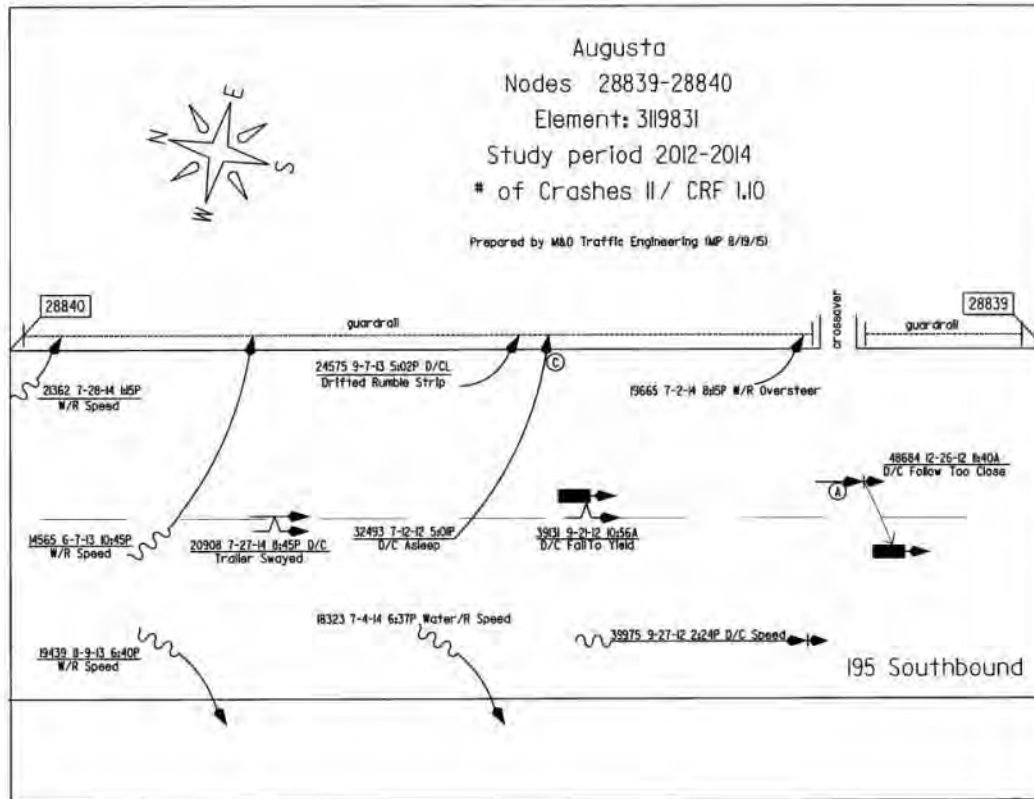
**Figure 2: 2012-2014 I-95 SB Crash Diagram** depicts the most recent available HCL diagram for this location. This location was also Identified as an HCL during the 2013-2015 time period over the past 10 years.

As shown in **Figure 2**, there were 11 crashes resulting in a 18.2% injury rate during this analysis period.

- 5 of these crashes were caused as a result of speed
  - 1 of these 5 also involved water in the travel way
- 7 of these crashes resulted in vehicles departing from the travel way
  - 5 of these 7 resulted in vehicles colliding with guardrail
- 2 of these crashes involved heavy vehicles
- 7 of the 11 crashes at this location were single vehicle crashes
- All but 1 of these crashes occurred between the months of June and September
- 6 of these crashes occurred during the evening hours of 5:00pm to 9:00pm

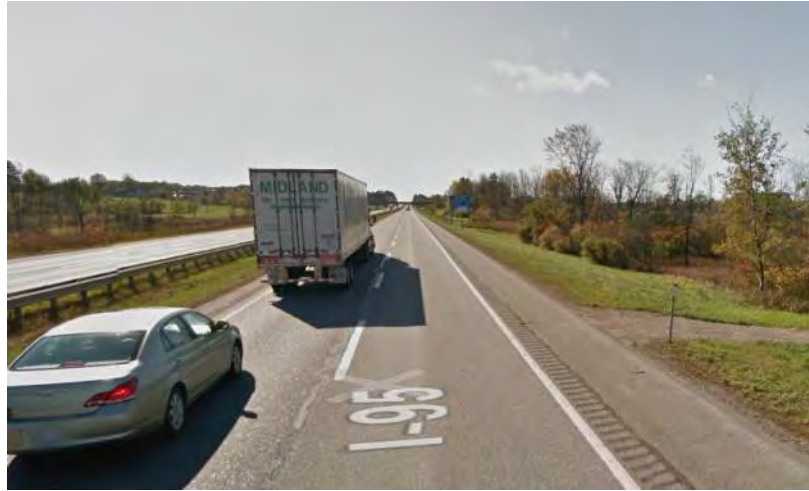
**Photo 1: I-95 SB Just South of Exit 109 Interchange** captured by Google Maps in October of 2011 depicts the condition of this location at the time that it was most recently noted as an HCL.

Existing Road Audit	
Road alignment and Cross Section	This segment has some slight horizontal curvature at the northern end, but is straight and flat beyond that.
Lighting	Lighting exists along this segment near the Exit 109 interchange.
General Sign Issues	There is speed limit signage along this segment.
Marking and Delineation	This location is adequately marked to separate lanes as well as shoulders.
Barriers and Clear Zones	Median barrier exists along the entirety of the segment to separate the northbound and southbound travel directions.
Bridges and Culverts	No bridges or culverts exist along this segment.
Pavement	The pavement along this segment has been most recently given a pavement condition rating <sup>2</sup> of B.
Heavy Vehicles	This segment has a percentage of heavy vehicles that tends to average around 9% to 12%.

This has not been a high crash location since 2015. No Recommendations at this time.
